AVOIDANCE OF GEOTECHNICAL FAILURES

Ir. Dr. Gue See Sew
Managing Director
SSP Geotechnics Sdn Bhd

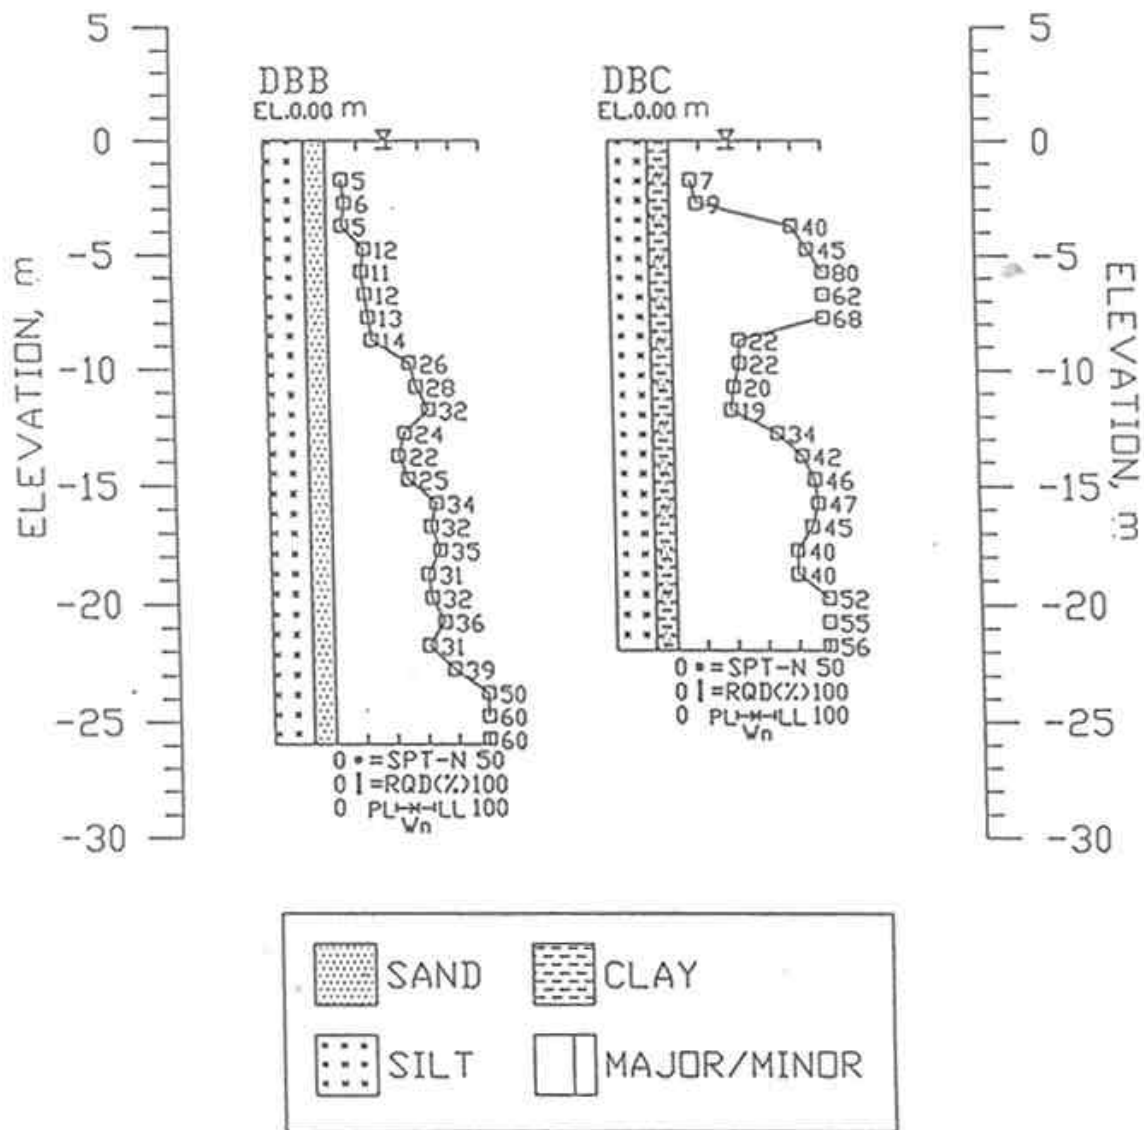
FIG 1 BORELOGS

The site was undulating and the two silos were built on a 1.5 m thick filled platform on the granitic formation. There was no borehole at the exact location of the silos. Two boreholes were drilled at some distance away to the north and south of the cement silos during the design stage. One of these boreholes indicated the presence of a very dense gravelly materials at 5 m - 8 m depth (SPT values varied between 45 to 80) as shown in Figure 1. Underlying the very dense materials was a 5 m thick layer of medium stiff sandy silt with N_{SPT} of about 20.

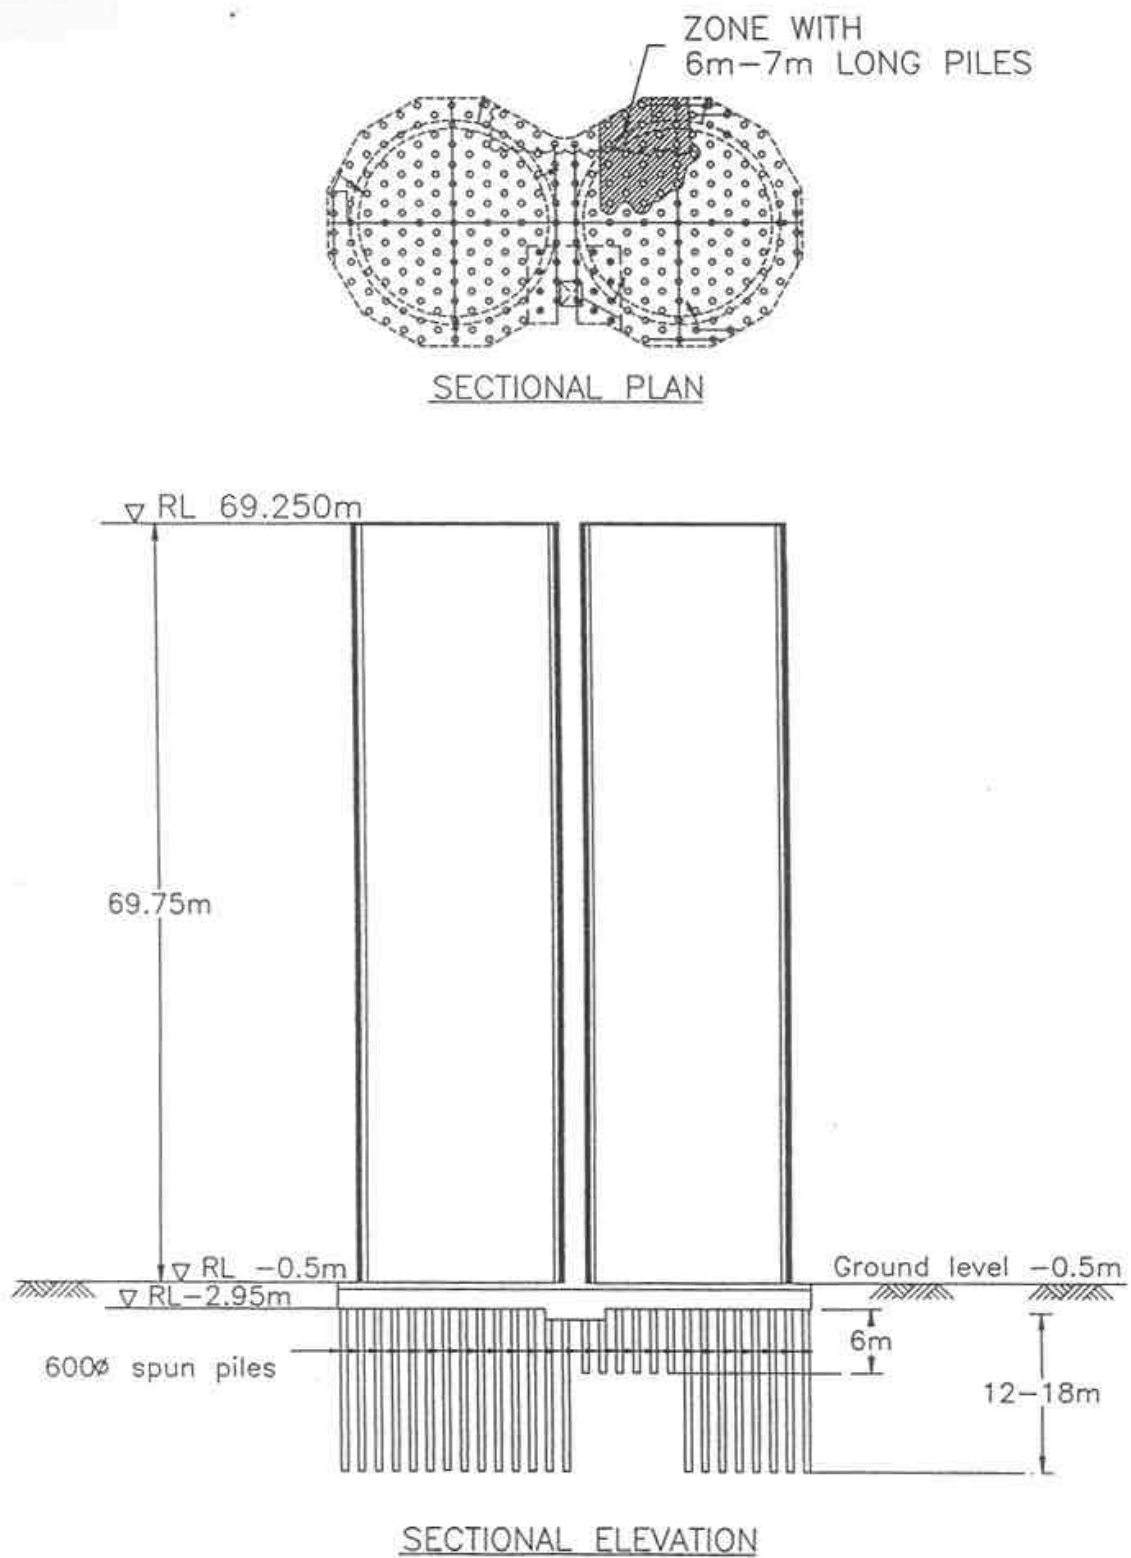
FIG 2 PILE ARRANGEMENT

Tracing back the pile driving records indicated that there was a cluster of 26 piles which set at depths varying from 6 m to 7 m. The rest of the piles set at about 17 m as shown in Figure 2.

The construction drawing only specified that piles are to be driven to set to achieve its structural capacity. Hence all piles were terminated when a set of 2 mm per blow or less (20 mm per 10 blows) was achieved.

The Q_{ult} for the 6 m to 7 m pile is about 1.2 times the working load of the pile and the Q_{ult} for the 17 m pile is about 2.5 times the working load. The Q_{ult} for the group is about 2 times the working load. The settlement analysis indicates that the settlement of the shorter pile group is about 90 mm, which is about twice that of the settlement under the longer piles.

The results of the analysis indicate that the piles have a factor of safety of 1.2 to 2.5 for the short and long piles respectively and the group has a factor of safety greater than 2. However the settlement of the shorter piles was twice higher than that of the longer piles. Hence when the silo on the cluster of short piles was loaded by storage material filling, the cluster of short piles settled more than the longer piles, thus causing the silo to tilt towards the short piles.

The monitoring of settlements and tilts of silos is still in progress to check the rates of settlements and tilts during loading and unloading. The remedial measures will only be decided after the results of the monitoring confirm the prediction of future movements.
