Massive Creep Movements of Post-Glacial Deposits in Kundasang Areas

S. S. LIEW & S. S. GUE

Gue & Partners Sdn. Bhd., Malaysia

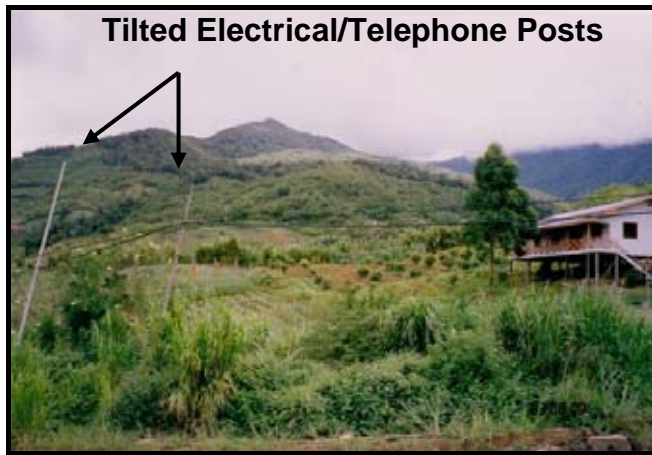
Photo 2: Tilted Electrical/Telephone Posts

There are a power transmission line running across the cattle farm and a telephone line running along the road alignment. The posts on the sloping ground were tilted due to the ground movements and the tensioning electrical cables was observed holding the top of the posts in place whereas the posts on the higher flatter and stable ground were being pulled at the top becoming tilting posts towards downhill. Photo 2 shows the tilted posts with tensioned cables.

1. The electrical posts and telephone posts show tensioning in the wires or cables within the affected area. Some of the posts were tilted and indicating direction of ground movements. The mapping of relative ground movements based on the conditions of the tilted electrical and telephone posts is shown in Figure 10.

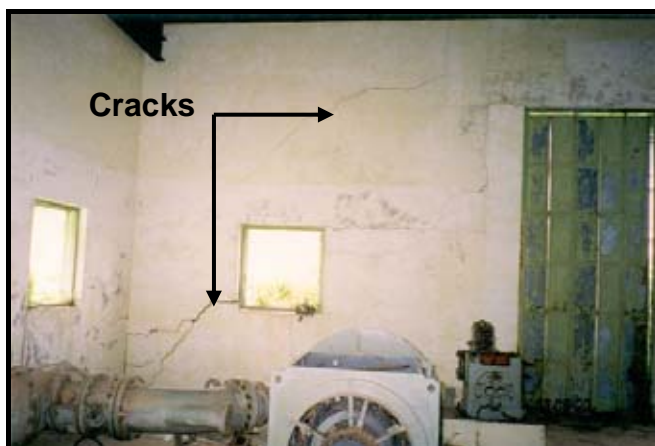
Photo 4: Distressed Pump House

It was also intended to be the power scheme for Sabah Electricity Board (SEB). The Mesilau Mini Hydro project was commissioned in 1983 but has not been used since 1985. In October 1987, a massive slip occurred and tilted the pump house, PH-2 and part of the pipeline. From the site observation, the pump house has suffered distresses due to differential settlement and lateral

ground movements. Photos 4 and 5 show the shear cracks and the detached floor slab respectively as a result of the ground movements.

2. The pump house, PH-2, at the left-hand-side of Jalan Cinta Mata near to the road junction shows a substantial displacement as the structure has tilted and displaced significantly from its original location.

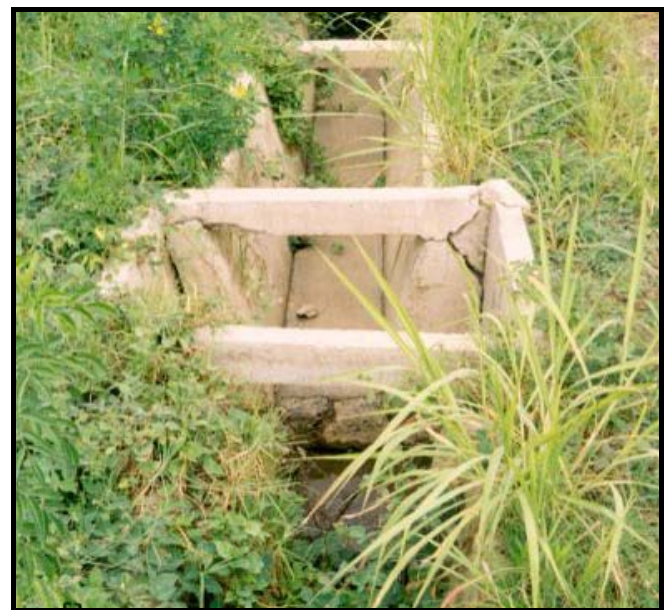
Photo 6: Distorted Drain Sump

As a result of ground movement, the concrete drains on the higher ground along the roadside also show serious cracks due to shearing and tensioning. No indication of damage on drains due to compressive thrust at the lower passive zone was observed except some distortions of the T-junction concrete drain sump as shown in Photo 6. This is because the concrete drains were constructed across the active wedge areas where tension cracks occur and probably did not extend to the passive wedge at the lower portion of the landslide masses. Repair works have been carried out to seal the cracked drain. Photo 7 shows the repaired drain.

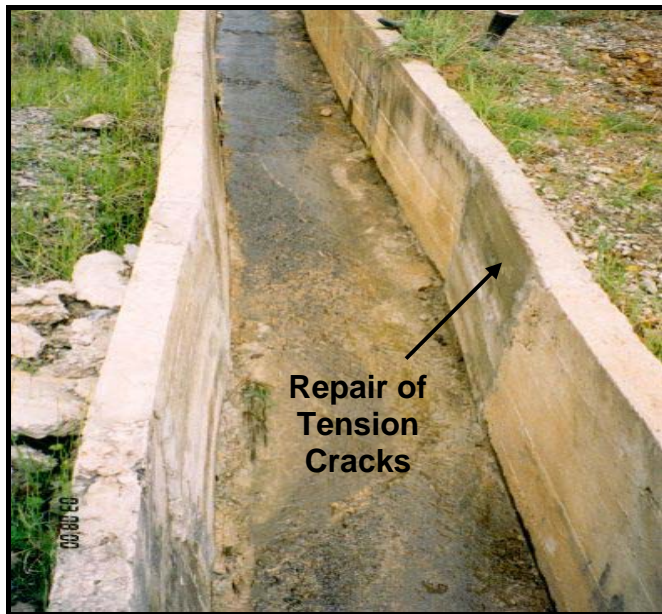
Photo 7: Repaired Cracked Drain

3. The repaired and new tension cracks along the roadside drains were observed.
4. The road pavement at the affected areas was all damaged primarily due to differential displacement on the road subgrade. It was also observed that the development of new tension cracks within the affected area was fairly active. Within few months of monitoring period, the changes of the site condition were obvious.

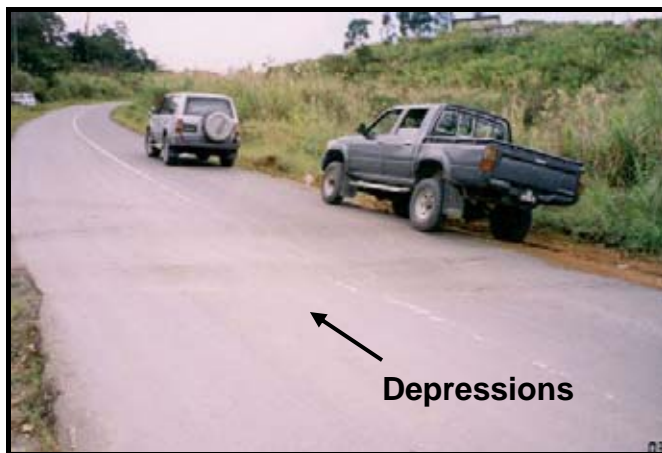
Photo 8: Depression on Road Pavement

The road pavement along the affected chainage generally shows tension cracks, potholes, Settlement and bearing capacity failure, probably due to weak subgrade as a result of ground

movement. This is shown in Photo 8. The rapid rate of distresses on the pavement indicates that the ground movements are still very active.

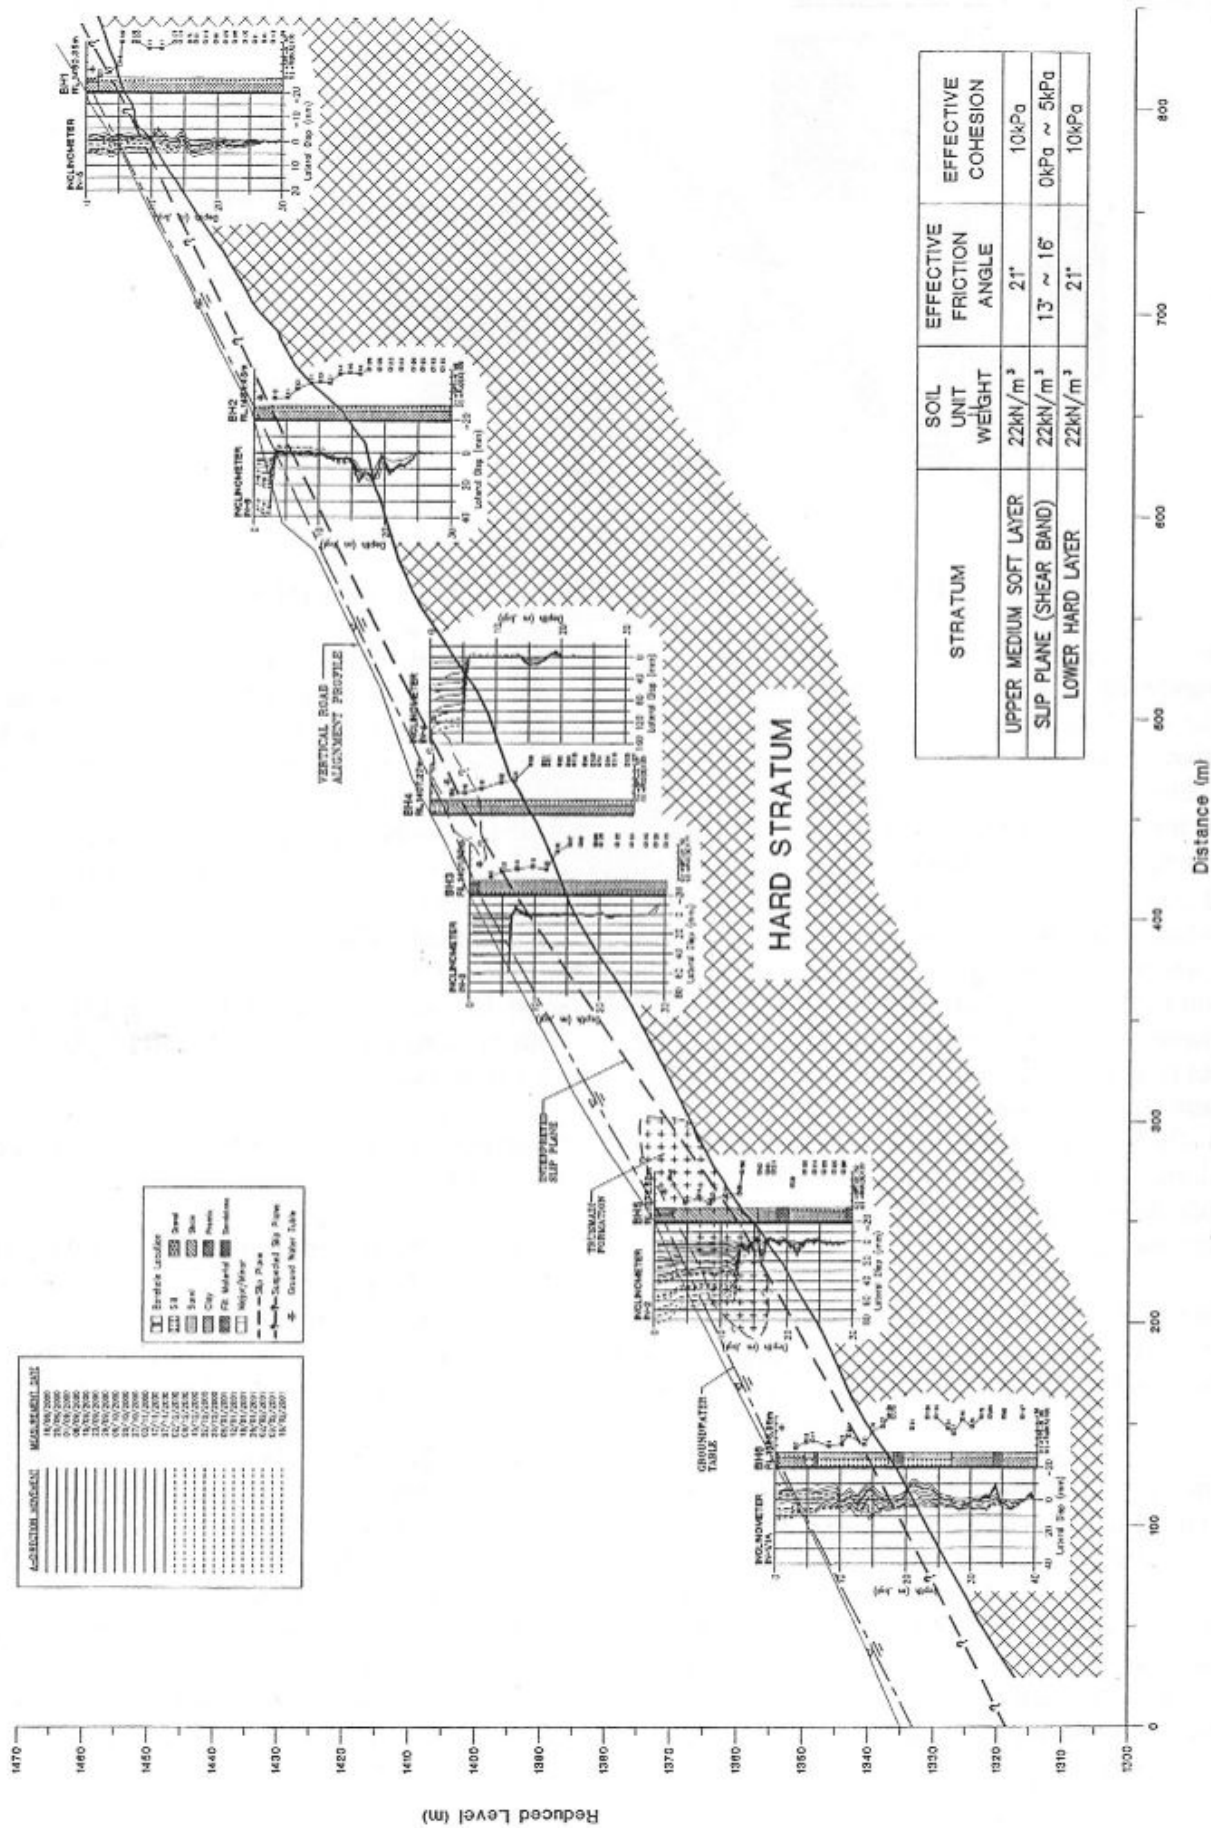
Figure 6: Subsurface Profile and Inclonometers Results

The interpreted borelog profile and the groundwater conditions are shown in Figure 6. From the inclinometer results, it is observed that distinct shear planes can be identified, particularly at inclinometers, IN-2, IN-3, IN-4 and IN-6. The direction of lateral movement of these inclinometers is in the narrow range between 225° and 250°. The maximum lateral movement is 140mm, which is in Inclinometer IN-4. The rates of maximum lateral ground movements in these inclinometers are generally in the range of 2mm/week to 14mm/week with few exceptional cases of maximum up to 21mm/week as shown in Figure 7. Whereas, inclinometers IN-1, IN-1A and IN-5 show lateral movement profile of a buckling casing and indicate that there is some compression within the subsoil at these inclinometers.

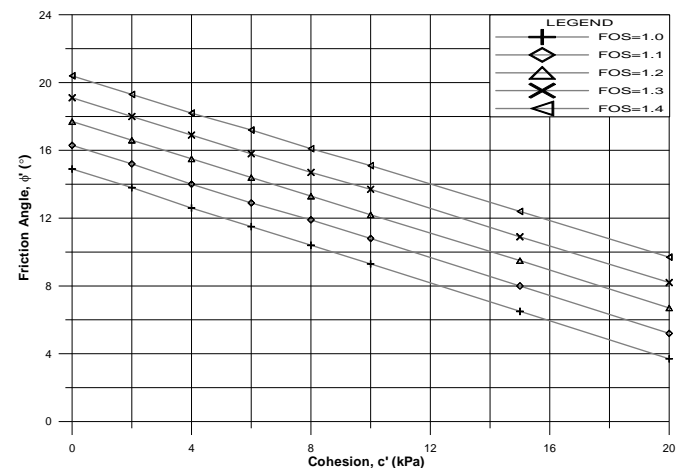
Figure 11: Back-Analysed Strength Parameters for Case A

The results of these analyses are shown in Figures 11, 12 and 13. The possible range of the back-analysed shear strength parameters at the shear plane are : $c' = 0$ to 5kPa , $\phi' = 13^\circ$ to 16° . These back-analysed soil strengths should be verified by appropriate testing on the soil samples within the slip surface during the detailed SI

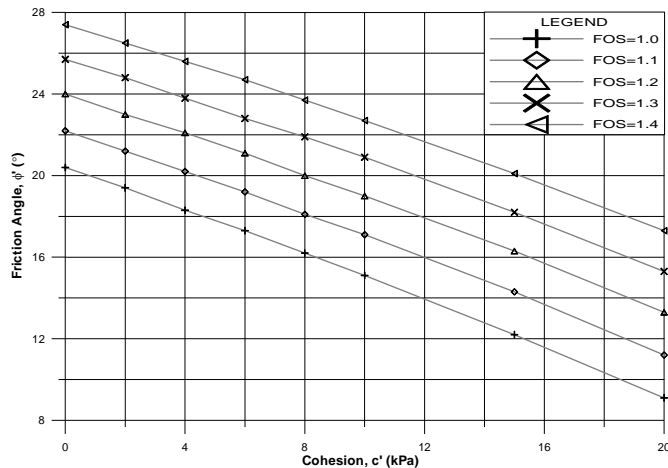
Figure 13: Back-Analysed Strength Parameters for Case C

Case C analyses are carried out solely to check the upper bound of the soil strength as such case will certainly require higher strength to keep the slope in stable condition as compared to the other two cases. But the back-analysed soil strengths are still lower than the aforementioned interpreted soil strength from the laboratory tests if cohesion intercept is taken as 10kPa. If the cohesion is ignored, the back-analysed friction angle is same as the friction angle interpreted from the laboratory test results, which means the safety

factor for the localised stability at the river bank is just about 1.0. If such localised instability can retrogress uphill to trigger the blanket sliding failure mode as indicated from the inclinometers, there shall be some multiple shear planes in the inclinometer results. However, there is no obvious multiple shear planes observed in all six inclinometers. Therefore, such mode of failure is ruled out for further investigation.
