Geotechnical Investigation and Monitoring Results of a Landslide Failure at Southern Peninsular Malaysia (Part 1: Investigating Causes of Failure)

Liew, S. S., Gue, S. S., Liong, C. H.

Director, Gue & Partners Sdn Bhd, Malaysia.

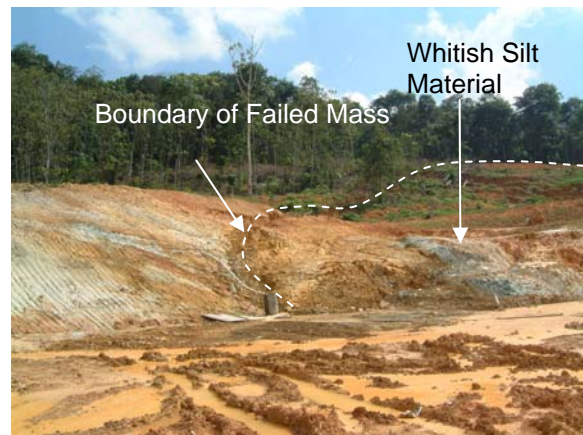
Figure 2 Front View of Failed Slope

A site inspection was carried out shortly after the slope collapsed. Whitish silt material was found on the cut surface of the failed slope as shown in Figure 2. Tension cracks were also observed at top of slope as shown in Figure 3.

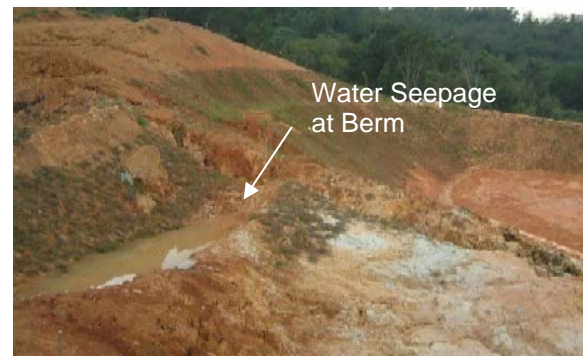
Figure 4 Water Seepage at Berm

Figure 4 shows water seepage at various locations, indicating potential high groundwater level at the failed slope. Small boulders were also observed on the surrounding of the slope. The existence of boulders (diorite and gabbro) within the subsoil was further confirmed during the borehole exploration.

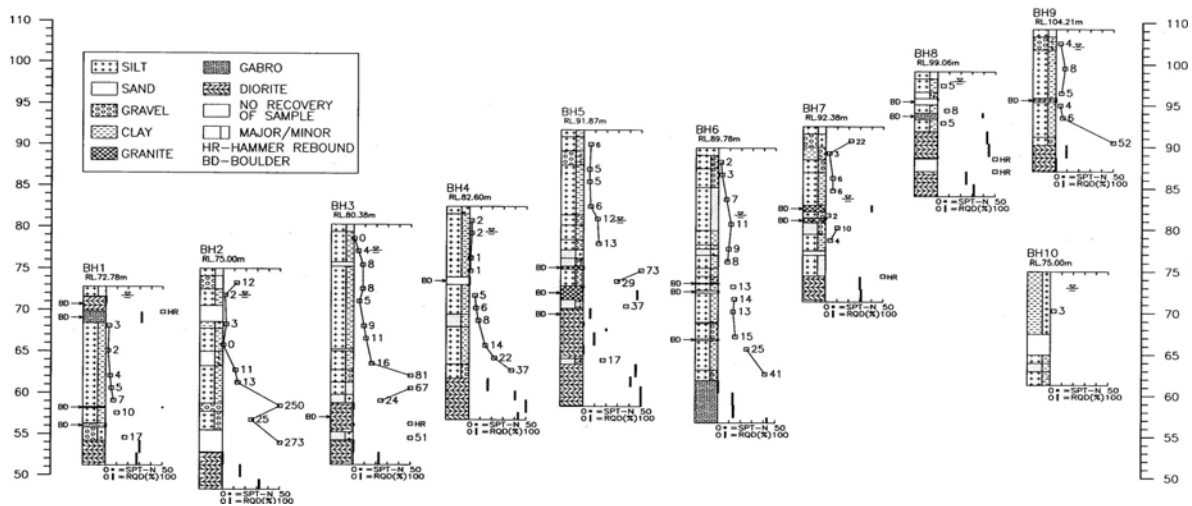
Figure 6 Interpreted Subsoil Profile

sunk within the failed mass. Upon completion of boring operation and sample collection, inclinometers, IN-1, IN-2 and IN-3 were installed in the boreholes. Apart from the inclinometers, three observation wells, OW-1, OW-2 and OW-3 were also installed at 1m away from boreholes BH-1, BH-2 and BH-3 respectively. Liew & Gue (2001) have presented a similar investigation for post glacial deposit in East Malaysia, in which the inclinometers have successfully determined the creep movements and slip surface. Figure 6 shows the interpreted subsoil profiles. The overburden material is generally weak, with SPT-N ranging from 0 to 15.

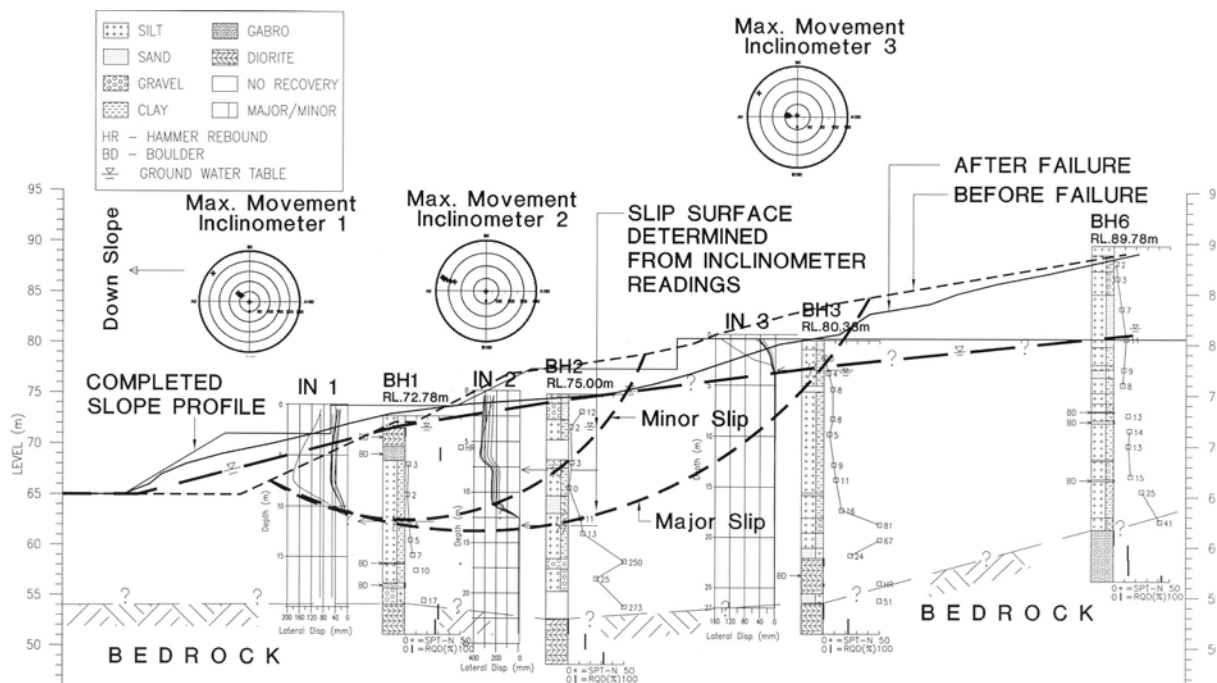
Figure 7 Multiple Slip Surfaces Interpreted from Inclinerometers

Inclinometers, IN-1 and IN-2, were sheared off at 10.5m and 12.0m below ground level shortly after installation. Subsequent monitoring revealed that inclinometer, IN-2, was sheared off again at another higher location, 6.0m below ground level. Finally, IN-3 was sheared off at 2.5m below ground level. The first major slip surface was identified when the three inclinometers were sequentially sheared off. The three shear-off points of the inclinometers resemble a well defined circular slip surface when joined together. The circular slip surface also agrees well with the tension cracks and bulging of the slope toe indicating where the slip surface starts and ends on the slope profile. The second shear off point at inclinometer, IN-2, revealed another minor slip surface formed after the first major slip surface. The inclinometer results are shown in Figure 7, which shows the interpreted multiple slip surfaces in the failed slope. Figure 7 indicates that collapsed mass has resultant movements towards south-west direction.

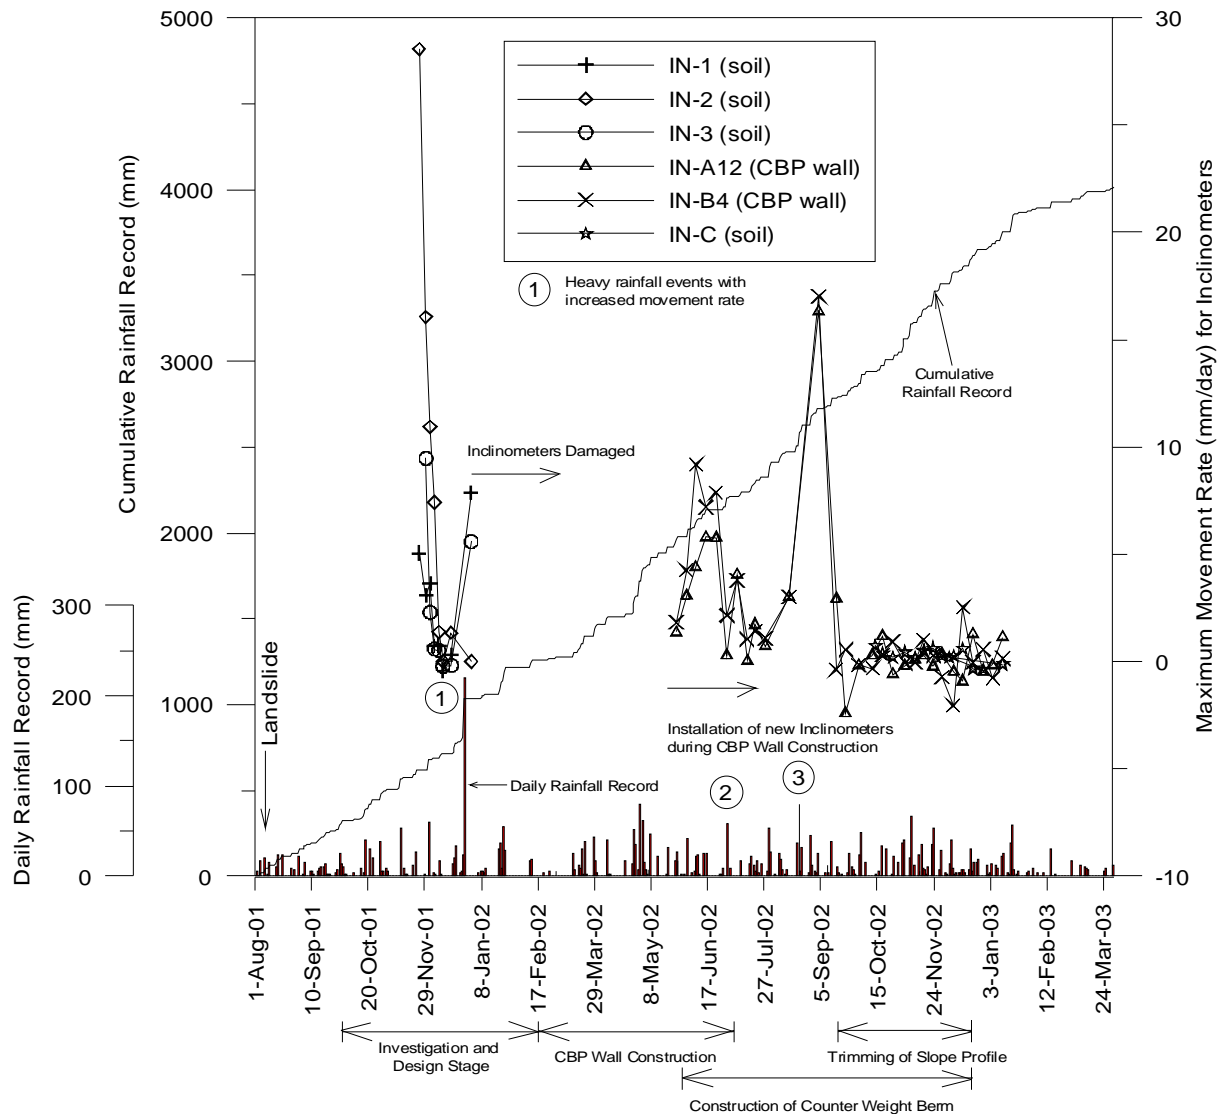
Figure 8 Rainfall Record and Maximum Movement Rate for Inclinerometers

The rates of maximum movement of the inclinometers are shown in Figure 8 together with the daily and cumulative rainfall records. Inclinometer, IN-2, registered the largest movement rate during the initial monitoring period as it was installed in the middle of the collapsed mass. The trend of movement rate for the other inclinometers was very similar and consistent. The movement rate started with a peak and reduced gradually. However, during investigation, the movement rate increased before the inclinometers were damaged. It is observed that the increased movement rate corresponds with an extremely heavy rain recorded on 27 Dec 2001.

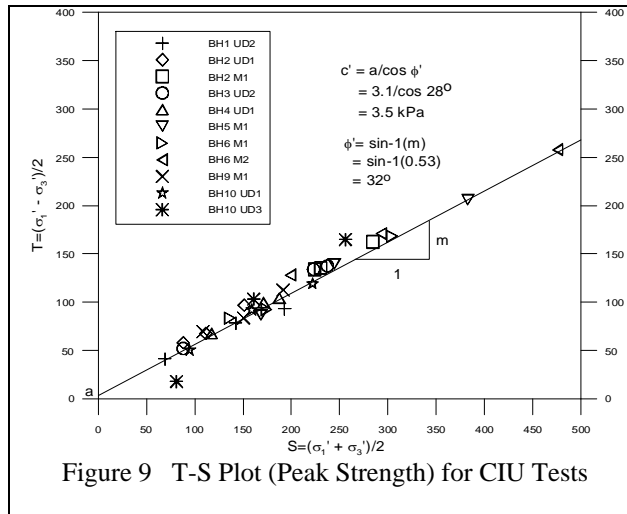
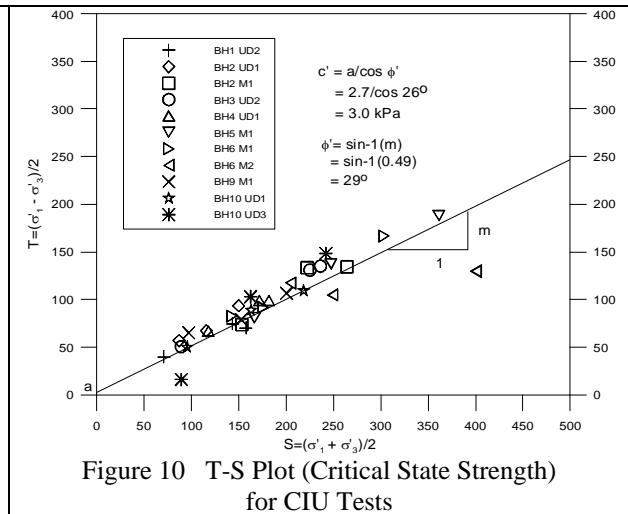
Eleven (11) numbers of C.I.U. tests were carried out on the thin wall and Mazier samples. Figures 9 and 10 show both the T-S plot for the interpreted peak strength ($c' = 3.5$ kPa and

$\phi'=32^\circ$) and critical state strength ($c' = 3.0$ kPa and $\phi'=29^\circ$). As shown in the graphs, the C.I.U. results are fairly consistent.

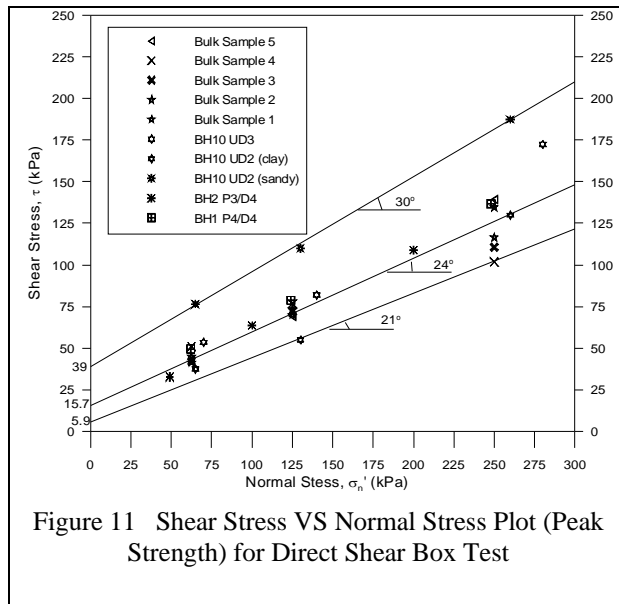
Figure 11 shows the upper bound of the peak strength of : $c'=39.0$ kPa, $\phi'=30^\circ$ while the lower bound value of : $c'=5.9$ kPa, $\phi'=21^\circ$. The average shear strength obtained is : $c'=15.7$ kPa, $\phi'=24^\circ$.

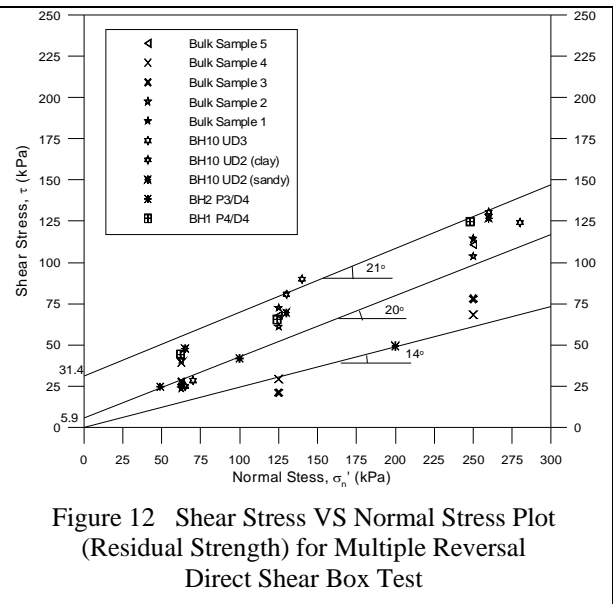
Figure 12 shows the upper bound of the residual strength of : $c'=31.4$ kPa, $\phi'=21^\circ$ while the lower bound value of : $c'=0$ kPa, $\phi'=14^\circ$. The average shear strength obtained is : $c'=5.9$ kPa, $\phi'=20^\circ$. The scatter of interpreted residual strength is rather large and could be largely due to inconsistency in generating the smooth shearing surface in this particular soil type during the reversal shearing process. A continuous large strain shearing in one direction, like ring shear test, could have produced a more consistent residual strength.
