Chapter 23

Failures of Ground Improvement Works in Soft Ground

See-Sew, Gue and Yean-Chin, Tan

Gue & Partners Sdn Bhd, Geotechnical Consultants, Kuala Lumpur, Malaysia

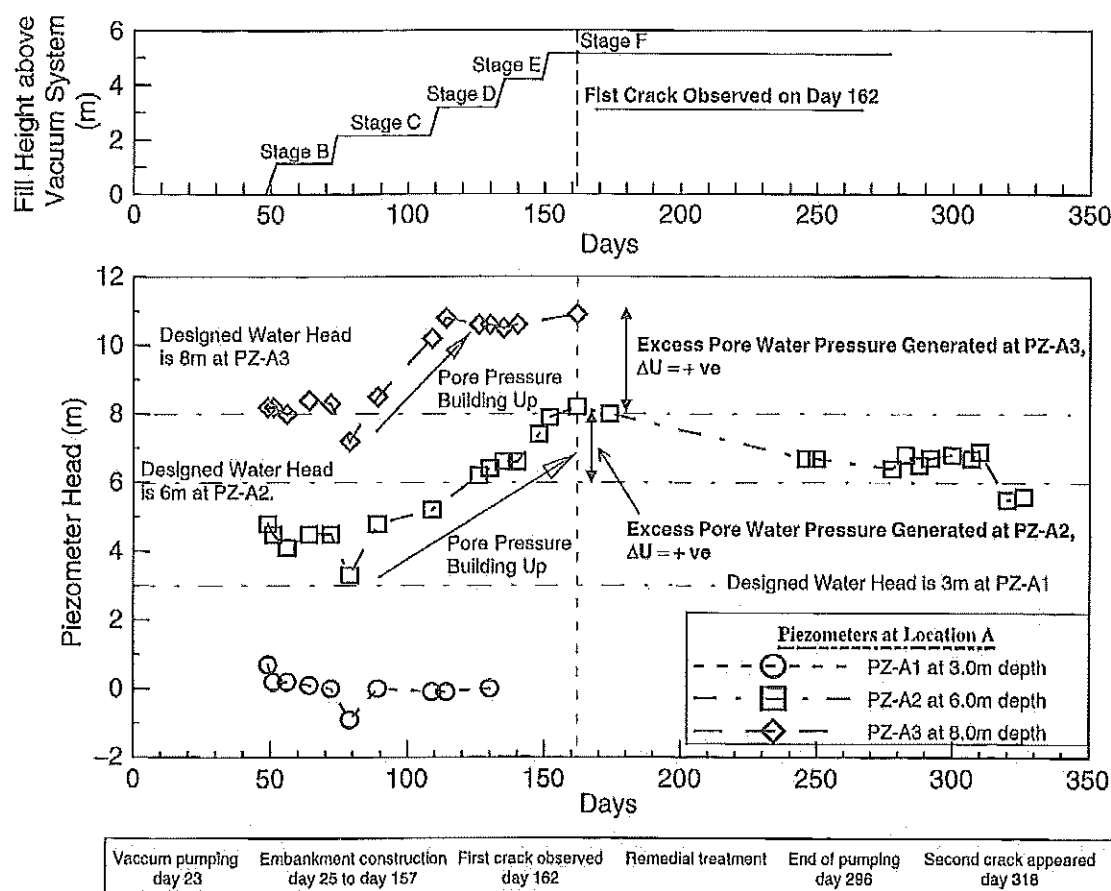
As shown in Figure 3, from Stage C filling onwards, the pore water pressures measured from piezometers PZ-A2 and PZ-A3 at depths of 6 m and 8 m respectively, increased until failure at day 162 after reaching the final fill height. Piezometer PZ-A1 at depth of 3 m did not show an increase in pore water pressure until it was out of order after day 130. In brief, the measurement from piezometers PZ-A2 and PZ-A3 at Embankment A indicated that the vacuum suction at these depths was not functioning properly to prevent increase in pore water pressures in the cohesive subsoil with respect to the filling.

The trend of increase in pore water pressures has been observed for more than 1 month but no contingency action was taken by the contractor, who was also responsible for the design, to investigate the causes and to stop filling until the pore water in the subsoil returned to the allowable design values.

The independent analyses carried out by the authors employing both Undrained Strength Analysis (Ladd and Foott, 1974; Ladd, 1991) and the Effective Stress Method also indicate that the design of the vacuum preloading was acceptable if the vacuum system performed as designed. Therefore, if the contractor had taken the initiative to review the monitoring results of the piezometers installed in the subsoil as part of the required procedures for vacuum preloading, the failure could have been prevented because the trend of increase in the pore water pressures in the subsoil was very clear and easily identified.

Figure 3. Construction sequence and monitored pore water pressure changes of failed embankment A.

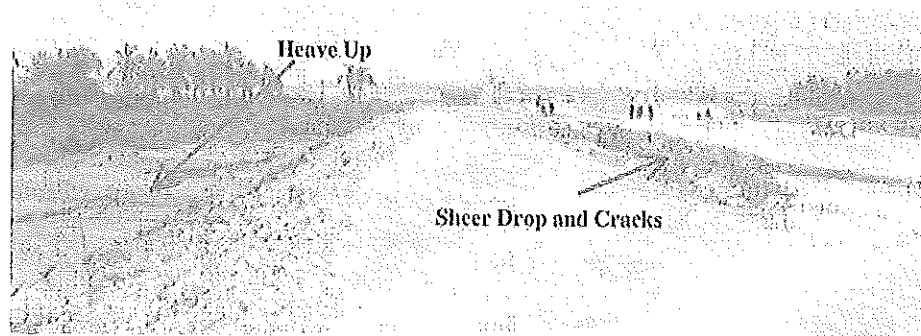
Figure 5. Failure of Embankment A treated with stone columns.

of the stone columns, the embankment failed with large cracks (as shown in Figure 5) when the fill height reached 3.2 m, which is 2.3 m lower than the required fill height of 5.5 m.

The authors' review indicates the design by the specialist contractor only used Priebe's methods (1995) to check on the stability and settlement of the subsoils treated with stone columns. There was no evidence of separate calculations using other methods to check on the bulging and general shear failures of the stone columns when determining the ultimate bearing capacity; these failure modes are not sufficiently covered in Priebe's method. Table 1 lists some of the methodologies available for bulging and general shear failure check.

From the investigation by the authors using disturbed strength of the subsoil on the methods listed in Table 1, the results show that generally bulging failure is not a concern but 'general shear failure' is grossly inadequate.

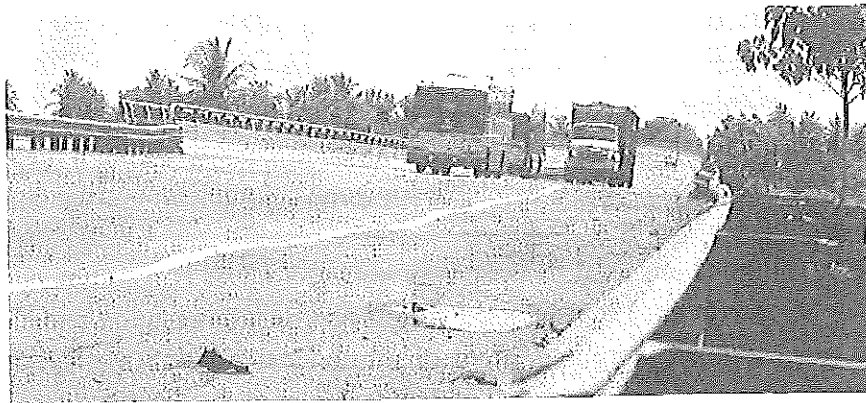
Figure 7. 'Mushrooms' and undulating surface on expressway.

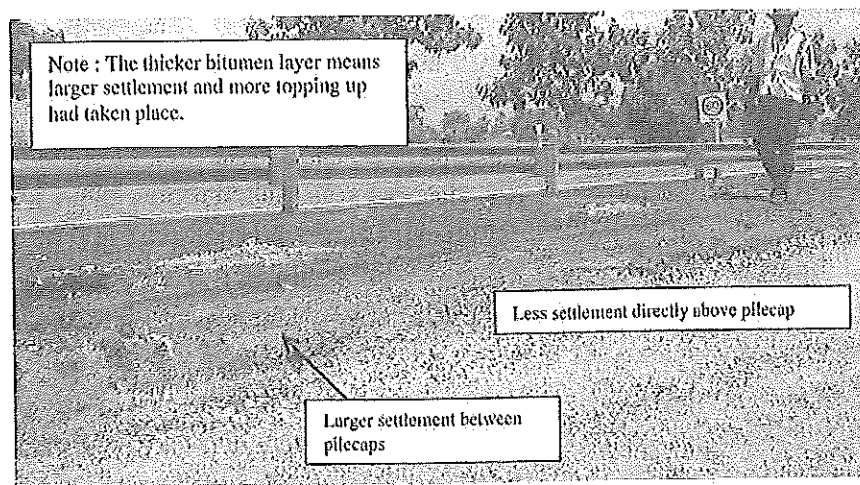
Figure 8. Differential settlement observed after excavation to a depth of about 300 mm for construction of remedial works.

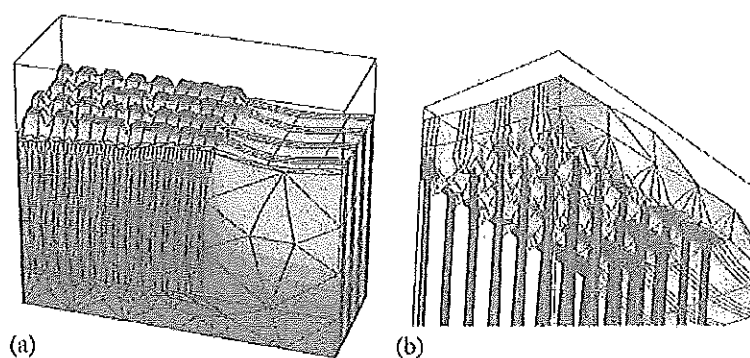
Results from the FEM analyses have shown that the differential settlement of the embankment ranges from 64 mm to 156 mm with angular distortion as high as 4% (1/25). This is in excess of the recommended values of 1% (1/100) by BS8006 (1995). Typical results from the FEM analyses showing the 'mushroom' problem are shown in Figure 10.

Figure 10. Results of 3D FEM analyses showing 'mushroom' problems: (a) top view (b) bottom view.

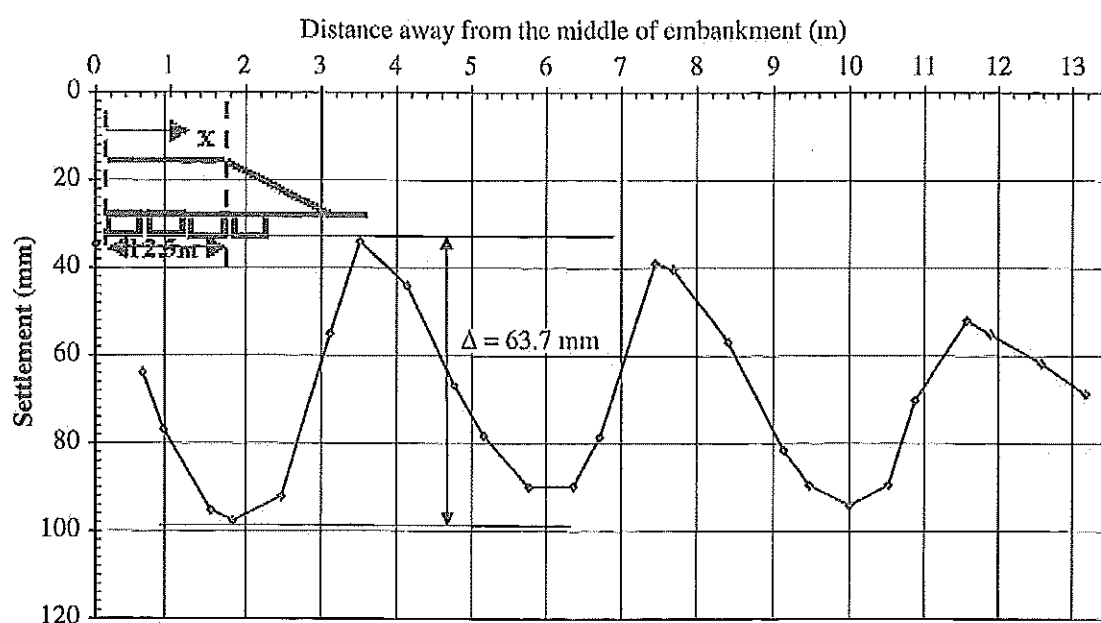
The settlement profile along a typical section of the embankment showing the computed differential settlement and angular distortion is plotted in Figure 11. In summary,

Figure 11. Settlement profile before remedial treatment across the embankment.

results of FEM analyses have shown that the 'mushroom' problems arise due to the ineffective arching mechanism influenced by the following factors:

- (a) unsuitable fill materials,
- (b) large pile spacing to the height of fill.

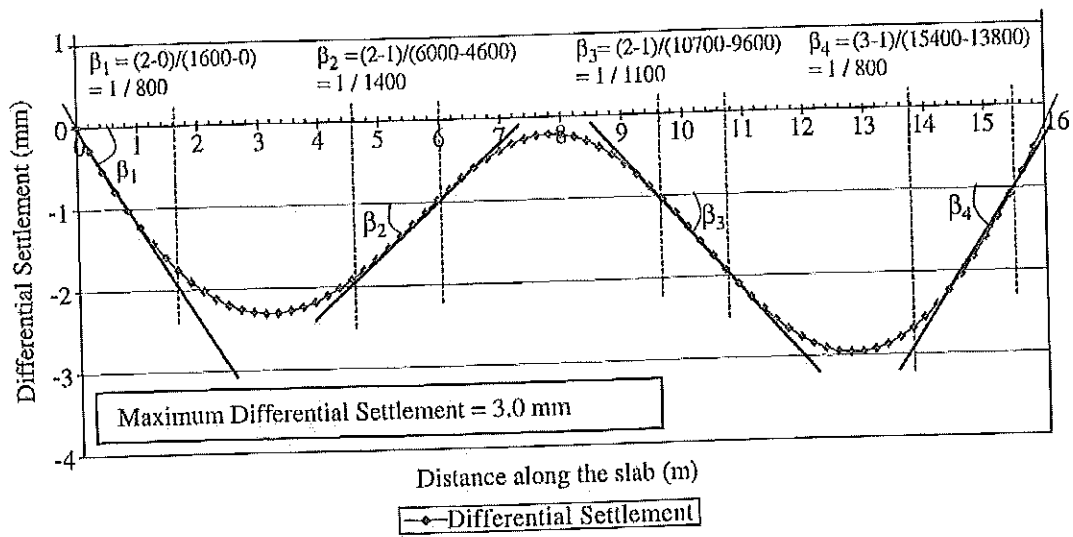
Figure 12. Settlement profile after remedial treatment across embankment using RC raft at shallow depth.

The design was checked using FEM analyses to ensure the required long-term angular distortions of 1% (1/100) as recommended by BS8006 (1995). Results of FEM analyses have indicated that the angular distortion of the embankment is below 1% upon construction of the RC raft. Figure 12 shows typical results from the FEM analyses with the computed angular distortions and maximum differential settlement. In summary, the RC raft at shallow depth solution adopted consists of

- (a) Raft thickness = 250–300 mm depending on embankment characteristics (fill height, pile spacing, etc.).
- (b) Reinforcement required = T16–150 mm c/c (Top and Bottom).
- (c) Characteristic concrete strength = 35 N/mm².

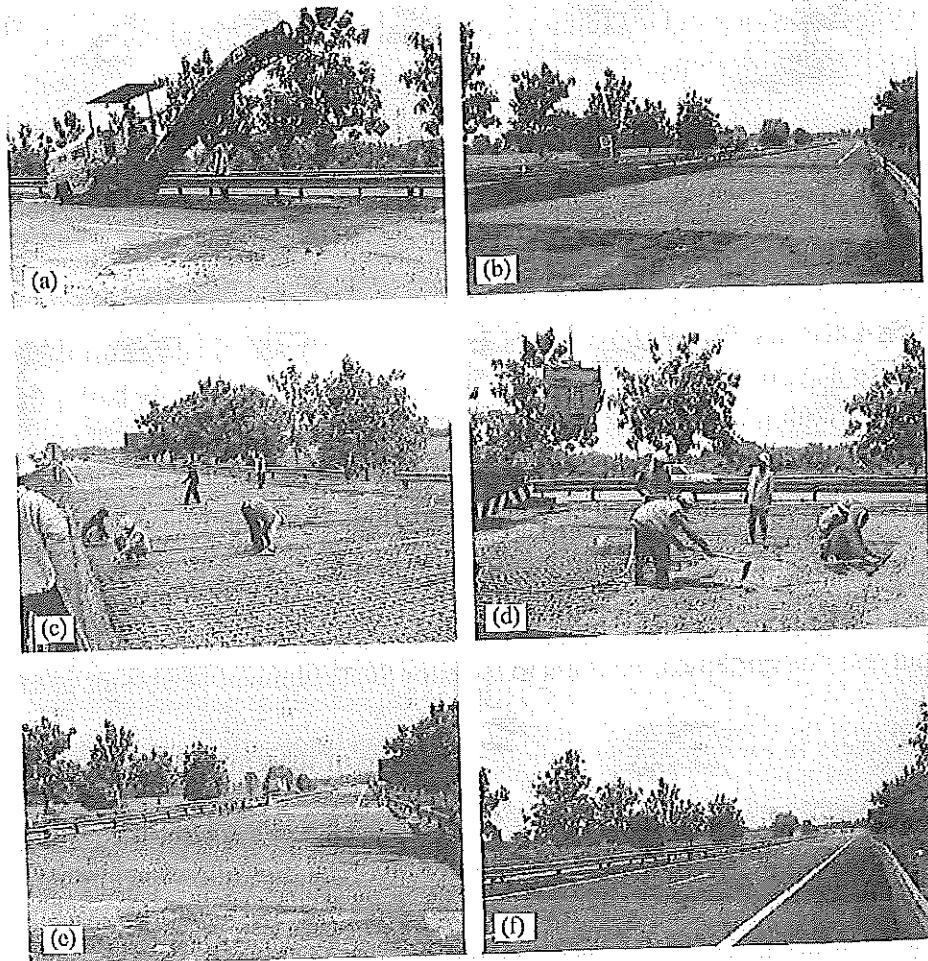
Figure 13. (a) Milling works up to 300 mm deep in progress (b) after milling (c) laying of steel reinforcement (d) concreting (e) completed RC Raft (f) pavement completed, traffic re-opened.

The simple construction sequence is very important for this site due to its location within a busy expressway. Therefore, the simple construction sequence will minimize lane closure for the construction works. In addition, the remedial solution is easy to construct and does not require a specialist contractor. The typical construction sequence of the works for a recently completed pilot stretch is shown in Figure 13.
