*IEM-GSM Oktoberforum 2005: “Case Histories in Engineering
Geology and Geotechnical Engineering”, 4th Oct. 2005,
Petaling Jaya*

DISCONTINUITIES STUDY AND ROCK SLOPES STABILITY ANALYSIS FOR ROCK MASS AT DAMANSARA AREA, P.JAYA

Prepared by:
Nur Huda & Yew, C.K.

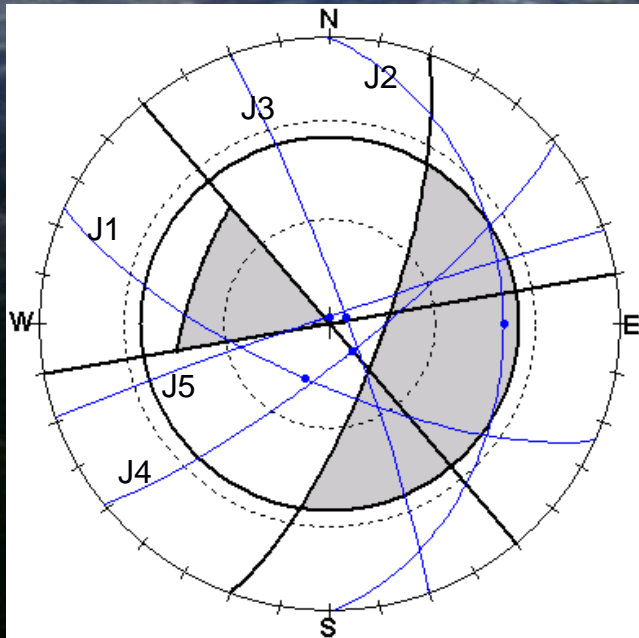
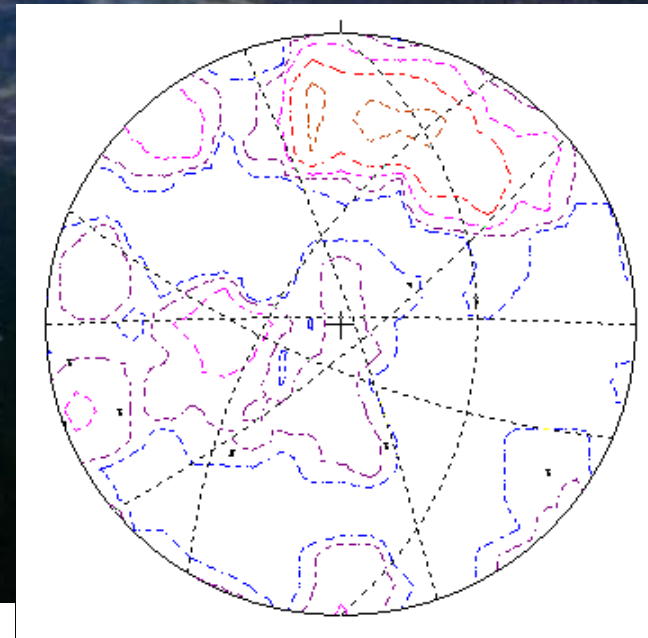
a) Zone A

- Located at the northeast part of the Damansara Hill
- Major Discontinuities: J1 (203/73), J2 (090/40), J3 (071/85), J4 (140/80) and J5 (360/88)
- Potential Wedge Failure: J1 & J2, J2 & J4, J2 & J5
- Potential Plane Failure: J2

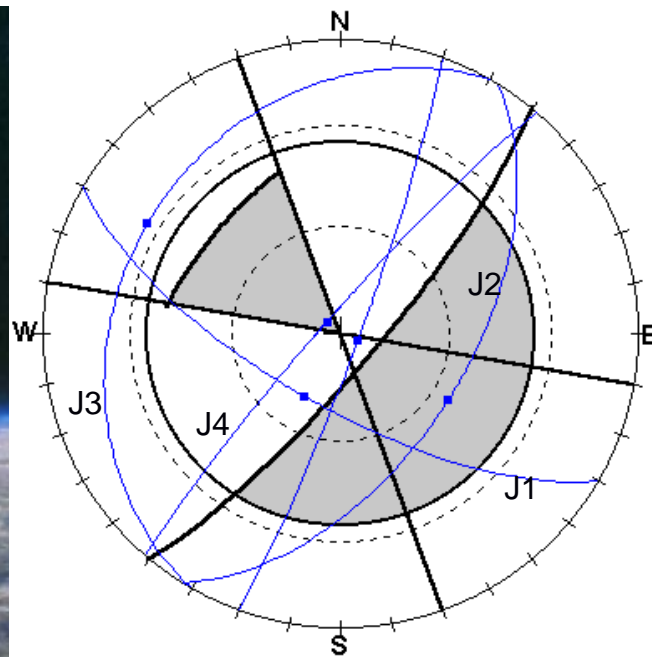
b) Zone B1

Zone B1 was located at the highest part of the Damansara Hill

Major joints: **J1 (210/70)**, J2 (110/85), J3 (300/26), J4 (310/85)

Potential Wedge **Failure**: J1 & J2

Potential Toppling Failure: J4

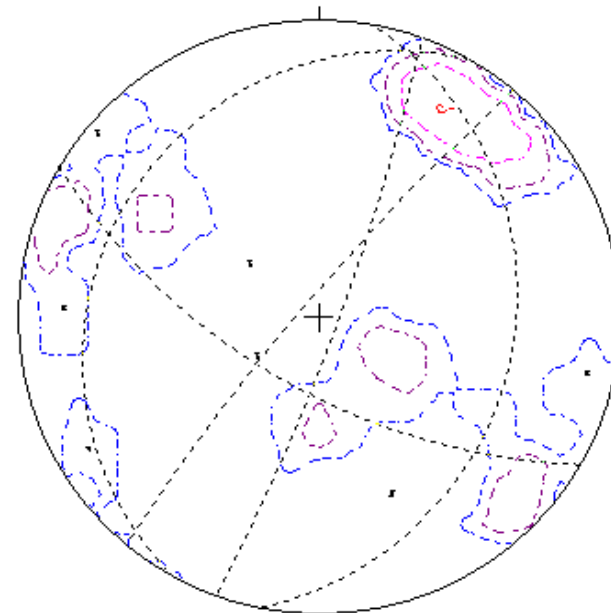
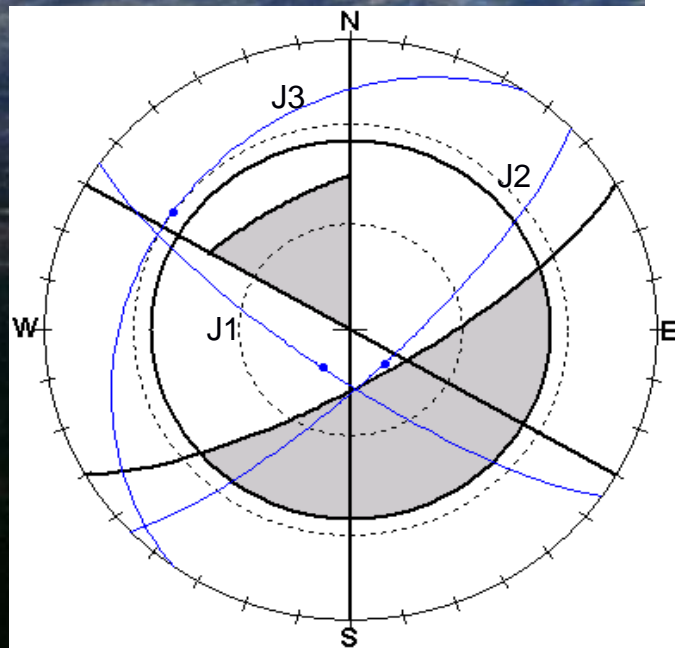
c) Zone B2

Zone B2 located at the southern part of the study area.

Three possible failure identified are circular, plane and wedge failure from the three major discontinuities of J1 (215/77), J2 (136/77, and J3 (305/30)

Analysis on the pole plot shows that the discontinuities data scattered randomly - **possibility of circular failure**

Potential Wedge Failure: J1 & J2

Potential Plane Failure: J1

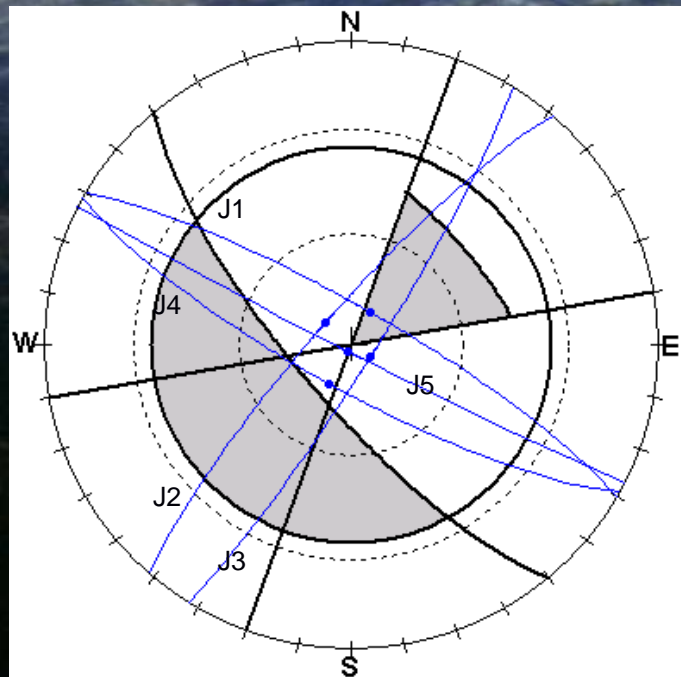
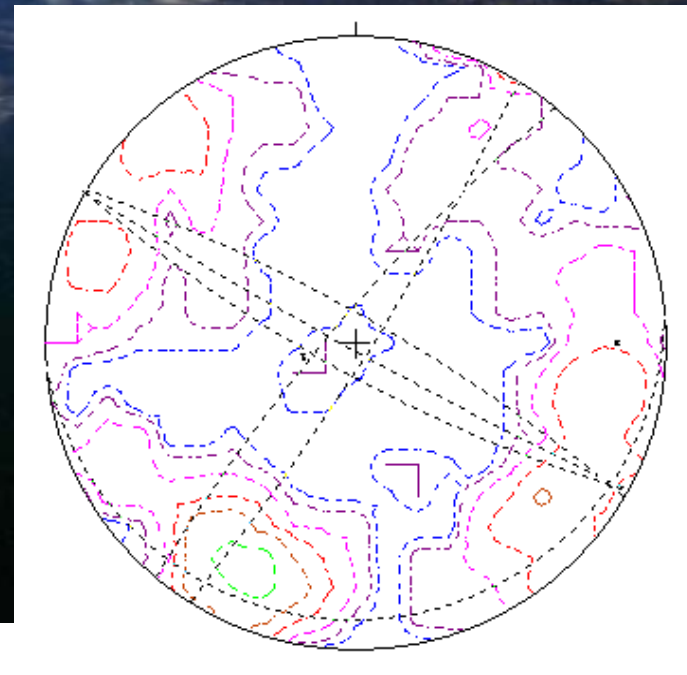
a) Zone C

Zone C is located at the Damansara business centre area at the southern part of the Damansara hill.

Major discontinuities: J1 (030/80), J2 (310/81), J3 (122/84), J4 (209/88) and J5 (209/78)

Potential Wedge Failure: J2 & J4

Potential Toppling Failure: J1

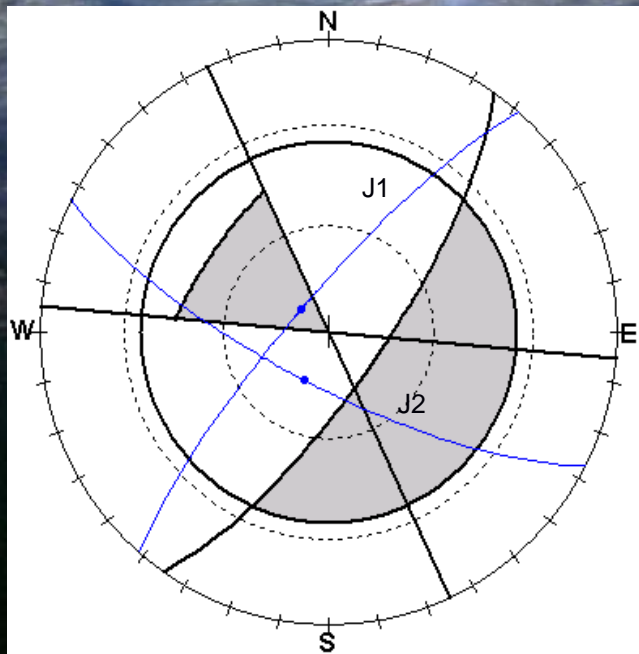
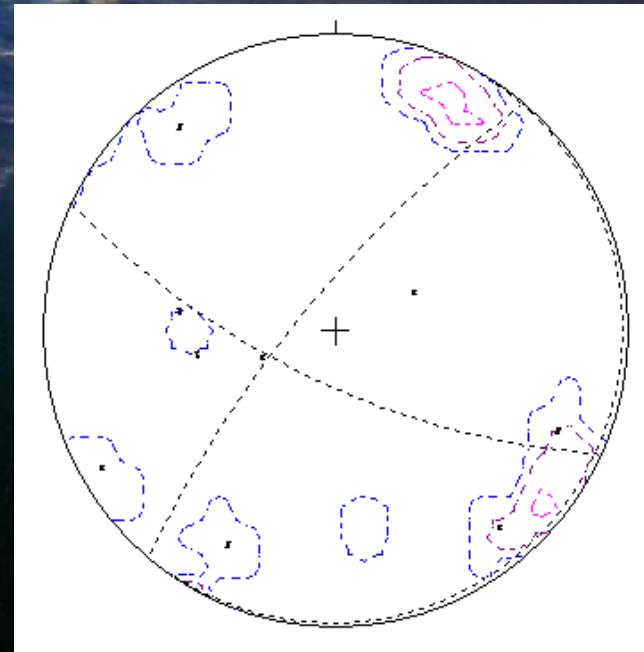
b) Zone D

Zone D is located at the northwest part of the study area
Major discontinuities: J1 (310/80), J2 (208/75),
Potential Toppling Failure: J1

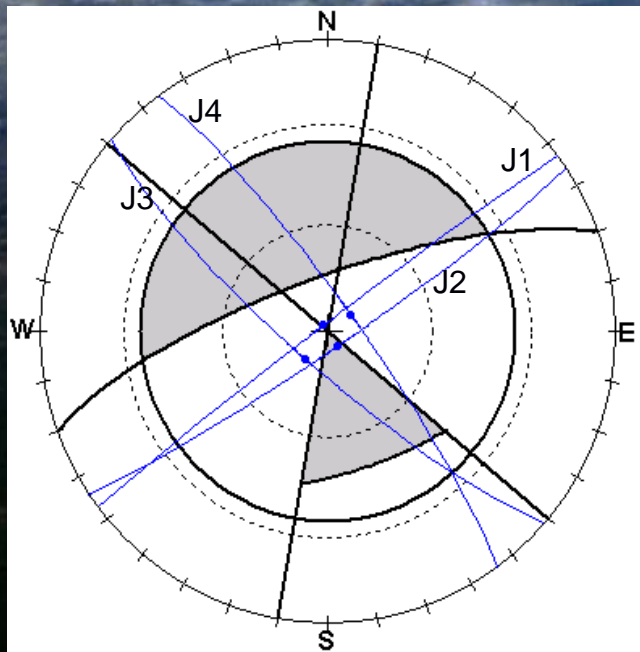
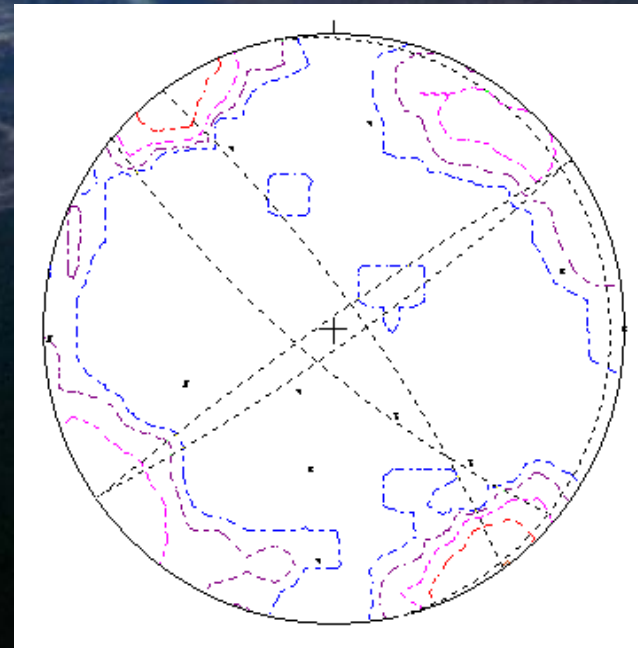
c) Zone E

Major discontinuities: J1 (325/88), J2 (145/85), J3 (220/80), J4 (054/82)

Potential **Toppling Failure**: J2

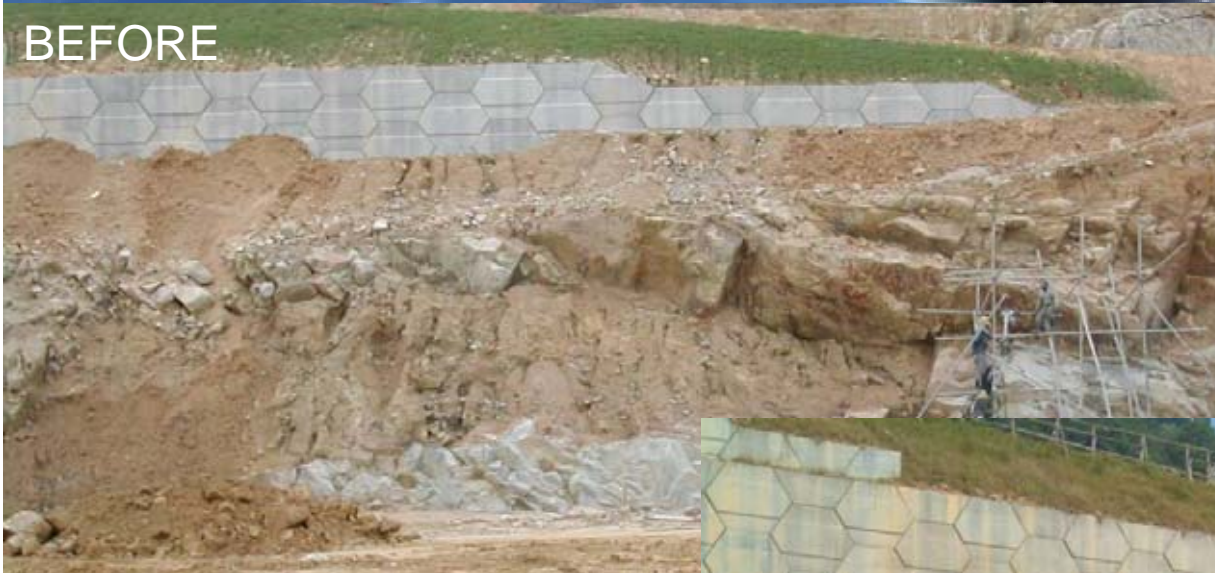
BEFORE

Zone A Rock Slope

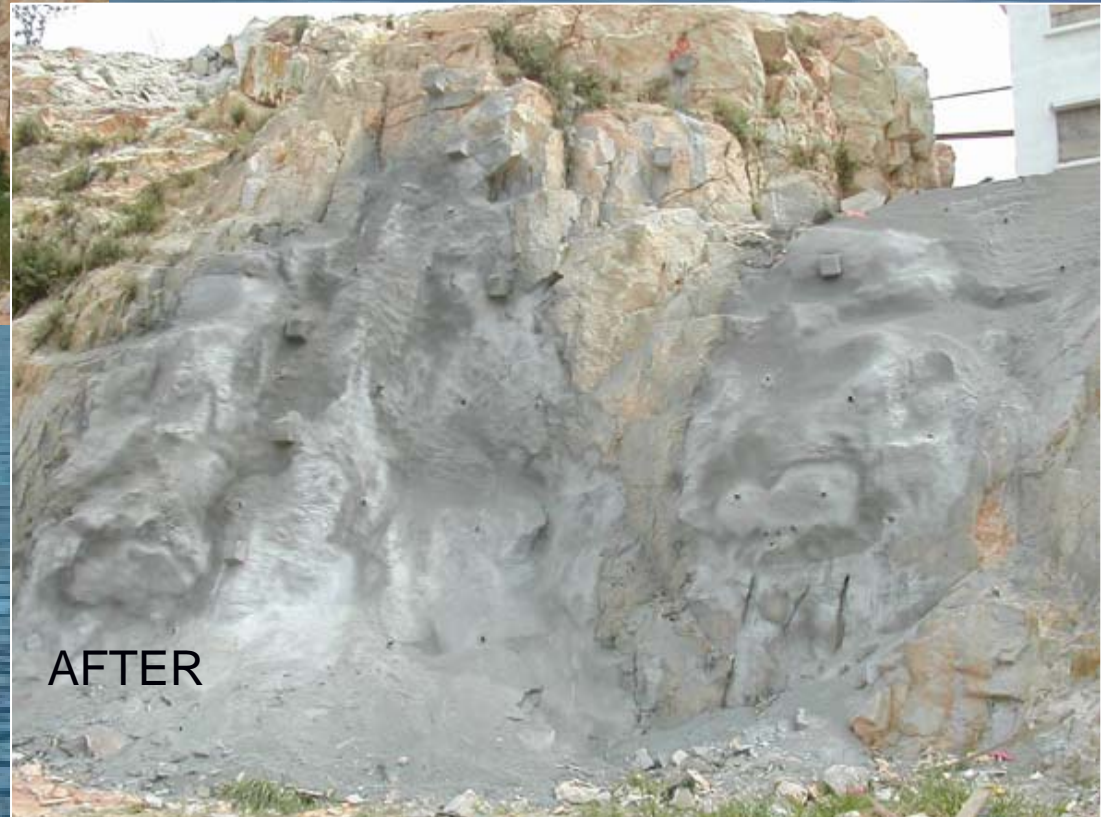
BEFORE

Zone E Rock Slope
