*IEM-GSM Oktoberforum 2005: “Case Histories in Engineering
Geology and Geotechnical Engineering”, 4th Oct. 2005,
Petaling Jaya*

DISCONTINUITIES STUDY AND ROCK SLOPES STABILITY ANALYSIS FOR ROCK MASS AT DAMANSARA AREA, P.JAYA

Prepared by:
Nur Huda & Yew, C.K.

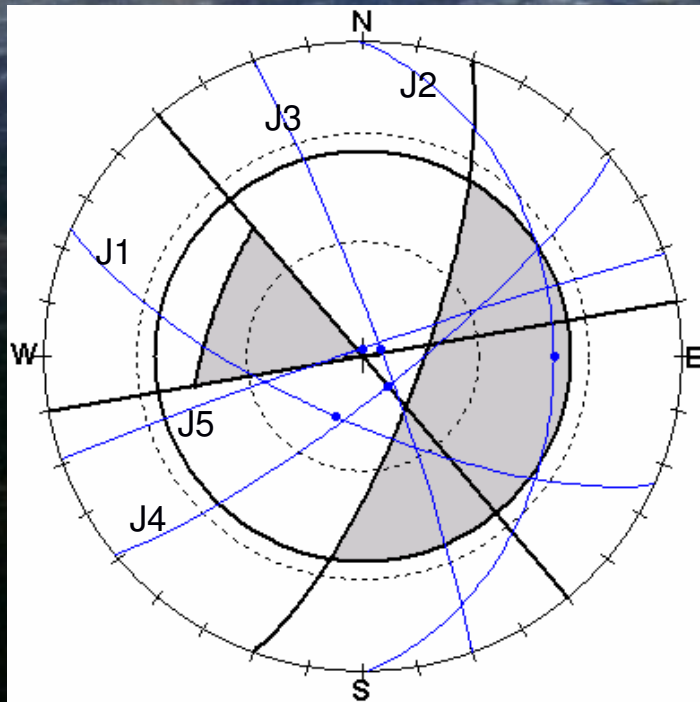
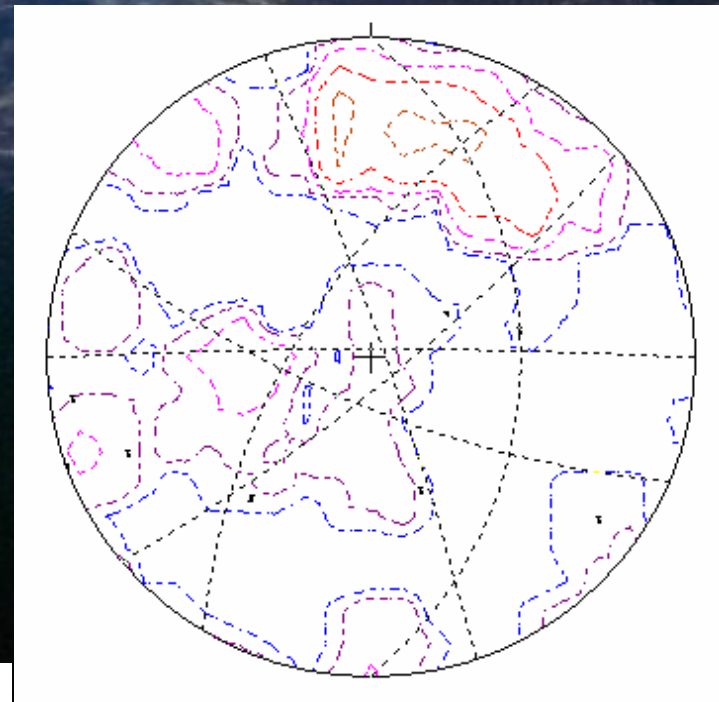
a) Zone A

- Located at the northeast part of the Damansara Hill
- Major Discontinuities: J1 (203/73), J2 (090/40), J3 (071/85), J4 (140/80) and J5 (360/88)
- Potential Wedge Failure: J1 & J2, J2 & J4, J2 & J5
- Potential Plane Failure: J2

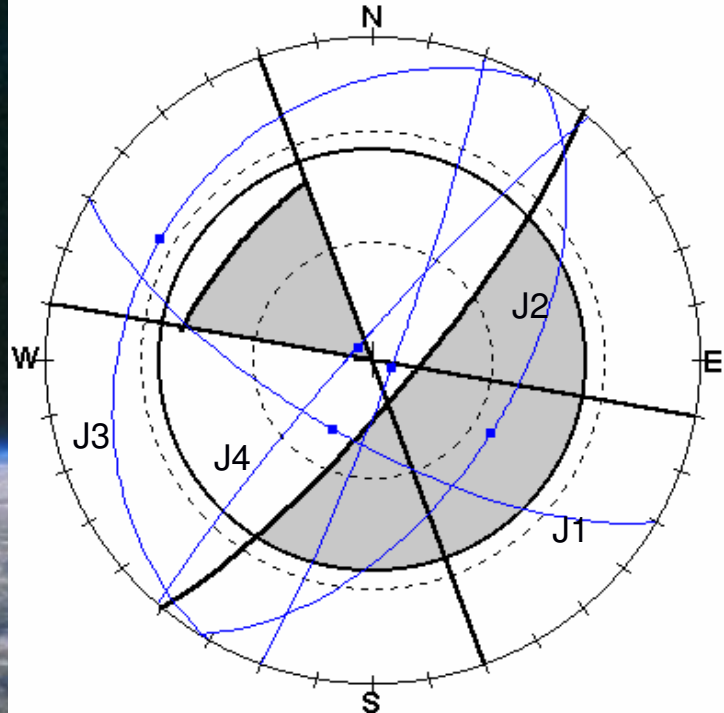
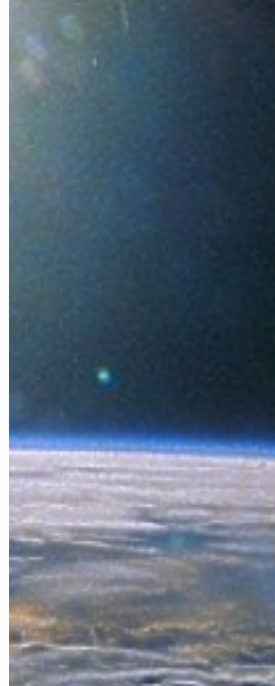
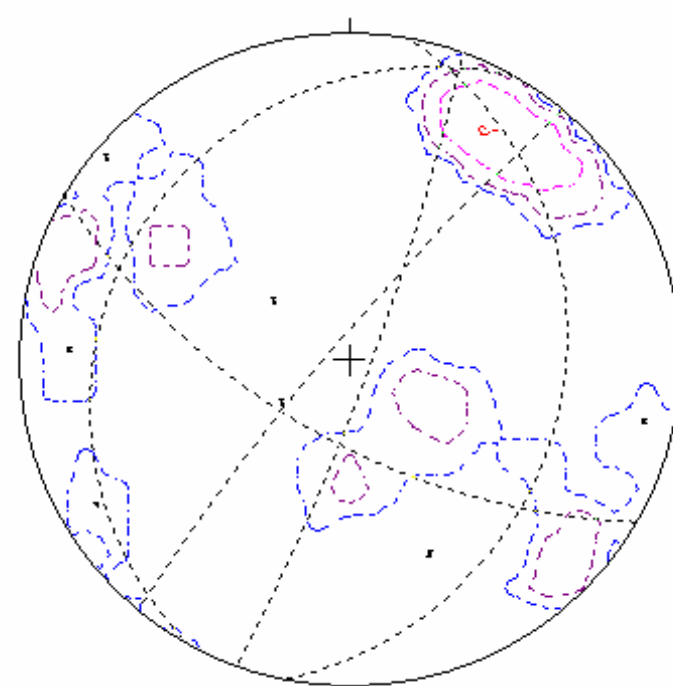
b) Zone B1

Major joints: **J1 (210/70)**, J2 (110/85), J3 (300/26), J4 (310/85)

Potential Wedge **Failure**: J1 & J2

Potential Toppling Failure: J4

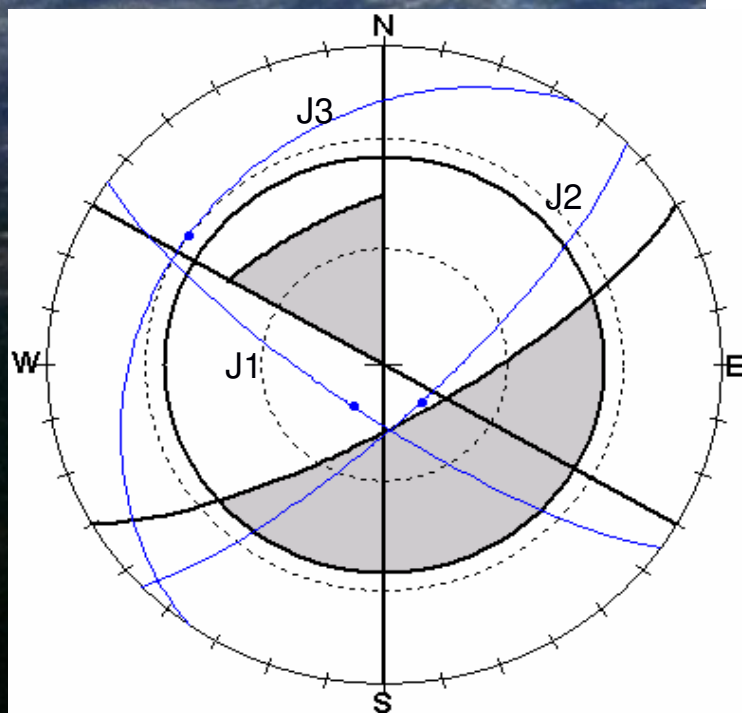
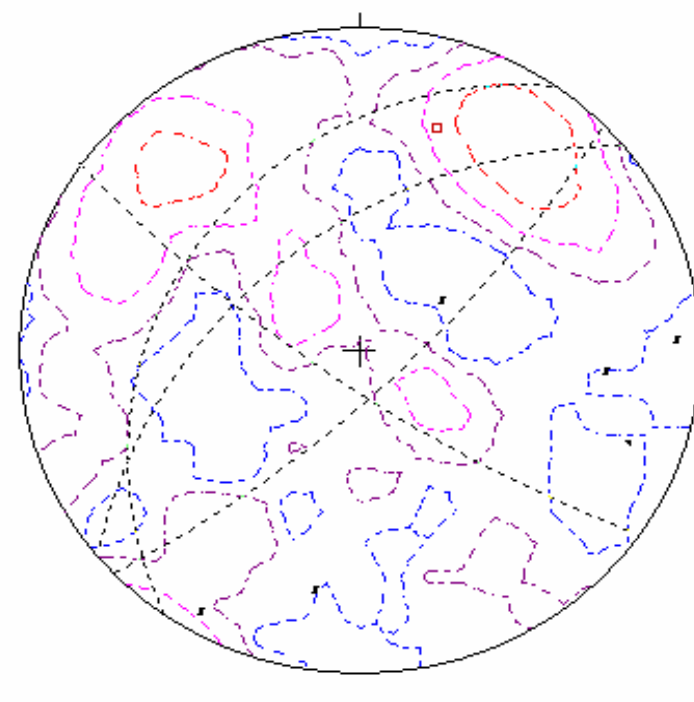
c) Zone B2

Three possible failure identified are circular, plane and wedge failure from the three major discontinuities of J1 (215/77), J2 (136/77, and J3 (305/30)

Analysis on the pole plot shows that the discontinuities data scattered randomly - **possibility of circular failure**

Potential Wedge Failure: J1 & J2

Potential Plane Failure: J1

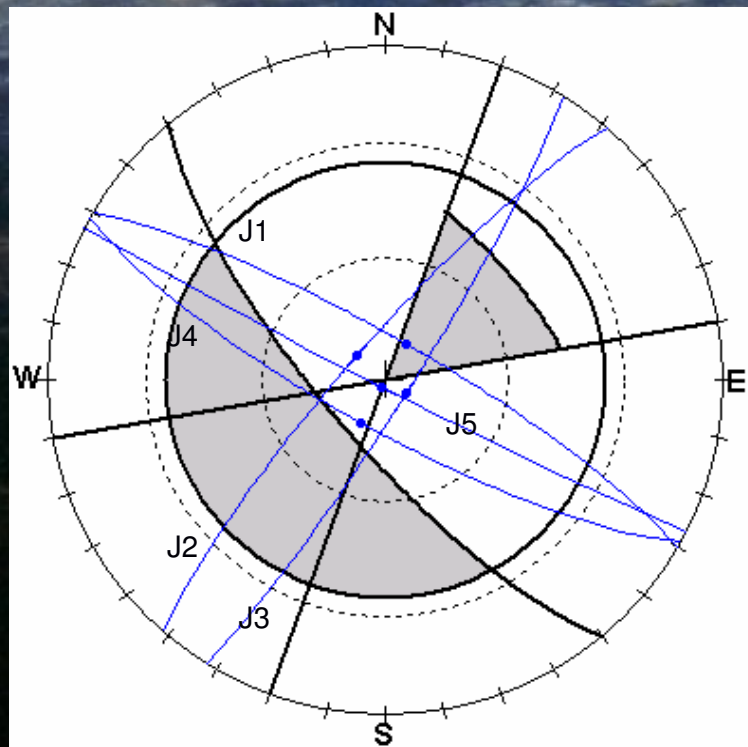
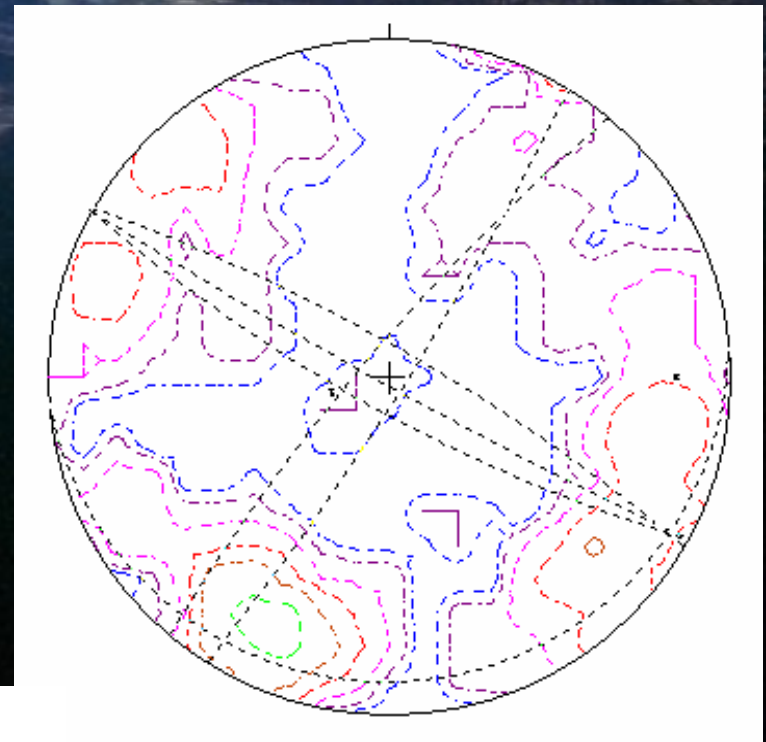
a) Zone C

Major discontinuities: J1 (030/80), J2 (310/81), J3 (122/84), J4 (209/88) and J5 (209/78)

Potential Wedge Failure: J2 & J4

Potential Toppling Failure: J1

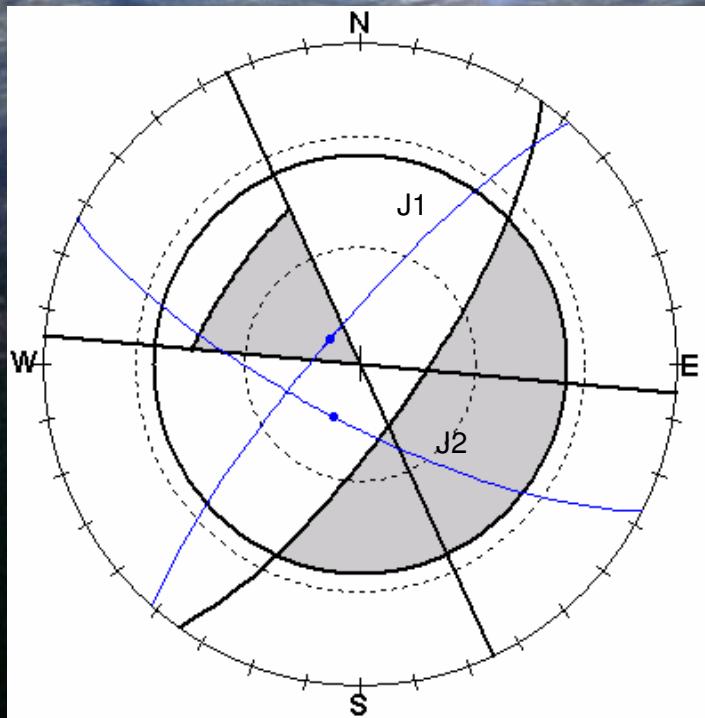
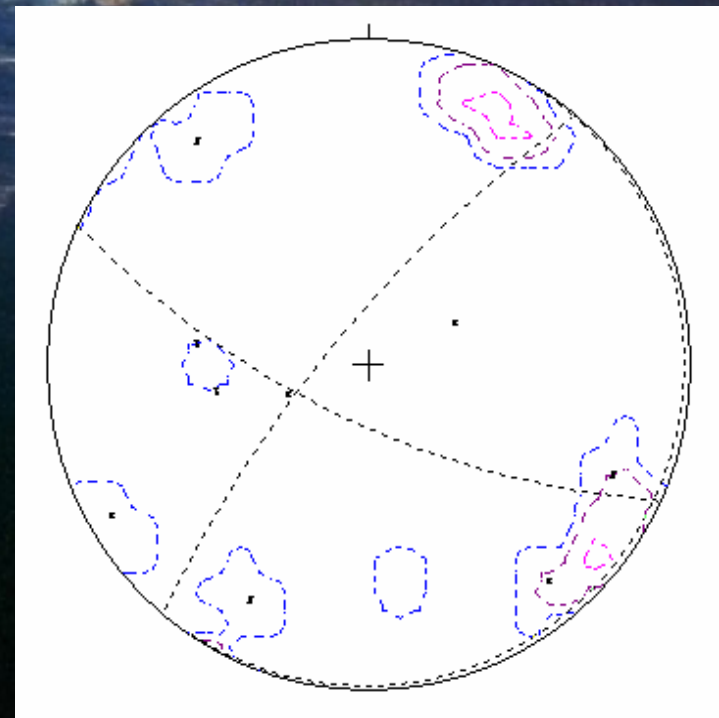
b) Zone D

Zone D is located at the northwest part of the study area
Major discontinuities: J1 (310/80), J2 (208/75),
Potential Toppling Failure: J1

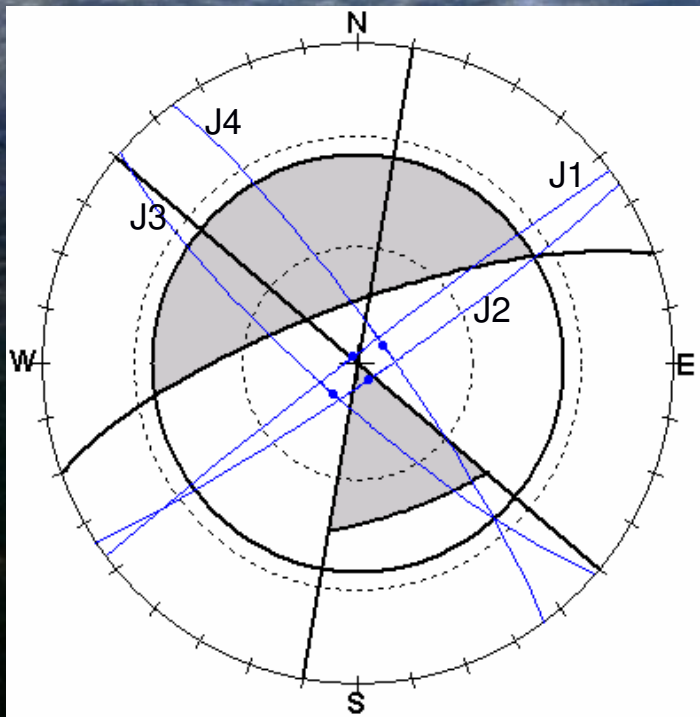
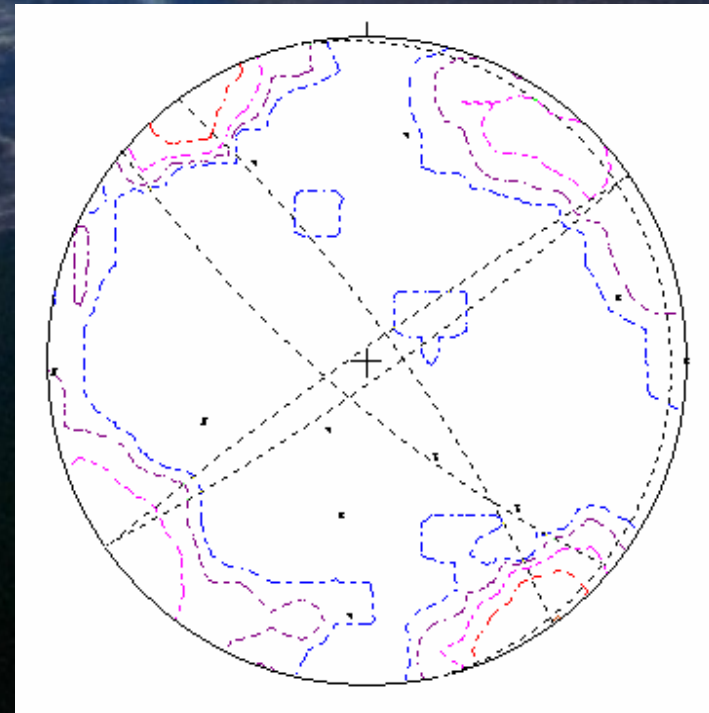
c) Zone E

Major discontinuities: J1 (325/88), J2 (145/85), J3 (220/80), J4 (054/82)

Potential **Toppling Failure**: J2
