## **Problem and Solutions of Weak Soil In Engineering Application**

Ir. Liew Shaw Shong

G&P Geotechnics Sdn Bhd, Kuala Lumpur, Malaysia

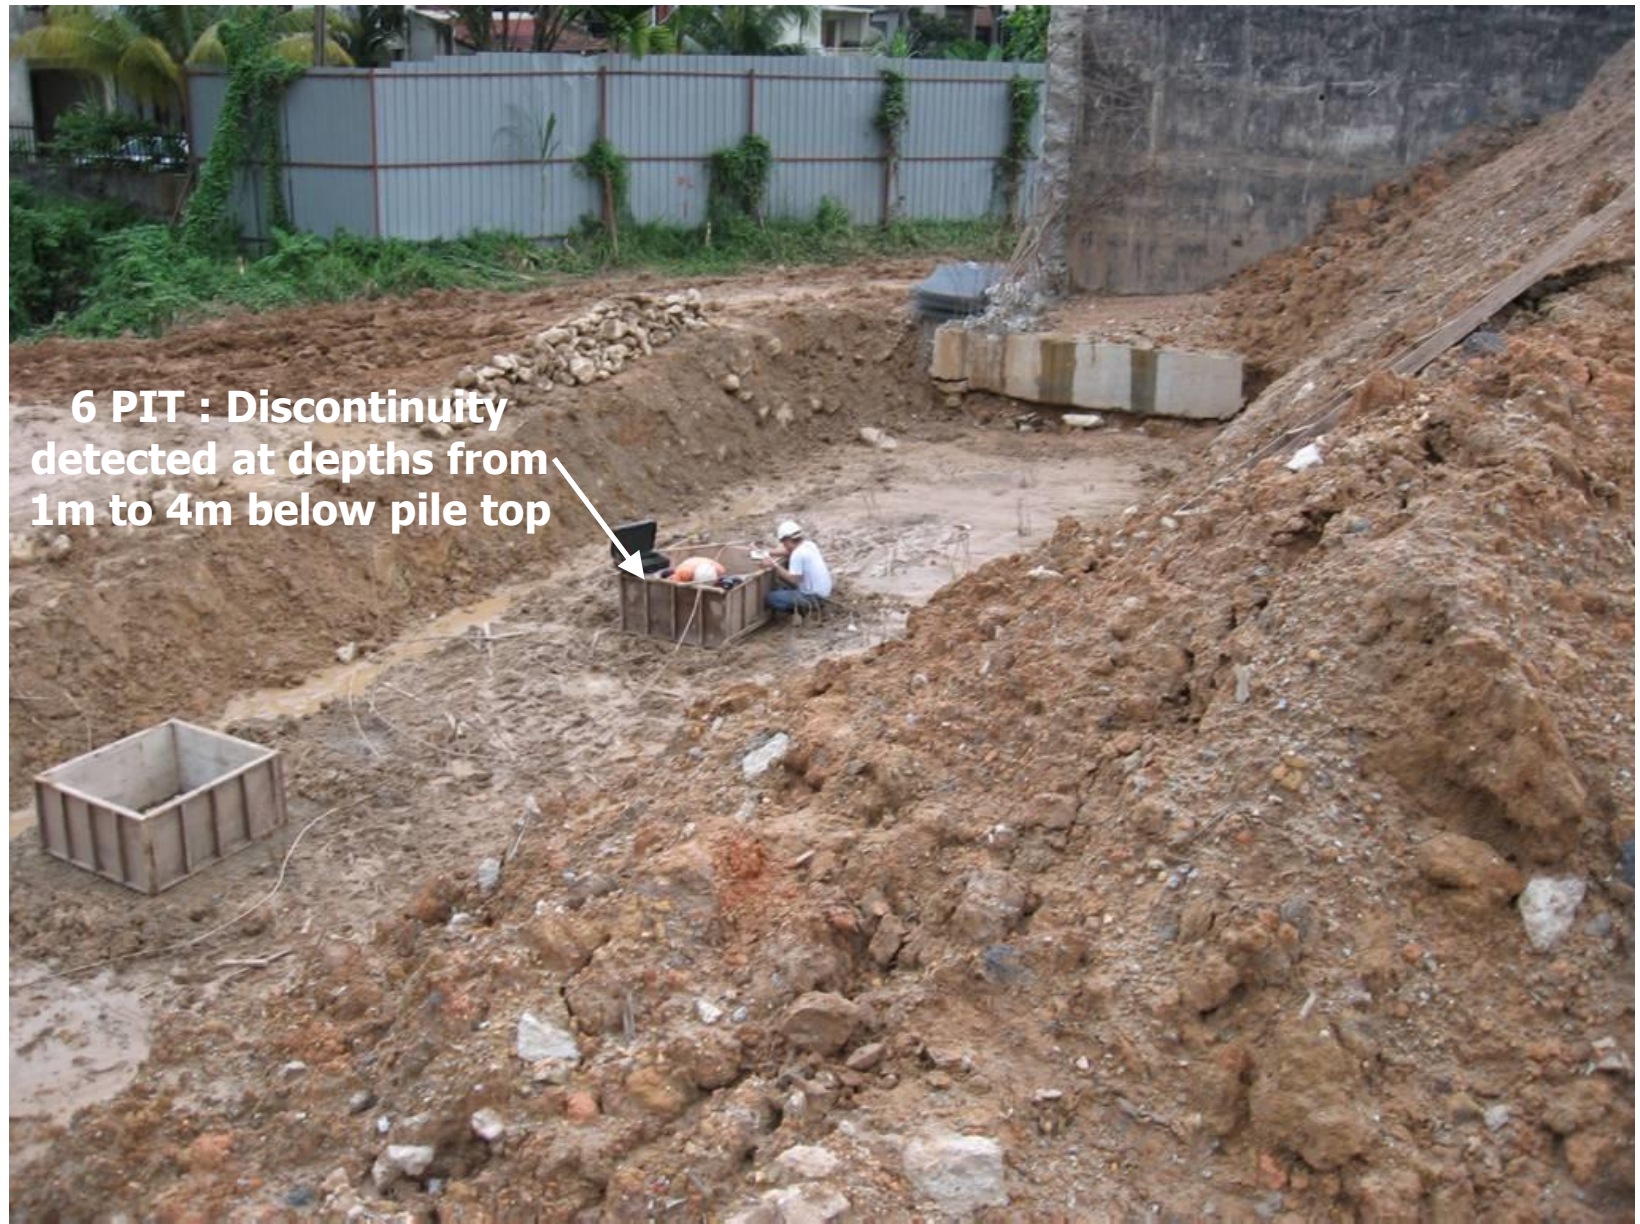
**6 PIT : Discontinuity  
detected at depths from  
1m to 4m below pile top**

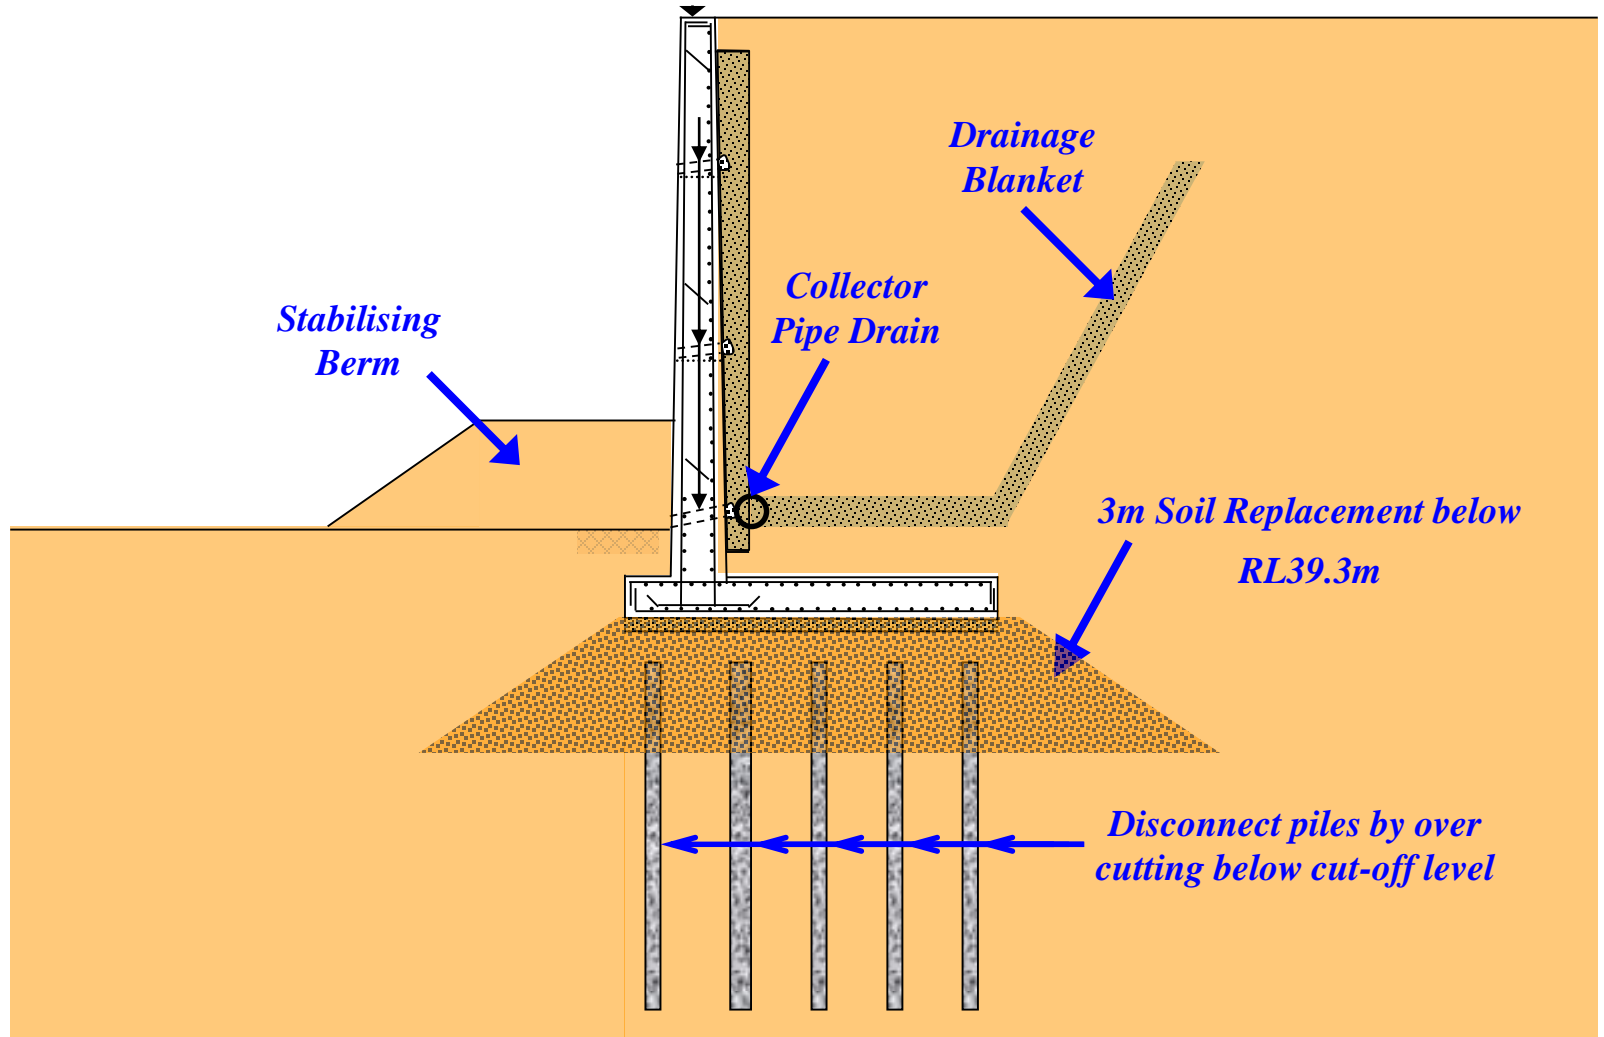
# *Remedial Solution*

- ⊗ Potential perched water regime in natural valley terrain after raining
- ⊗ Rise of groundwater increases the lateral force on wall
- ⊗ Inadequate lateral pile resistance
  - ▣ Fixed Head : 32kN/pile (Likely the case)
  - ▣ Free Head : 20kN/pile
- ⊗ Ultimate lateral pile capacity reached when  $RL42.5m < GWT < RL45m$
- ⊗ Reduction of effective soil strength due to reduction of vertical stress as wall loading carried by piles

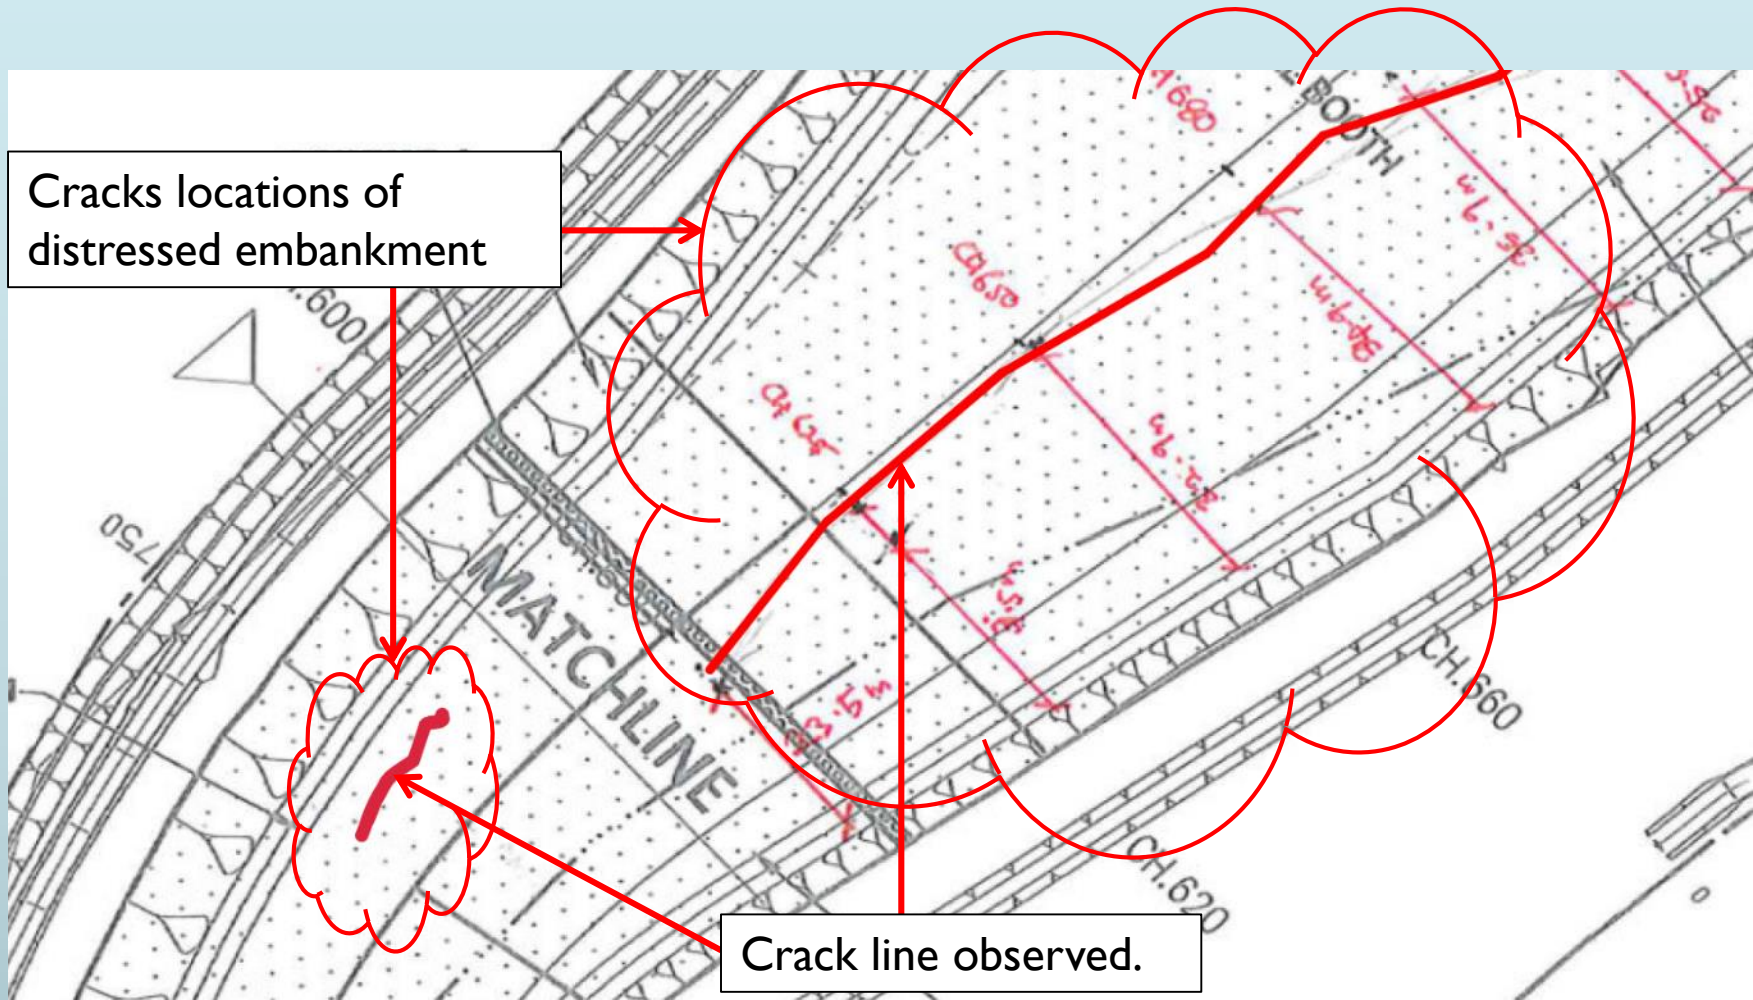
- ▶ Longitudinal flexural cracks on embankment surface

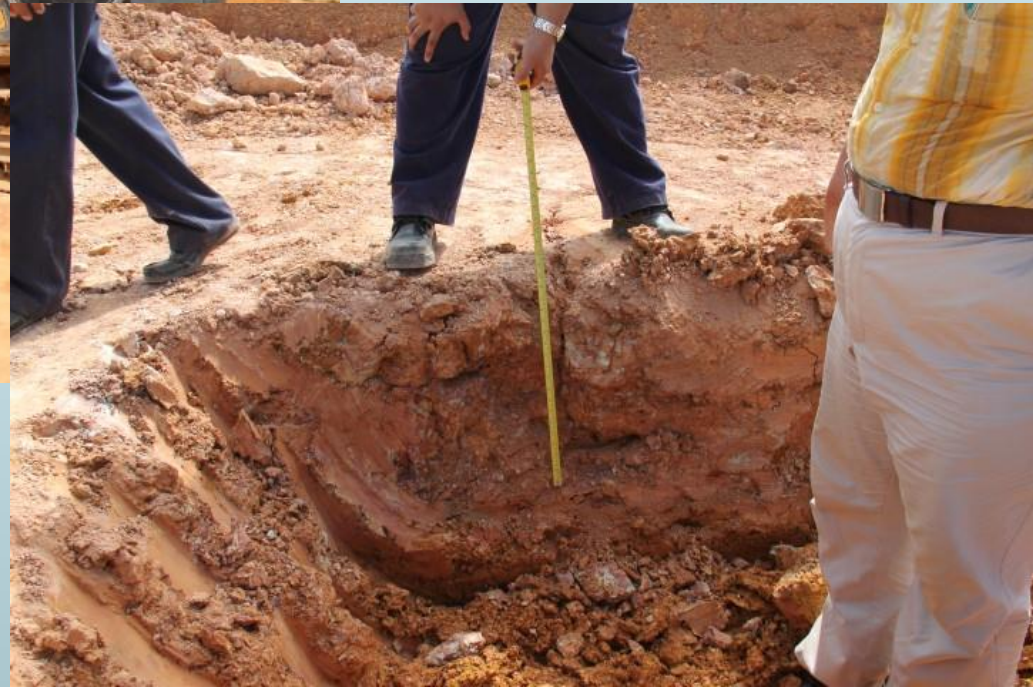
**Excavation on cracks found  
after 1m surcharge removal**

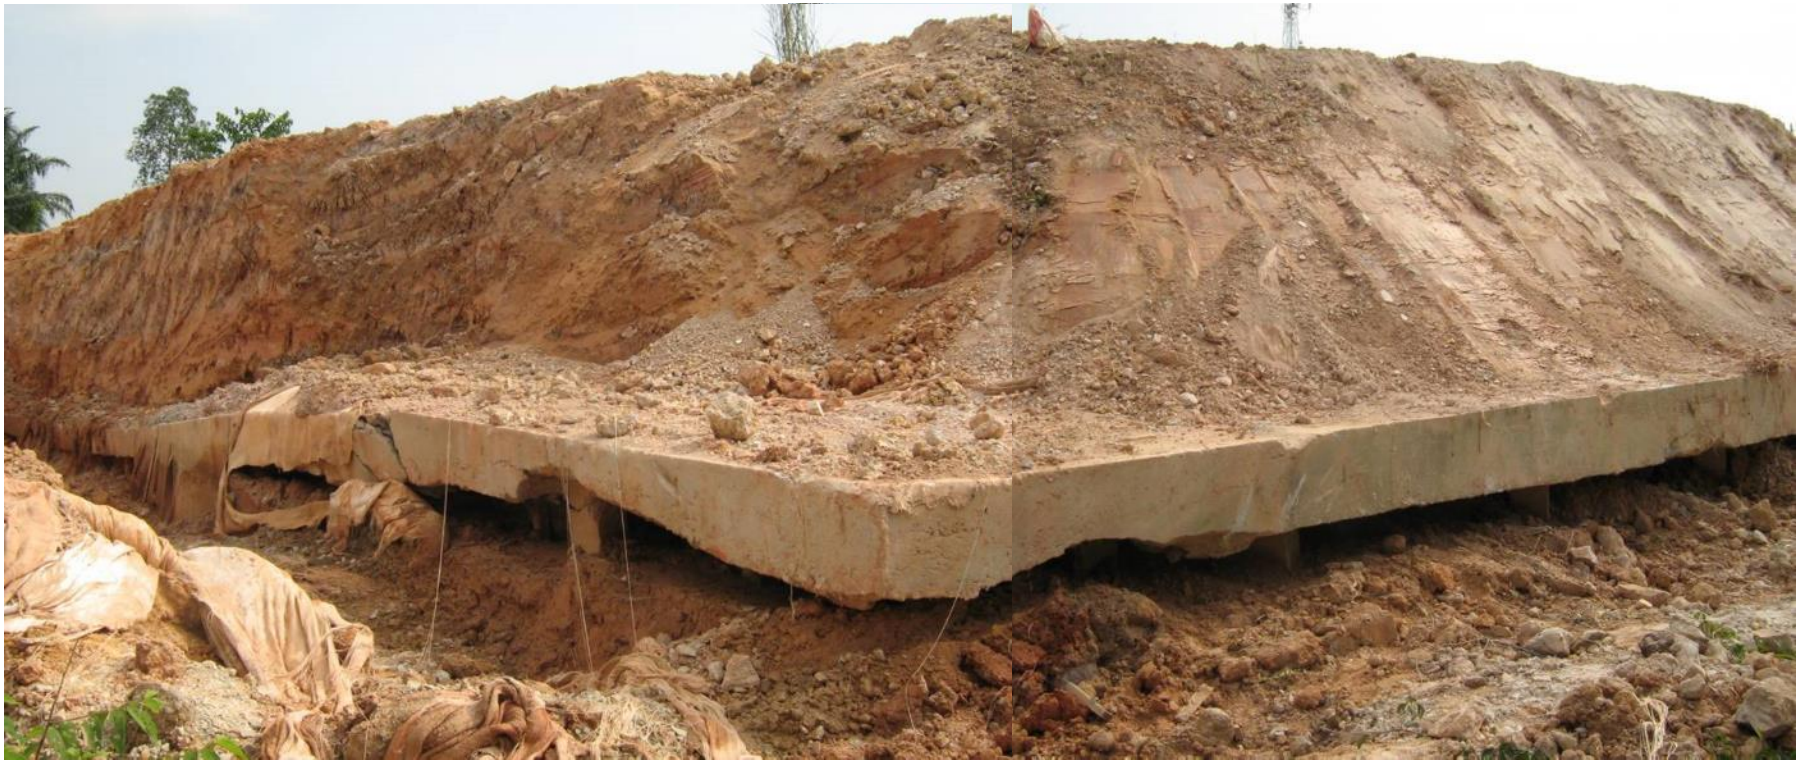
- ▶ Piled Embankment 30m from Abutment B shown structural distress

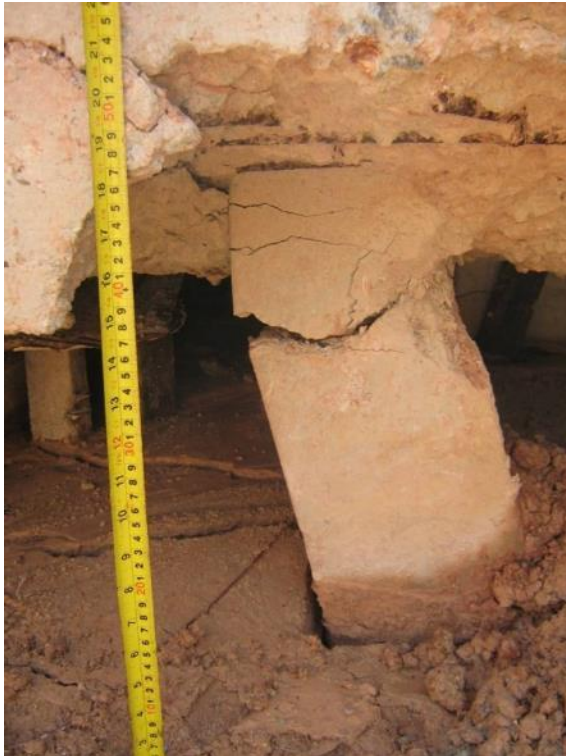
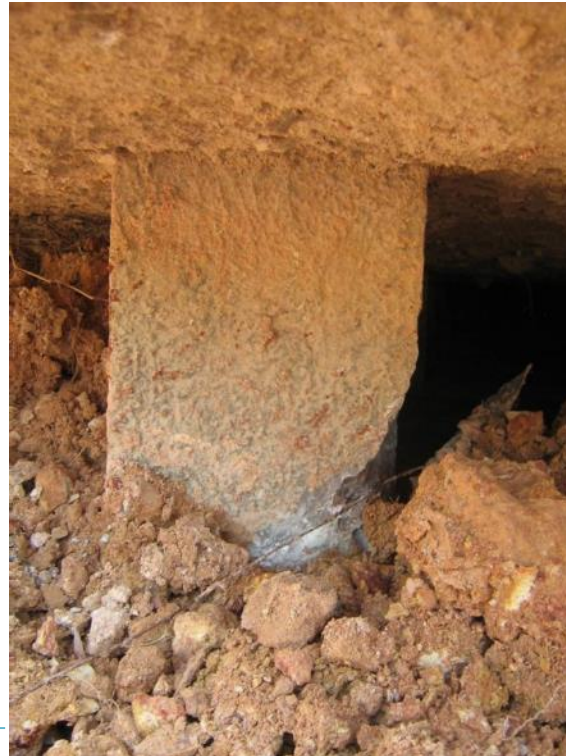
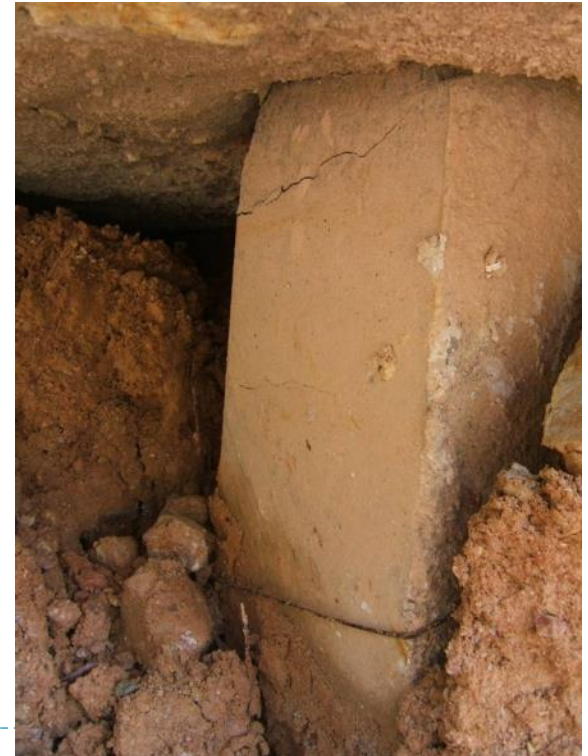
- Piles of Piled Embankment has shown flexural cracks

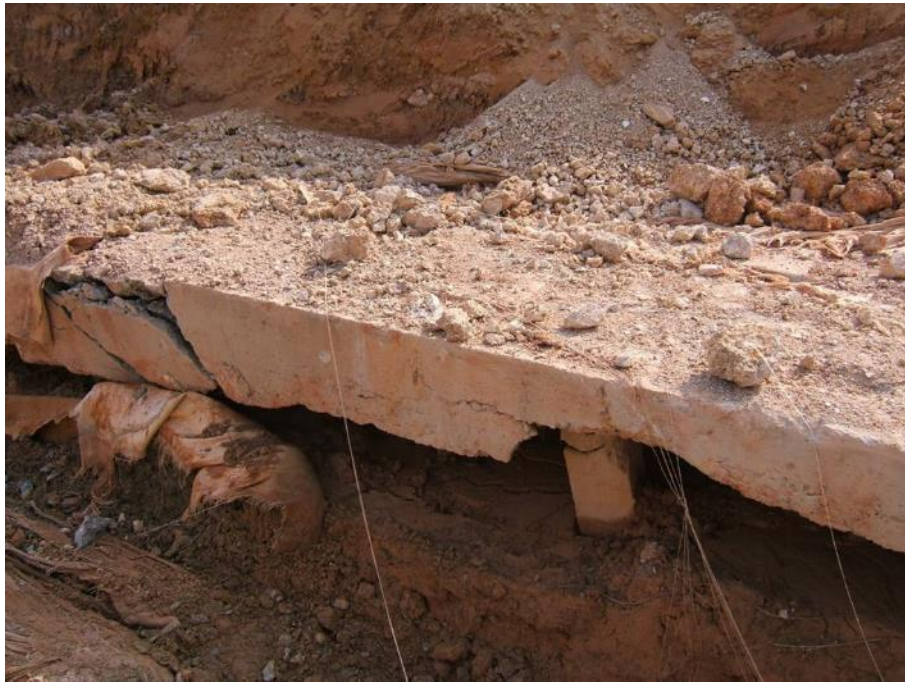
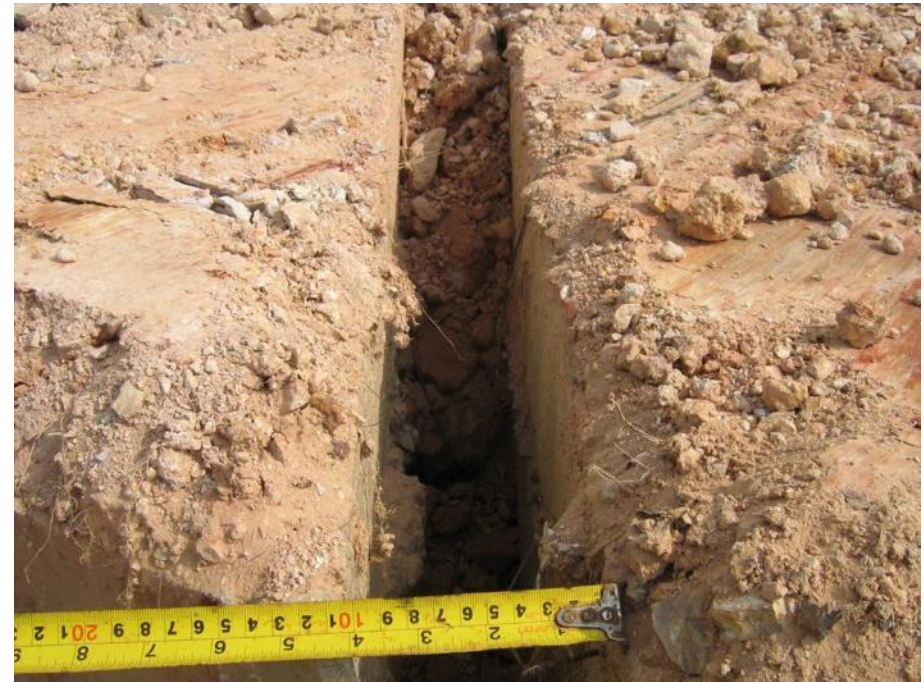
- ▶ Damaged piled embankment slab damaged & 100mm gap at slab joint

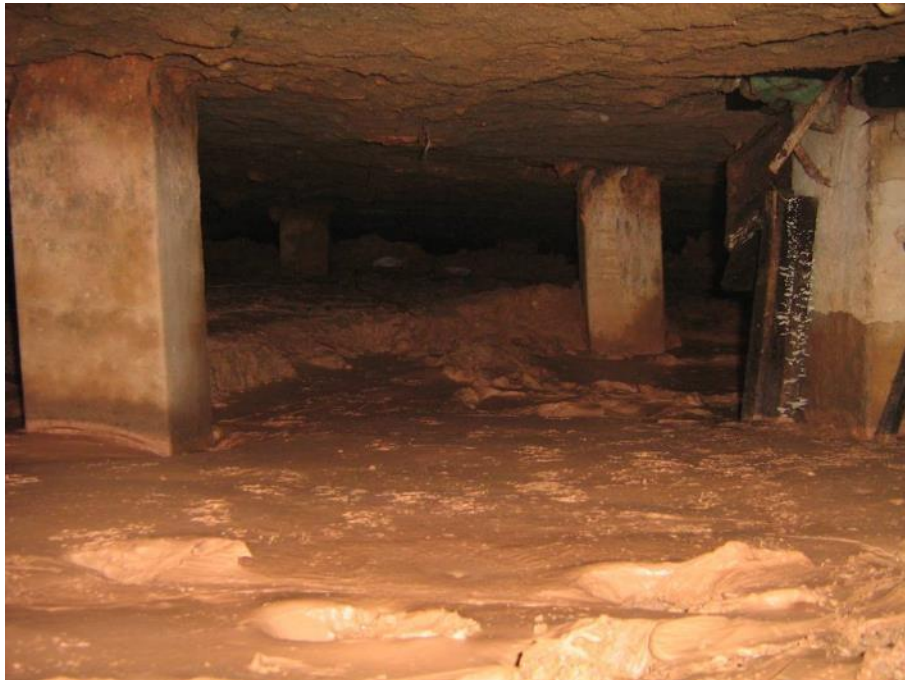
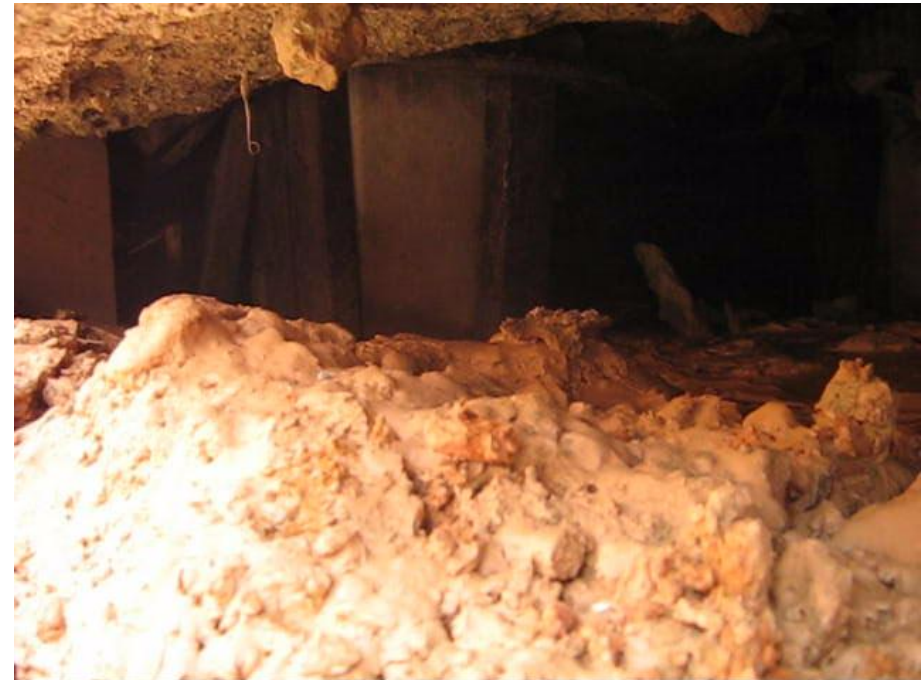
- Settlement of 0.4 to 1.0m under the Piled Embankment

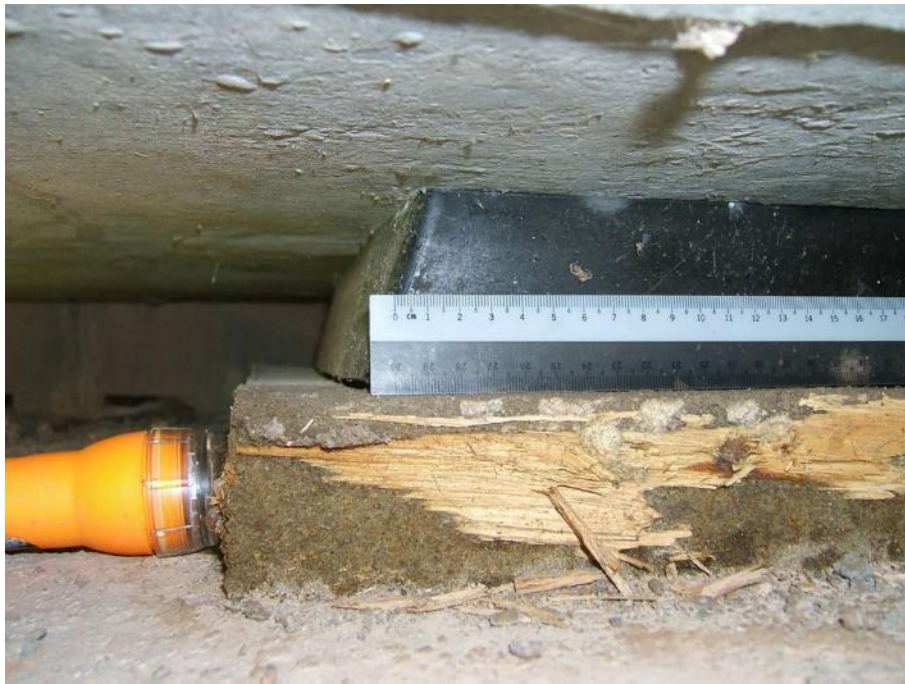
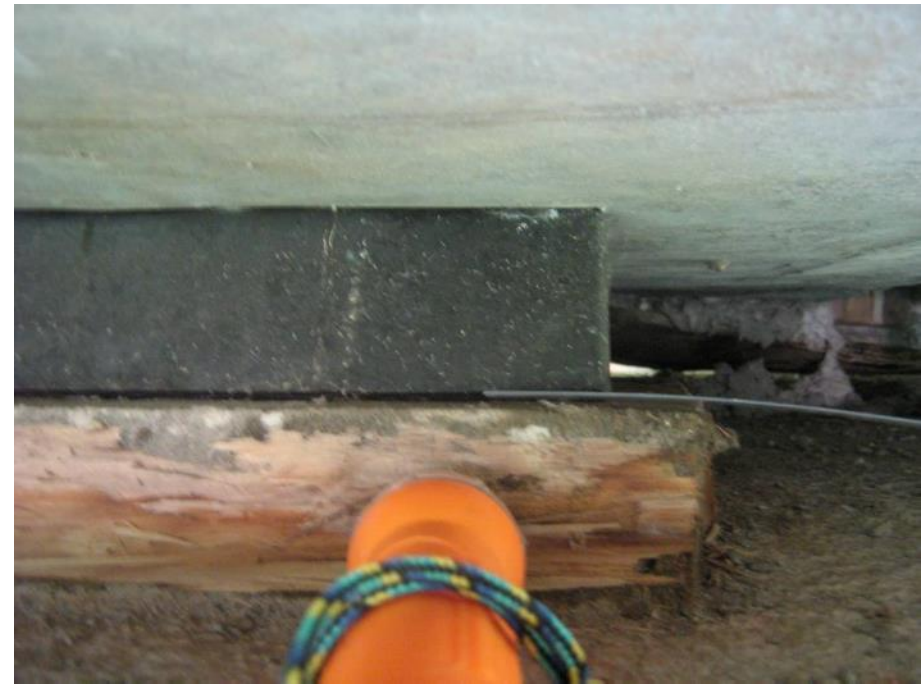
## ► Bearing distortion at Pier PI

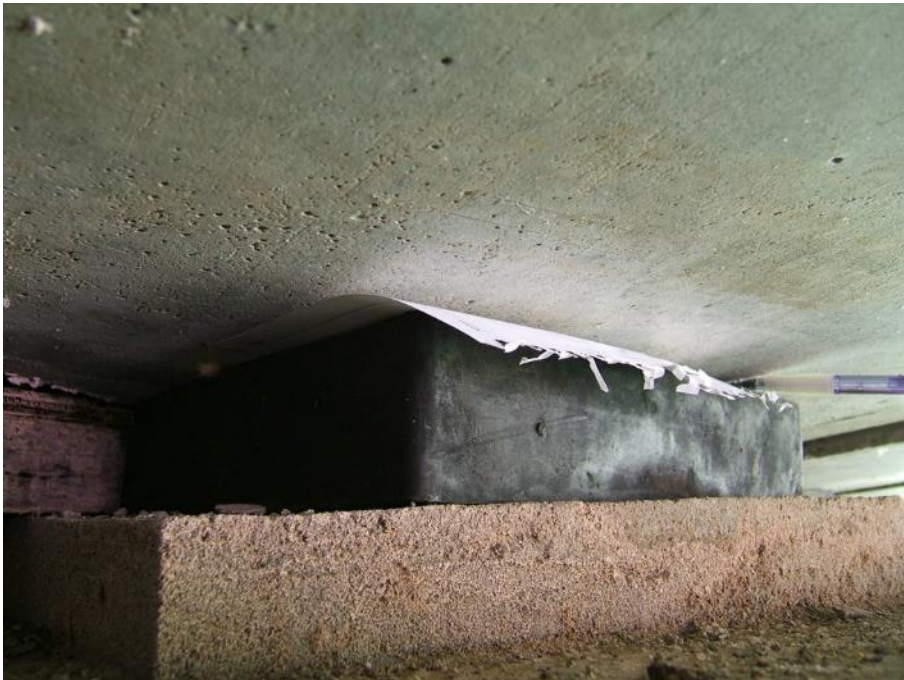
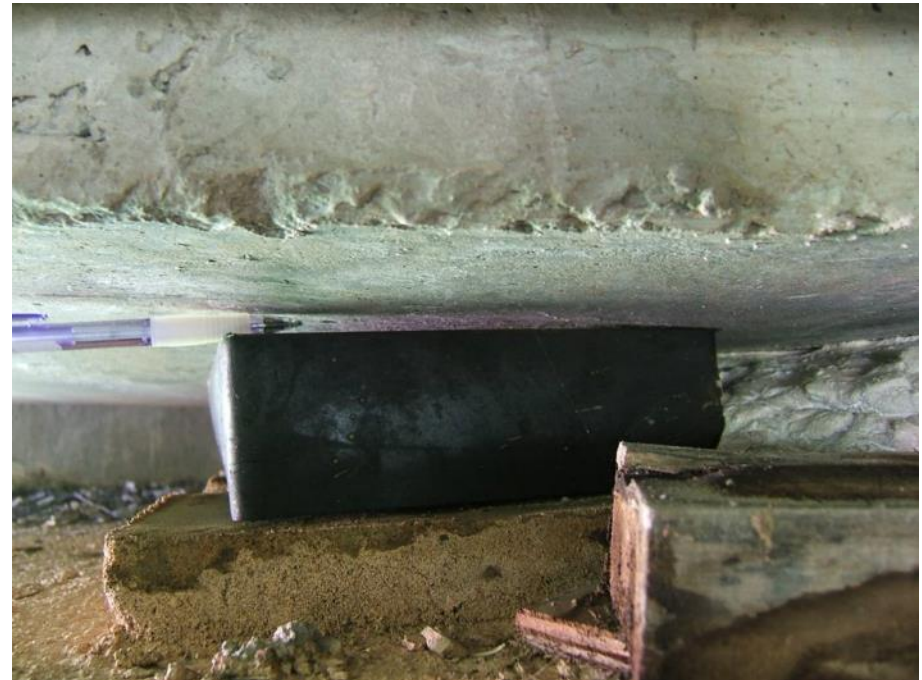
## ► Bearing distortion at Pier P2

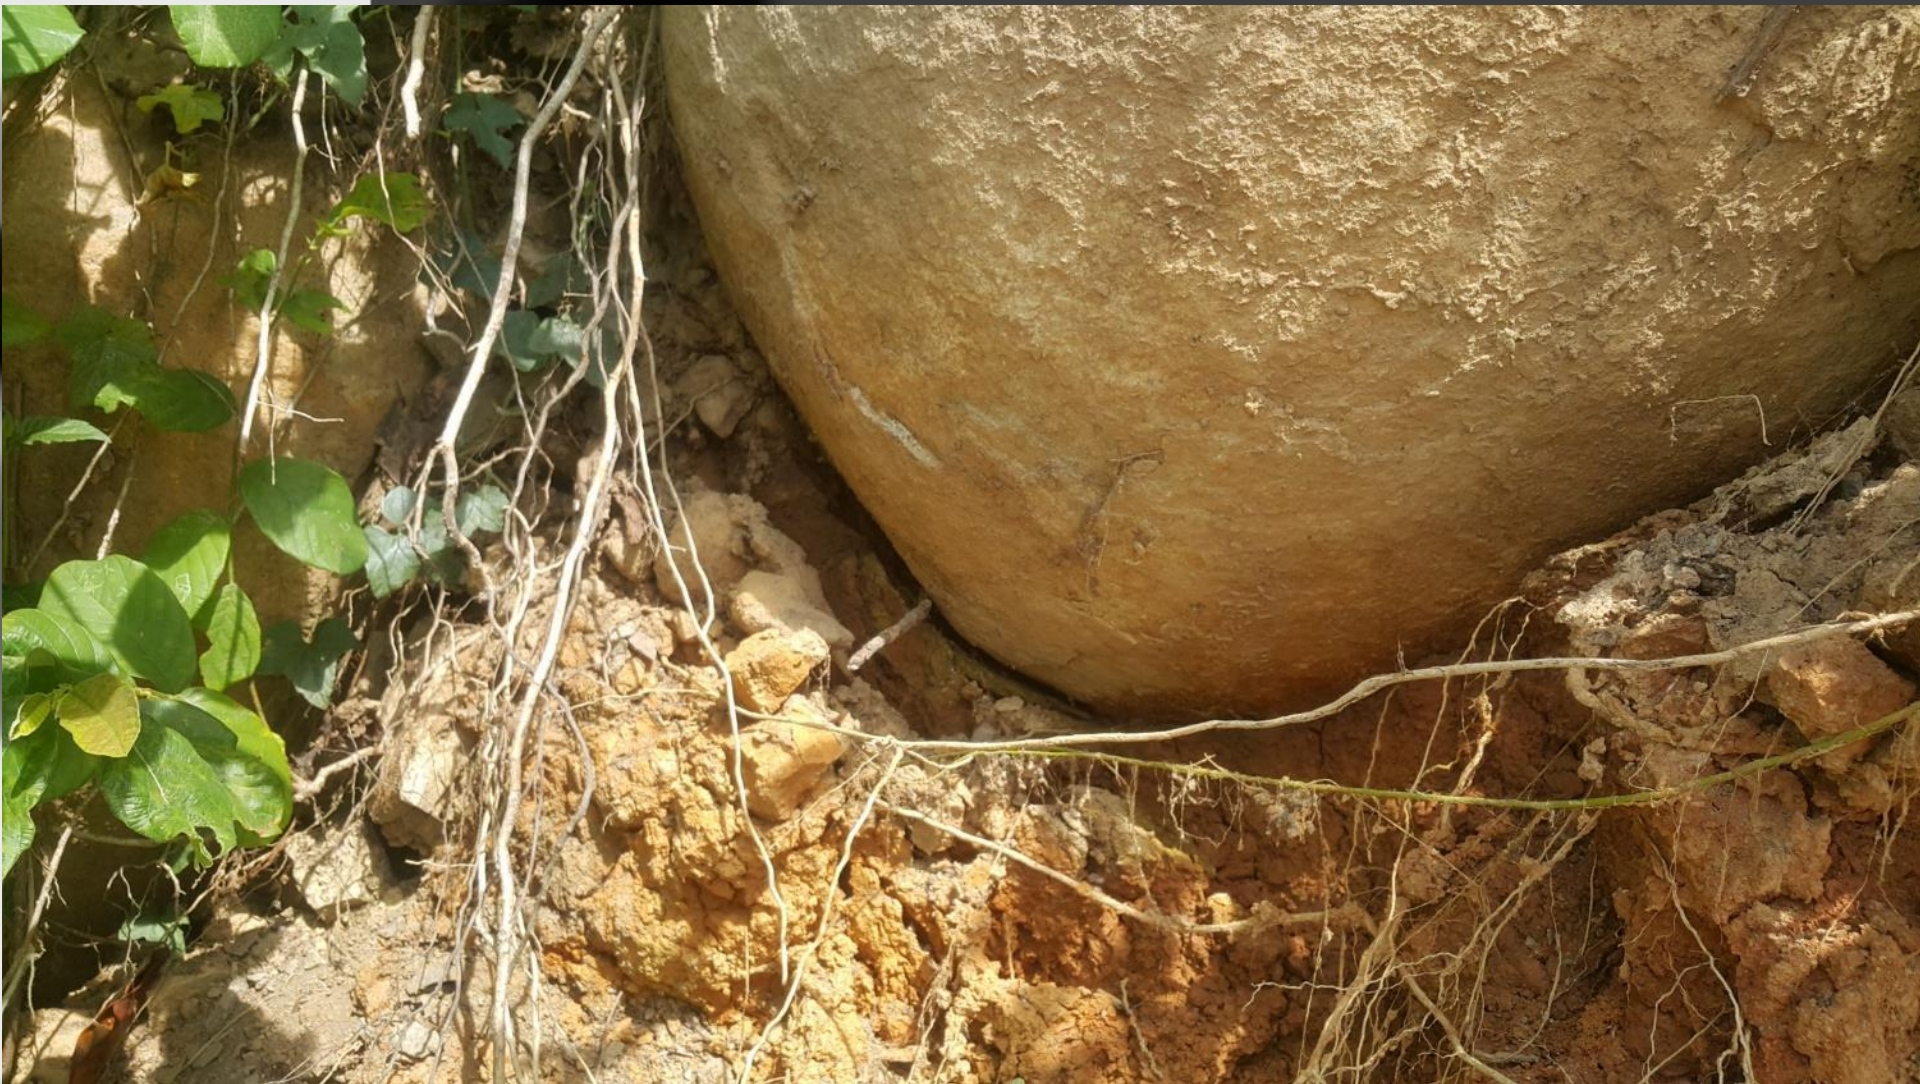
# Volumetric Shrinkage of Exposed Soil

- With intention of minimized earthwork cutting forming any platform, soil nailed slope profile is normally steep
- Facing capacity has remarkable effect on Internal Stability of steep soil nailed slope
- Volumetric swelling & shrinkage of soils with moisture variation are realistic observation
- Moisture depletion after covering with shotcrete surface results in volumetric shrinkage of slope soil face leaving air gap with separation of contact with shotcrete
- Mobilisation of face capacity in uncontacted slope surface is unrealistic, thus giving incorrect safety margin of slope stability
