# Geotechnical Failure Investigation of a Reinforced Soil Wall and Remedial Work Design

Tan, Yean-Chin; Kowng, Yan-Wen & Tan, Su-Kwong

G&P Geotechnics Sdn Bhd, Wisma G&P, 39-5 Jalan 3/146, Bandar Tasik Selatan, Kuala Lumpur, Malaysia.  
gnp-geo@gnpgroup.com.my

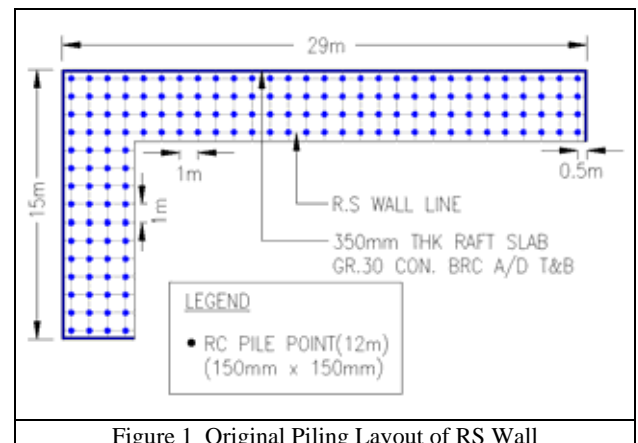
The original RS wall foundation consists of 150mm x 150mm square Reinforced Concrete (RC) piles at 1m c/c spacing driven to a penetration length of 9m. A 350mm thick RC slab is subsequently cast on the piles as the foundation of the RS wall. The piling layout of the original RS wall design is shown in Figure 1.

Figure 1 Original Piling Layout of RS Wall

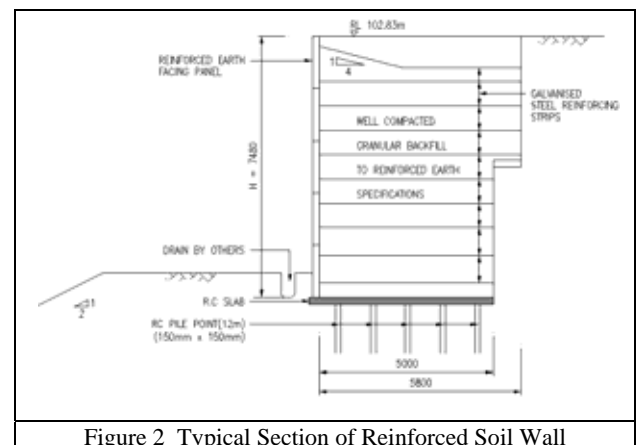
The 7.5m high RS wall design consists of well compacted granular backfill and galvanised steel reinforcing strips of highly adherent type (5mm thick x 45mm width) with length of 5.8m for the top half height of the wall and length of 5.0m for the lower half height of the wall. Typical cross section of RS wall design is shown in Figure 2.

Figure 2 Typical Section of Reinforced Soil Wall

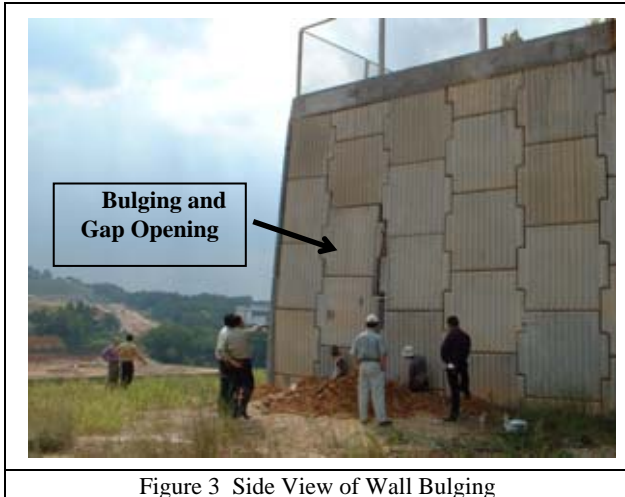
The RS wall panel showed visible signs of displacement, bulging and opening of gaps between the wall panels at the south-western corner of the wall as shown in Figure 3. This had caused backfilled material to be washed away when rain, inducing voids behind the RS wall as shown in Figure 4 that further aggravated the internal stability of the wall.

Figure 3 Side View of Wall Bulging

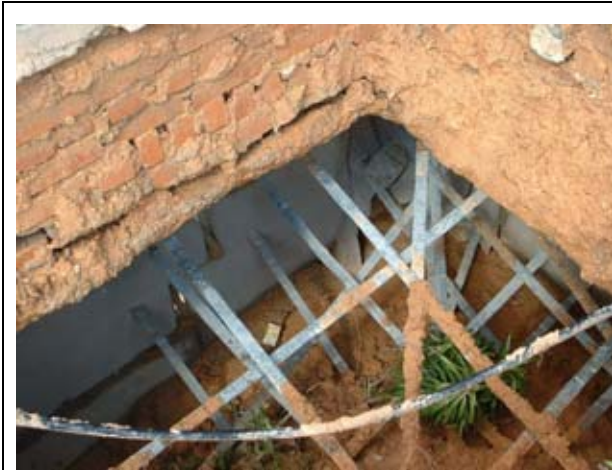
Figure 4 Voids Behind Wall Due to Backfill Materials Being Washed Away

In addition, due to the opening of the gap and bulging of the RS wall caused by the factors described above, the fill materials (granular materials) in the RS wall have dropped and washed out through the openings. The condition deteriorated more rapidly during rainy season. Due to the loss of materials, the internal stability of the wall was badly affected, inducing further widening of gap and bulging of the wall. The processes repeated until a large void was formed in the wall (as shown in Figure 4) and depression at the top of the wall.

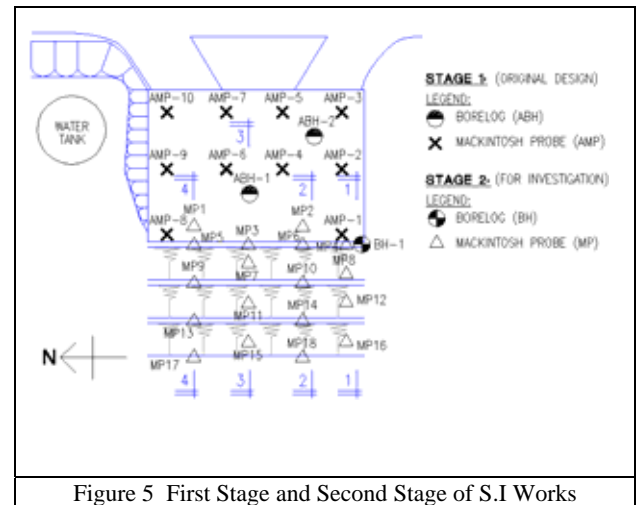
Mackintosh Probes (MP). The locations of field tests for both stages of S.I. are shown in Figure 5.

Figure 5 First Stage and Second Stage of S.I. Works

MP tests from the second stage of S.I. works were carried out along the slope as shown in Figure 5. Figures 7 and 8 show the MP profiles, which are generally consistent with the fill thickness.

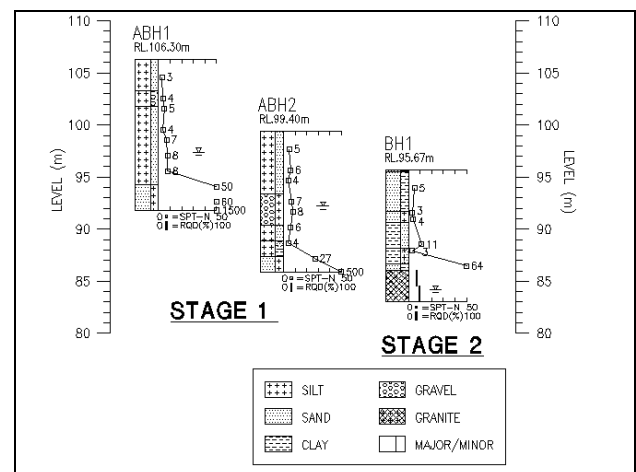
Figure 6 shows the interpreted subsoil profiles for both stages of S.I. works. Generally, borelogs of ABH-1 and ABH-2 indicate that the original subsoil consists of sandy SILT and silty GRAVELS. Based on the subsurface investigation carried out, the overburden soils in borehole BH-1 generally consist of clayey SAND at the top 5 m, which are the fill materials and underlain by the original residual subsoil. The depth of fill materials is consistent with the original topography plan, which shows that the original ground level is about 6m below the existing profile. The clayey SAND and sandy CLAY are generally very loose to loose and soft to medium stiff respectively with SPT 'N' values ranging between 3 and 11 up to a depth of approximately 8 m followed by slightly weathered granitic bedrock.

Figure 6 Interpreted Subsoil Profile from Both Stages of S.I. Works

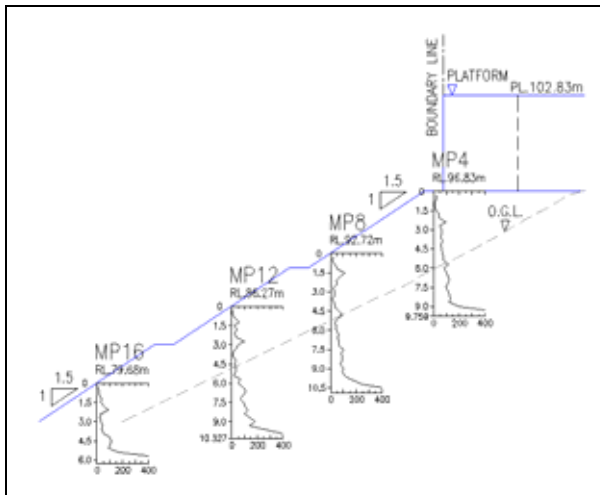
Figure 7 Mackintosh Probe Profiles for Section 1-1

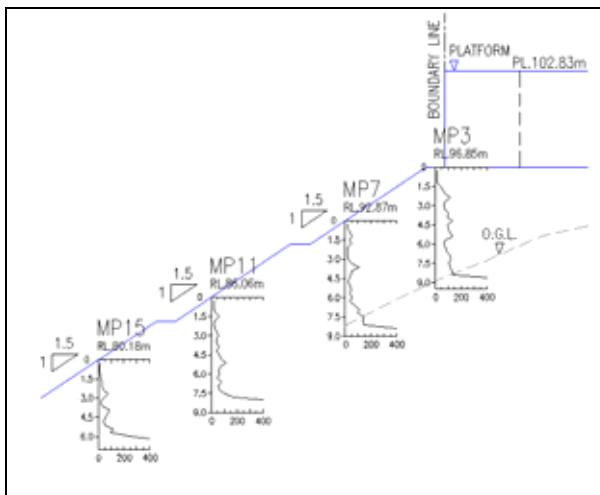
Figure 8 Mackintosh Probe Profiles for Section 3-3

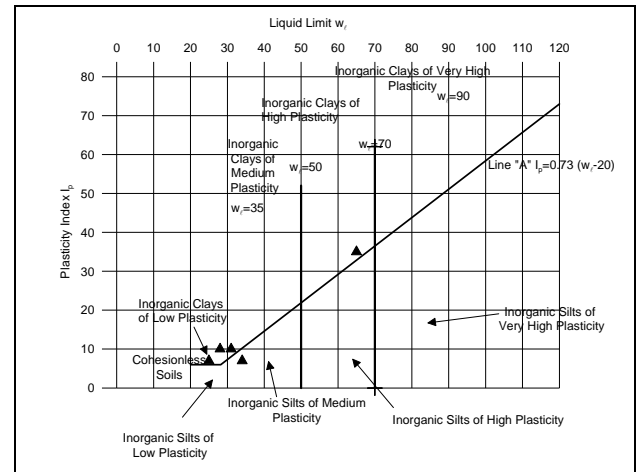
Figure 9 Atterberg Limit

1. Atterberg limits – see Figure 9
2. Particle size distribution
3. Single stage direct shear box test for wall granular backfill – see Figure 10
4. Isotropically consolidated undrained triaxial test (C.I.U) for in-situ subsoil – see Figure 11

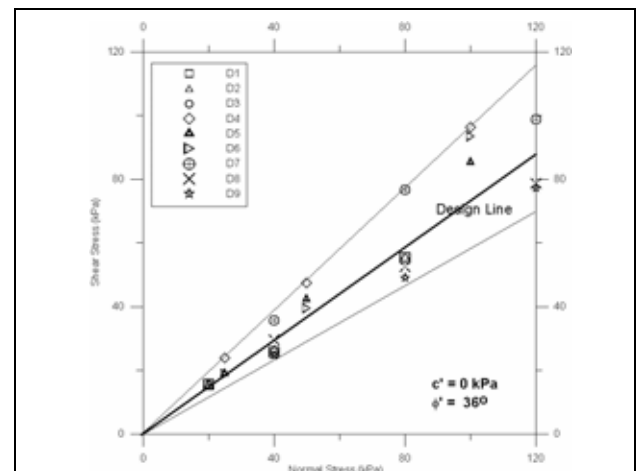
Figure 10 Single Stage Direct Shear Box Test Results for Granular Backfill Material of RS Wall

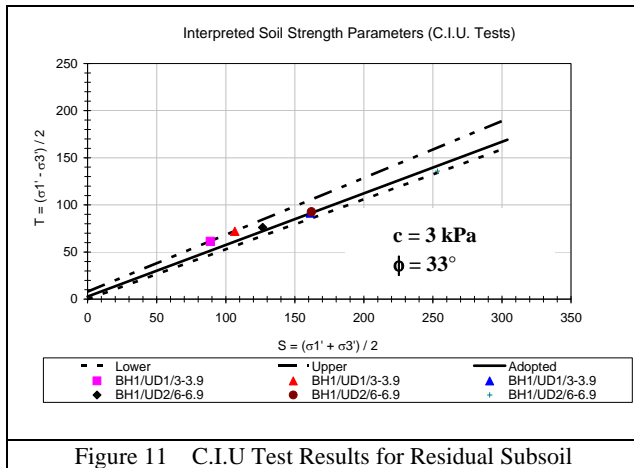
Figure 11 C.I.U Test Results for Residual Subsoil

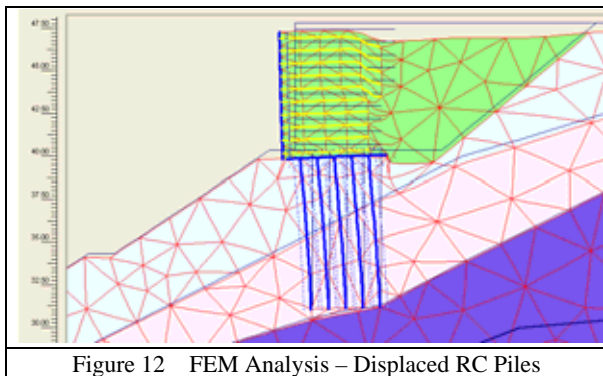
The original configuration of RS wall supported by RC piles has been analysed using a two-dimensional finite element method programme. Figure 12 shows the graphical printouts of the FEM analyses results (the deformation is plotted in exaggerated scale). As shown in Figure 12, the RC piles beneath the RS wall have bent and displaced significantly, and therefore part of the RS wall supported by piles also displaced together. The estimated pile displacement ranges from about 150mm to 170mm with induced maximum bending moment and shear force to the pile of 36 kNm and 64 kN respectively. The maximum mobilised bending moment and shear force induced onto the 350 mm thick slab is 146 kNm and 192 kN respectively. The comparison of the induced and ultimate bending moment and shear force of piles and slab are elaborated in Section 6.3.2 and 6.3.3 respectively.

Shear force and bending moment mobilised in the RC piles are extracted from the FEM analyses. As mentioned in Section 5.1.1, the maximum bending moment and shear force induced on the RC piles are 36 kNm and 64 kN respectively. The steel reinforcement details of the 150mm x 150mm RC pile that are commonly available in the local market using 4Y10 with link of  $\phi 5.5@69$ mm are adopted for computation of moment and shear resistances. The ultimate bending moment and shear force capacity of 150mm x 150mm pile are 10 kNm and 31 kN respectively and are found to be grossly inadequate. As a result of inadequate lateral resistance, the RC piles have structurally failed under bending and shear.

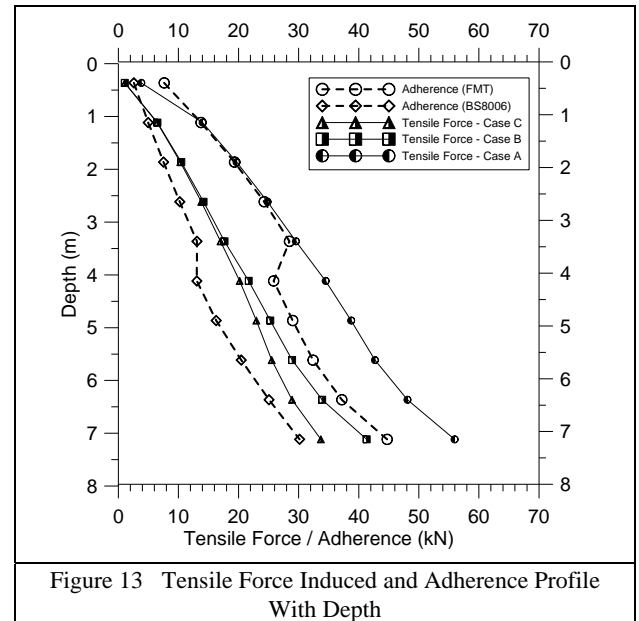
Figure 13 presents the results of the tensile force and adherence (calculated in accordance to BS8006:1995 and FMT) for all cases. As can be seen from Figure 13, the tensile force induced is higher than adherence. The non-compliance on adherence failure according to BS8006:1995, is due to insufficient reinforcement strip length provided there is no change to the strip width. The reinforcement for adherence is marginally adequate at the top 3m based on FMT's recommendations. It can be seen that the adherence reduces at the depth of approximately 3.5m for both BS8006 and FMT. This is attributed to the reduction in the length of steel reinforcing strips as explained in Section 3.

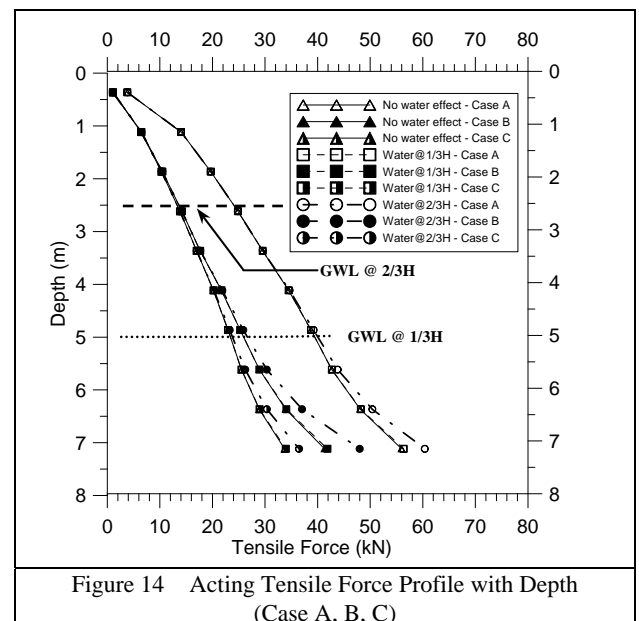
In order to investigate the effect of groundwater tables on the internal stability of RS wall, groundwater table of 1/3 and 2/3 of RS wall height are assumed in the analyses according to BS8006:1995. The tensile force does not significantly increase with the presence of groundwater table (GWL) as can be seen from Figure 14.

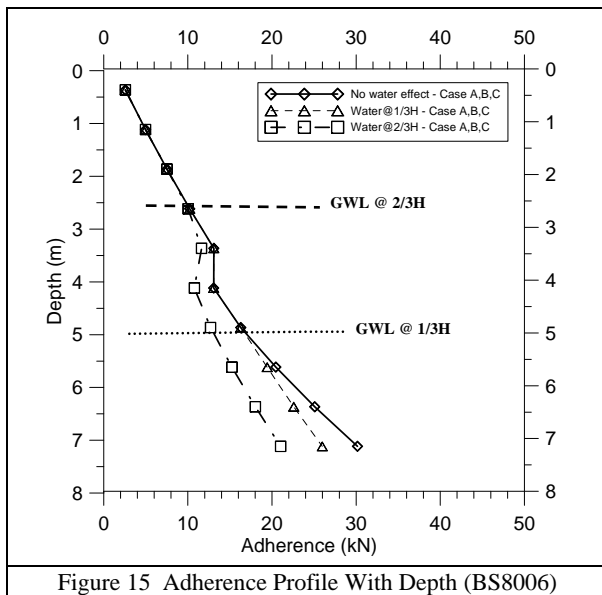
The effect of groundwater table on the adherence is also investigated. The adherence (in accordance to BS8006) with the presence of the groundwater table (at 1/3H and 2/3H) is expectedly lower than that without the presence of the groundwater table as illustrated in Figure 15.

Figure 15 Adherence Profile With Depth (BS8006)

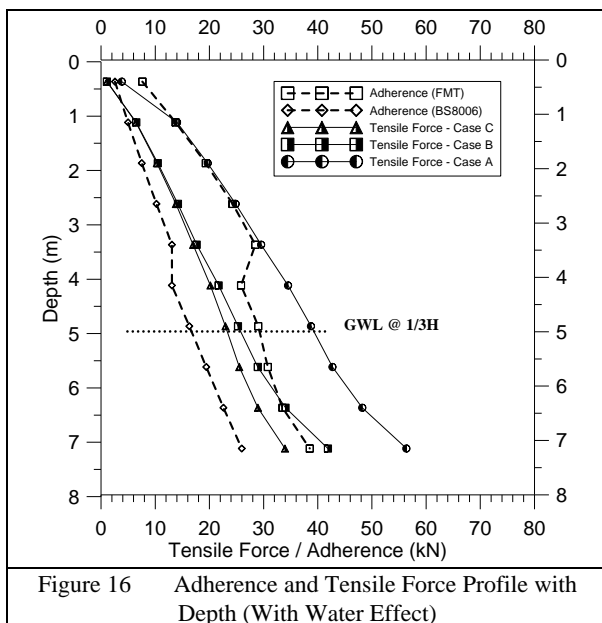
Figure 16 Adherence and Tensile Force Profile with Depth (With Water Effect)

When comparing the adherence and tensile force induced with the presence of groundwater table (Figure 16), it was found that the adherence is still inadequate. The adherence calculated using FMT is also included for comparison. In both methods of calculation of adherence, the tensile force exceeds the adherence with and without the presence of groundwater table indicating inadequacy of design length.

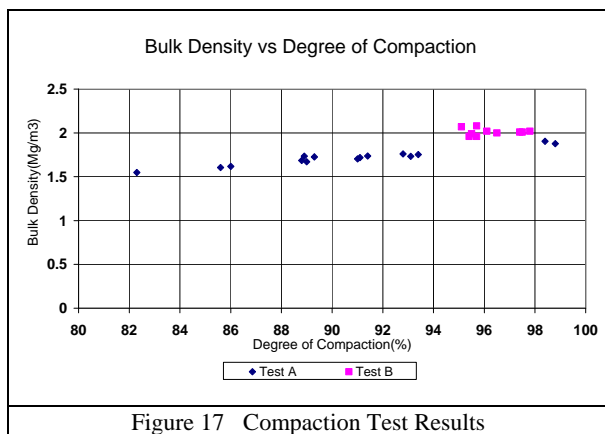
Compaction tests were carried out on the fill materials during filling of the platform and slopes and prior to the construction of the RS wall. The information on the locations of the tested samples was not made available at the time of investigation. Figure 17 shows the compaction test results which indicate that the degree of compaction of tested samples ranges from 82% to 99%. In other words, 56% of the tested samples have a degree of compaction less than 95%, indicating some localised areas with inadequate compaction. This can be observed from some of the Mackintosh Probes results (Figures 7 to 8), in which soil consistency increases and decreases alternately with depth at some MP locations.

Figure 17 Compaction Test Results

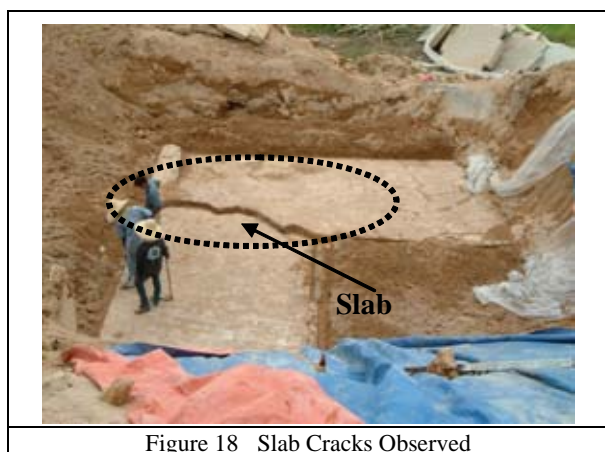
The inadequacy of the abovementioned main factors is confirmed via visible cracks observed on the slab upon exposing the base of the RS wall (as shown in Figure 18) for the remedial work.

Figure 18 Slab Cracks Observed

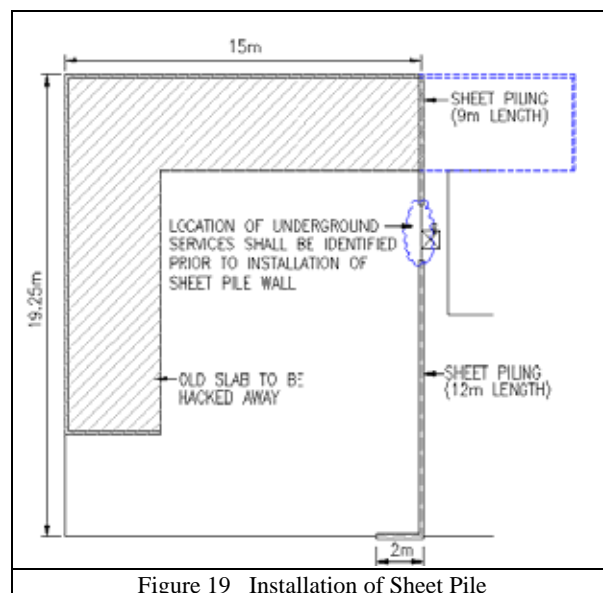
Figure 19 Installation of Sheet Pile

Since the convenient store is located near the slope, temporary sheet piles were necessary to minimise ground movement at the convenient store during the adjacent excavation.

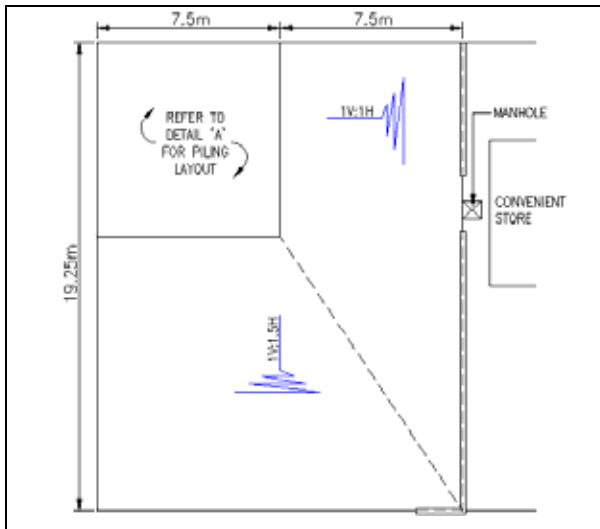
Figure 20 Excavation of Backfill Material, Hack Base Slab and Install Spun Piles

The spun piles were closely spaced and filled with reinforced concrete plug to provide adequate lateral resistance and the piles were driven into the competent hard layer. As such, it is not necessary to adopt raking piles to provide the lateral resistance.

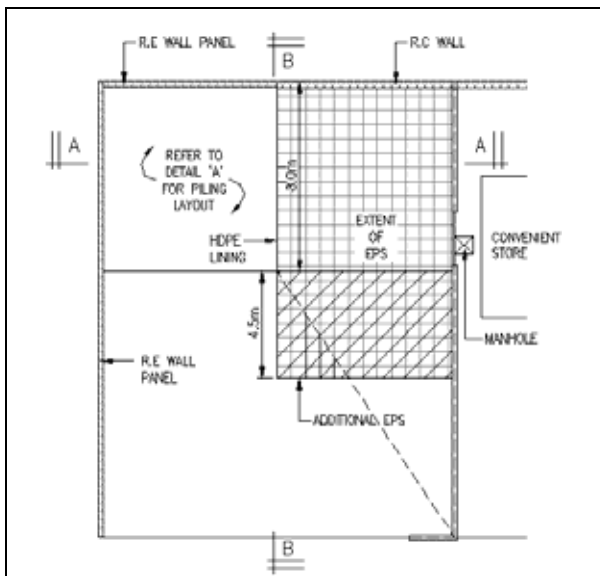
Figure 21 Reinstatement of RS Wall and Partial Replacement of Backfill Material using EPS

Longer wall reinforcement length was also used to achieve the required factor of safety of the wall against adherence failure while Expanded Polystyrene (EPS) was adopted to reduce the vertical overburden pressure at the wall section where replacement of wall reinforcements could not be done due to site constraints. Figures 19 to 24 illustrate the details and sequence of the proposed remedial works.

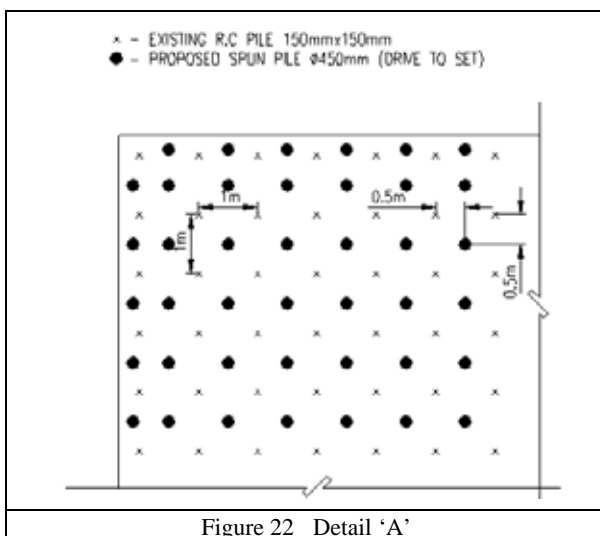
Figure 22 Detail 'A'

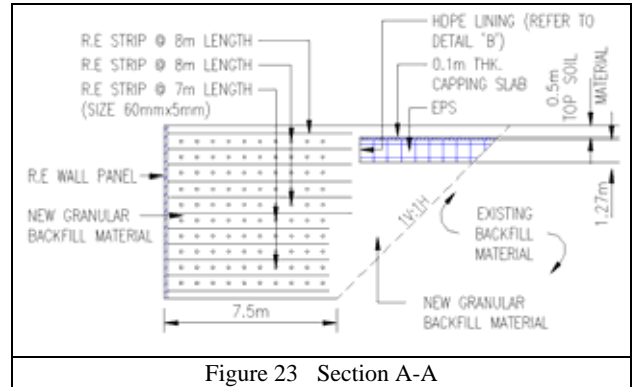
Figure 23 Section A-A

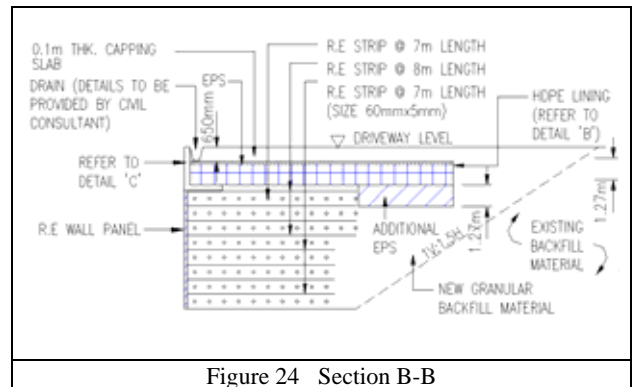
Figure 24 Section B-B

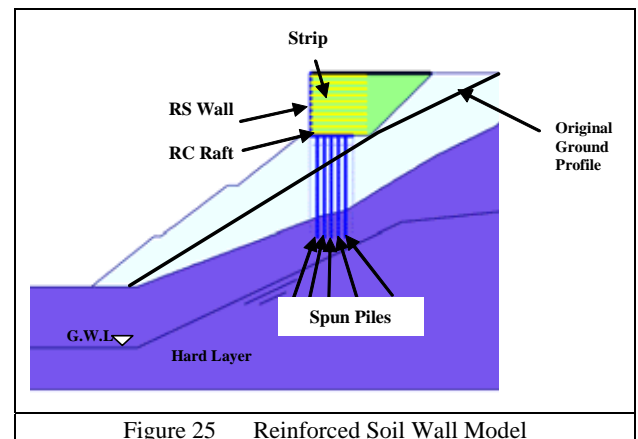
Prior to the actual construction of the proposed remedial works, finite element method (FEM) analyses on the proposed remedial solution were carried out to analyse the overall configuration in order to determine the performance of the proposed remedial solution. Figure 25 shows the model of RS Wall used in the FEM analyses. The Mohr Coulomb soil model was adopted in the analyses. In FEM modelling, both the spun pile and RC Raft were modelled as linear elastic materials with properties of Young's Modulus and Poisson's ratio. The spun piles and the RC raft were modelled as beam elements in order to determine the shear force and bending moment for detailed design thereafter. A summary of the material properties is presented in Table 5.

Figure 25 Reinforced Soil Wall Model

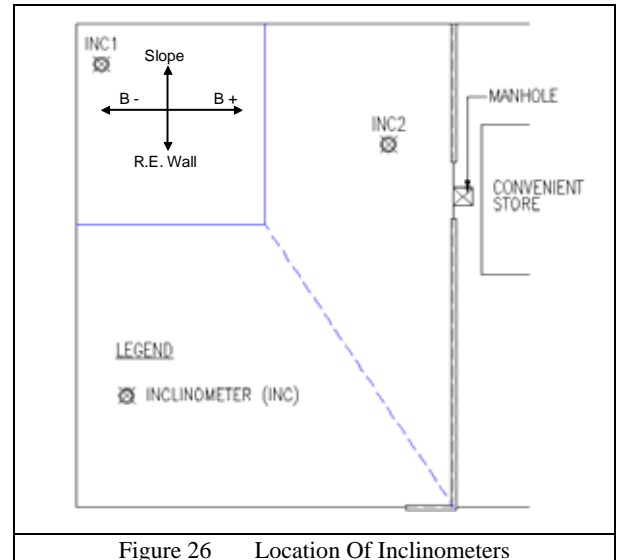
Figure 26 Location Of Inclinometers

A monitoring programme was recommended to monitor the long-term performance of the proposed remedial work. The proposed monitoring programme consisted of three (3) inclinometers. However, one inclinometer was damaged during installation. Therefore, only two (2) inclinometers were installed. The locations and typical details of inclinometers are shown in Figures 26 and 27. Readings of the instruments were recommended to be taken fortnightly for the first two (2) months and once a month thereafter for eight (8) months. Subsequently, the monitoring was carried out once every four (4) months for a year.

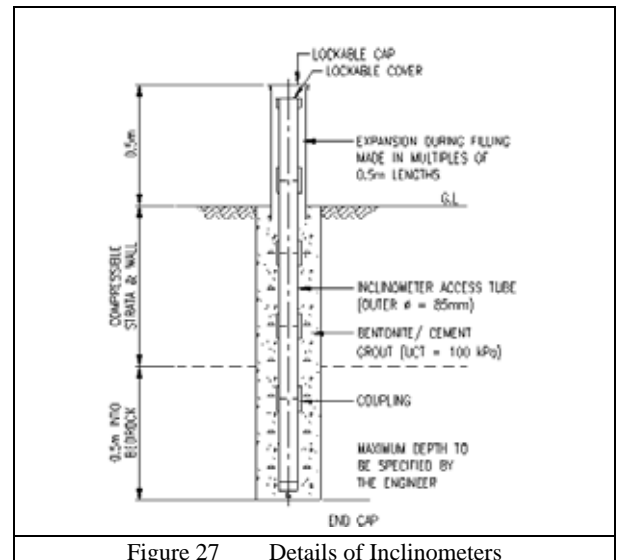
Figure 27 Details of Inclinometers

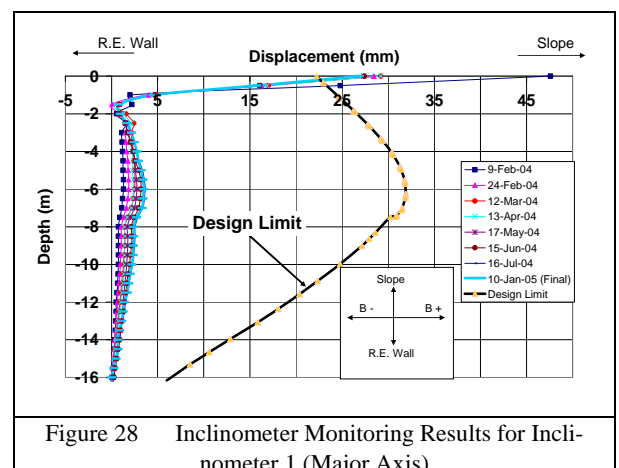
Figure 28 Inclinometer Monitoring Results for Inclinometer 1 (Major Axis)

Figures 28 to 31 show that the inclinometer monitoring results for Inclinometers 1 and 2 respectively in comparison with the FEM analyses. Upon reviewing the inclinometer monitoring results, it was found that the lateral displacement of the inclinometer showed a trend of stabilising readings and are within the acceptable limit as interpreted from the FEM analyses. Therefore, it can be concluded that the proposed remedial works are effective.

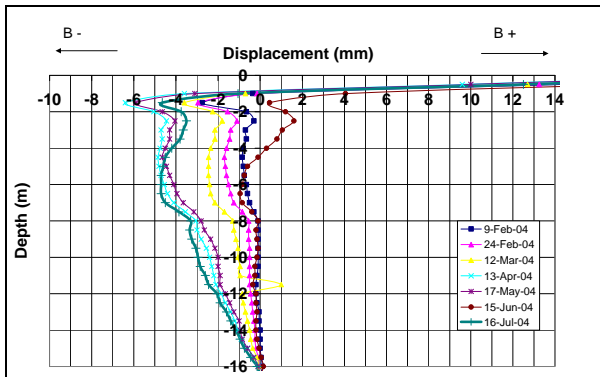
Figure 29 Inclinometer Monitoring Results for Inclinometer 1 (Minor Axis)

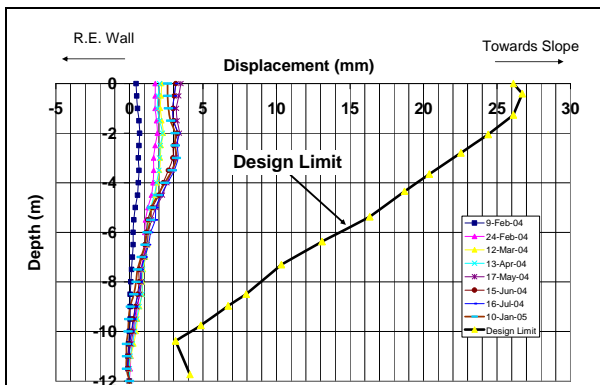
Figure 30 Inclinometer Monitoring Results for Inclinometer 2 (Major Axis)

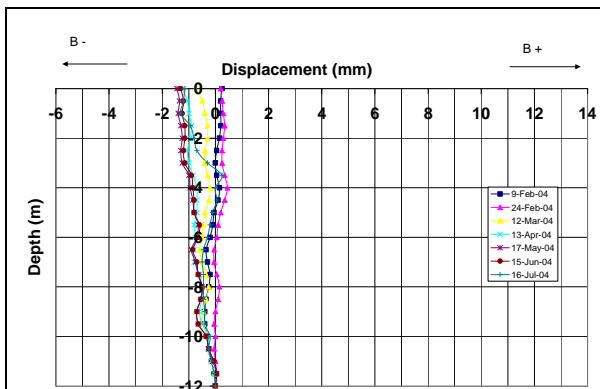
Figure 31 Inclinometer Monitoring Results for Inclinometer 2 (Minor Axis)
