Massive Creep Movements of Post-Glacial Deposits in Kundasang Areas

S. S. LIEW & S. S. GUE

Gue & Partners Sdn. Bhd., Malaysia

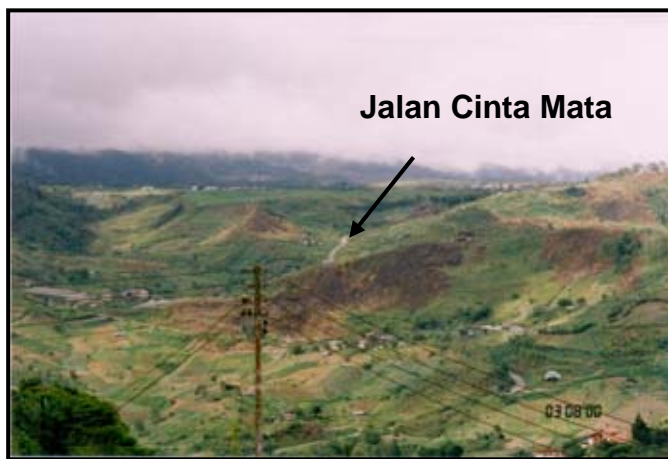
Photo 1: Overall Site Terrain

The overall site terrain is generally undulating in nature as shown in Photo 1.

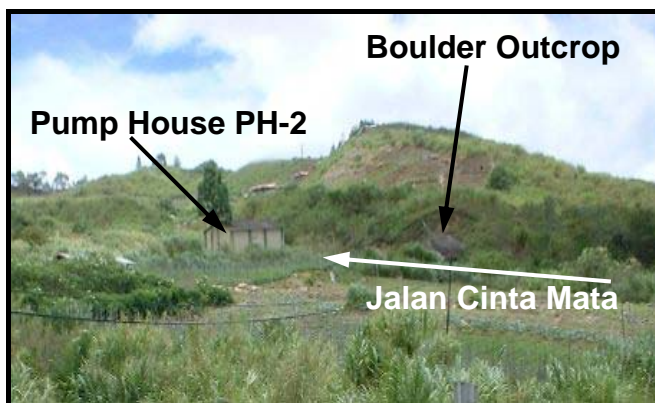
Photo 3: Overview of Jalan Cinta Mata Entrance

There is an abandoned pump houses (PH-2) at the left hand side after turning into the Jalan Cinta Mata and another pump house (PH-3) at the right hand side near the end of the affected chainage of the road. Photo 3 shows the location of the pump house (PH-2). This pump house is built for the Mesilau Mini Hydro project as part of the irrigation scheme, which provides irrigation for horticulture in the Kundasang areas.

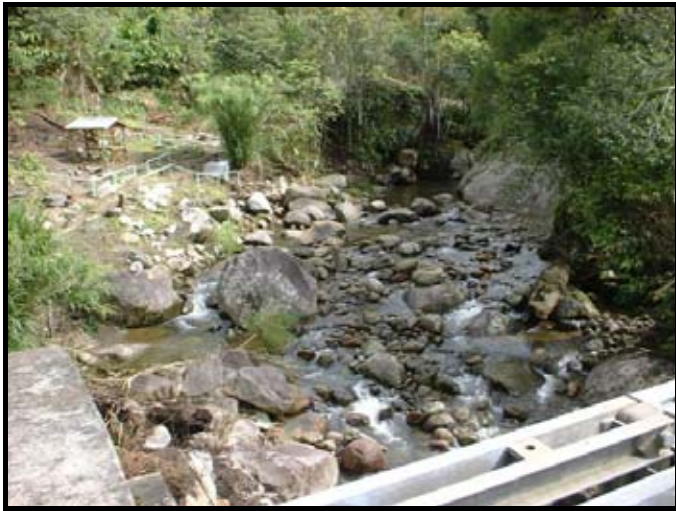
Photo 9: Outcrop at Sg. Mesilau

A geological walk-around at the studied area has confirmed the geological formation and aforementioned geological conditions. Photos 9 and 10 show the Pinosuk Gravels outcrops at the Sg. West Mesilau and the adjacent cut slope along the road respectively. Photo 11 shows the granitic boulders on the Desa Cattle Farm.

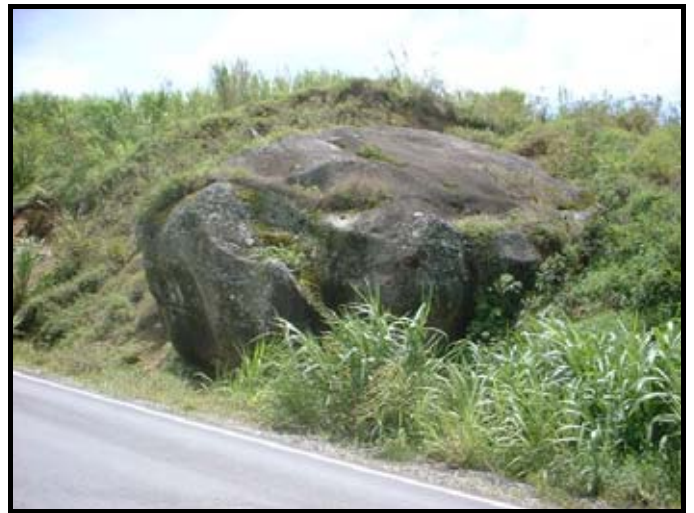
Photo 12: Granitic Boulder at Lower Plateau

5. Numbers of large granitic boulders were observed at the surrounding of the area. Photo 12 shows the gigantic granite boulder on the opposite side of the borehole, BH-6. This provides good evidence on the historical transportation of the glacial till derived from the Mt. Kinabalu. The walk-around by our geological expert on 22 September 2001 looking for the geological features on the outcrop and the exposure at the river has confirmed that the site is within the Pinosuk Gravels. An outcrop consisting of red shale, which is believed to be the remnants of the lower Trusmadi Formation, was observed in borehole BH-5 and the adjacent boulder outcrop.

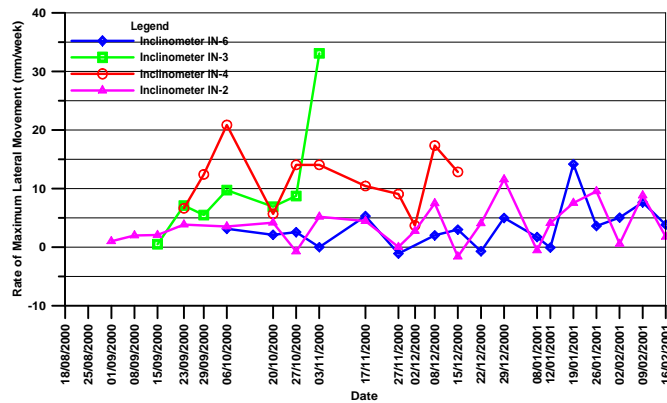
Figure 7: Rate of Maximum Lateral Movement

The interpreted borelog profile and the groundwater conditions are shown in Figure 6. From the inclinometer results, it is observed that distinct shear planes can be identified, particularly at inclinometers, IN-2, IN-3, IN-4 and IN-6. The direction of lateral movement of these inclinometers is in the narrow range between 225° and 250°. The maximum lateral movement is 140mm, which is in Inclinometer IN-4. The rates of maximum lateral ground movements in these inclinometers are generally in the range of 2mm/week to 14mm/week with few exceptional cases of maximum up to 21mm/week as shown in Figure 7. Whereas, inclinometers IN-1, IN-1A and IN-5 show lateral movement profile of a buckling casing and indicate that there is some compression within the subsoil at these inclinometers.

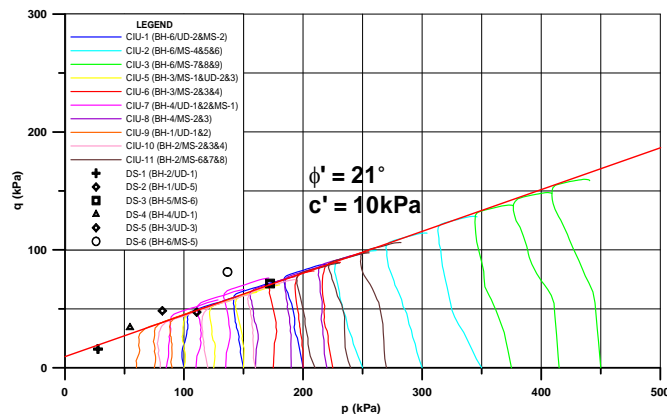
Figure 8: C.I.U. Tests & Direct Shear Box Tests

From the interpreted consolidated isotropically undrained (C.I.U) triaxial test results, the effective shear strength of the subsoils with vertical effective stress level ranging from 50kPa to 450kPa indicates : $\phi' = 21^\circ$ and $c' = 10\text{kPa}$, as shown Figure 7. The soil samples recovered from the boreholes are generally Silty Clay with sedimentary clast and occasionally Sandy Silt at the upper layer.

Six undisturbed soil samples near to the identified slip plane have been selected, reconstituted and tested in direct shear box to indicate the shear strength of the fine content of the soil mixtures. The test specimens were prepared from the soil particles passing through the 425 μm sieve with the adjusted moisture content. The normal effective stresses on these specimens were applied based on the corresponding vertical in-situ effective stresses. The interpreted soil strength from direct shear box tests is fairly near to the CIU strength with two data points having slightly higher values. This is also shown in Figure 8.

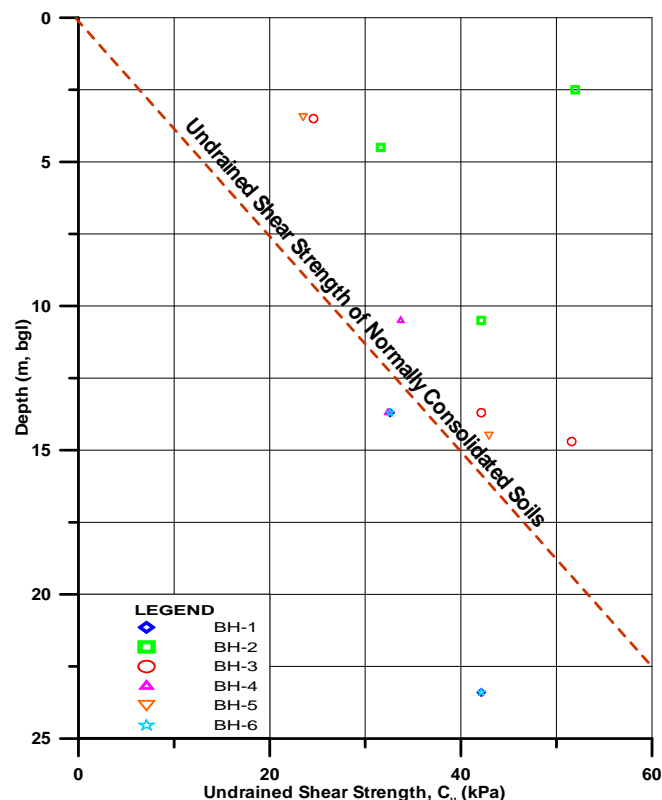
Figure 9: Undrained Shear Strength Tests

1. The natural water content in the subsoil of the moving soil mass is lower than the plastic limit of the subsoil. The natural water content of the soil samples is in the range from 7% to 13%.
2. The bulk density of the subsoil is generally in the range between 21 to 23kN/m³, except for sample, MS-6 in borehole, BH-5, which has the bulk density of 23.69kN/m³.
3. The undrained shear strengths of most undisturbed samples are considerably low as shown in Figure 9, which are
