Geotechnical Investigation and Monitoring Results of a Landslide Failure at Southern Peninsular Malaysia (Part 1: Investigating Causes of Failure)

Liew, S. S., Gue, S. S., Liong, C. H.

Director, Gue & Partners Sdn Bhd, Malaysia.

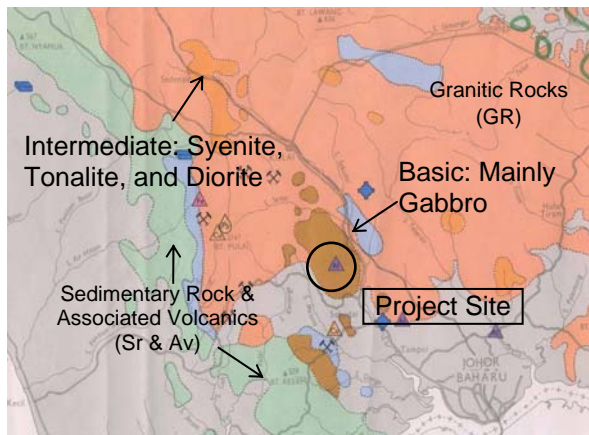
Figure 1 Regional Site Geology and Mineral Resources Map, 1982

The site is located on a relatively high ground with original reduced level ranging from RL 54.0m to RL 106.0m over a distance of about 320m. The regional geological map of Malaysia (1982) shows that the site is situated at Jurong Formation which is underlain by

mainly basic intrusive gabbro and intermediate intrusive rocks such as syenite, tonalite and diorite shown in Figure 1. It was observed that the vicinity of the site comprises of different lithological units.

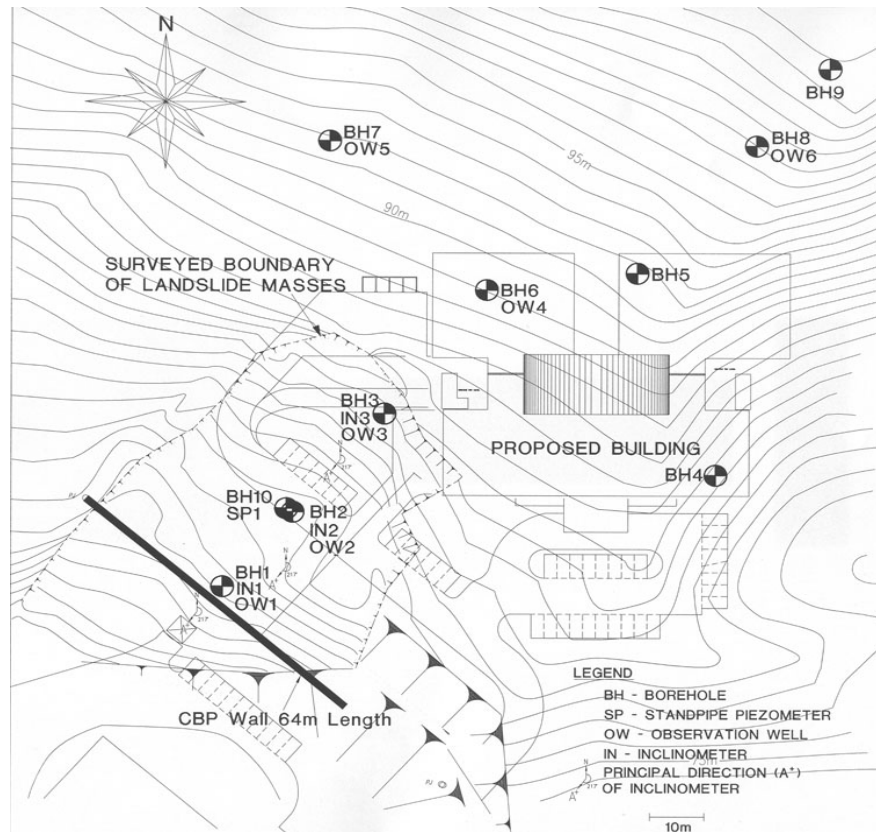
Figure 5 Layout of Borehole and Instrumentation Plan

Subsurface investigation and instrumentation programmes consisting of ten boreholes, three inclinometers, six observation wells and one standpipe piezometer were planned and implemented to investigate the causes of failure, to propose remedial measures and for geotechnical design of the upper proposed building. The layout of the boreholes and instrumentations is shown in Figure 5. Three boreholes, namely BH-1, BH-2 and BH-3, were

sunk within the failed mass. Upon completion of boring operation and sample collection, inclinometers, IN-1, IN-2 and IN-3 were installed in the boreholes. Apart from the inclinometers, three observation wells, OW-1, OW-2 and OW-3 were also installed at 1m away from boreholes BH-1, BH-2 and BH-3 respectively. Liew & Gue (2001) have presented a similar investigation for post glacial deposit in East Malaysia, in which the inclinometers have successfully determined the creep movements and slip surface. Figure 6 shows the interpreted subsoil profiles. The overburden material is generally weak, with SPT-N ranging from 0 to 15.
