Chapter 23

Failures of Ground Improvement Works in Soft Ground

See-Sew, Gue and Yean-Chin, Tan

Gue & Partners Sdn Bhd, Geotechnical Consultants, Kuala Lumpur, Malaysia

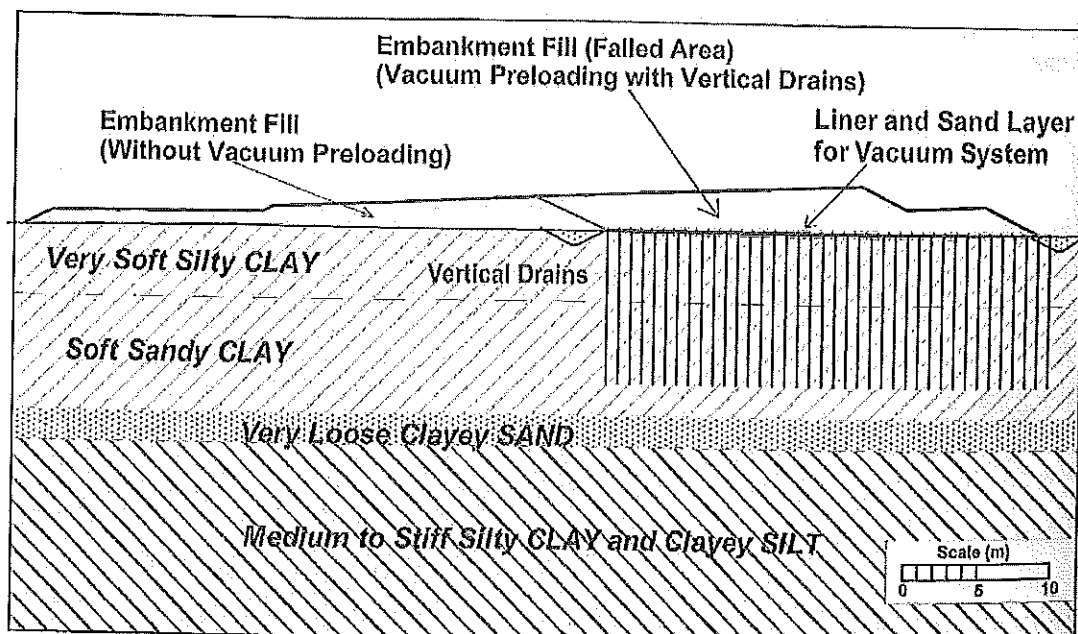
Figure 1. Cross-section of Embankment A.

The embankments were constructed on a very soft silty clay 4.5 m thick and underlain by a layer of soft sandy clay to a depth of about 12 m. Beneath these very soft to soft-cohesive soils is a layer of loose clayey Sand followed by layers of medium to stiff silty clay and sandy clay. Figure 2 shows the undrained shear strength (s_u) profile of the subsoil obtained from the field vane together with the adopted design values. The sensitivity of the soft clay ranges from about 2 to about 10 and can be categorized as sensitive to extra-sensitive clays according to the definition of sensitivity by Skempton and Northey (1953).

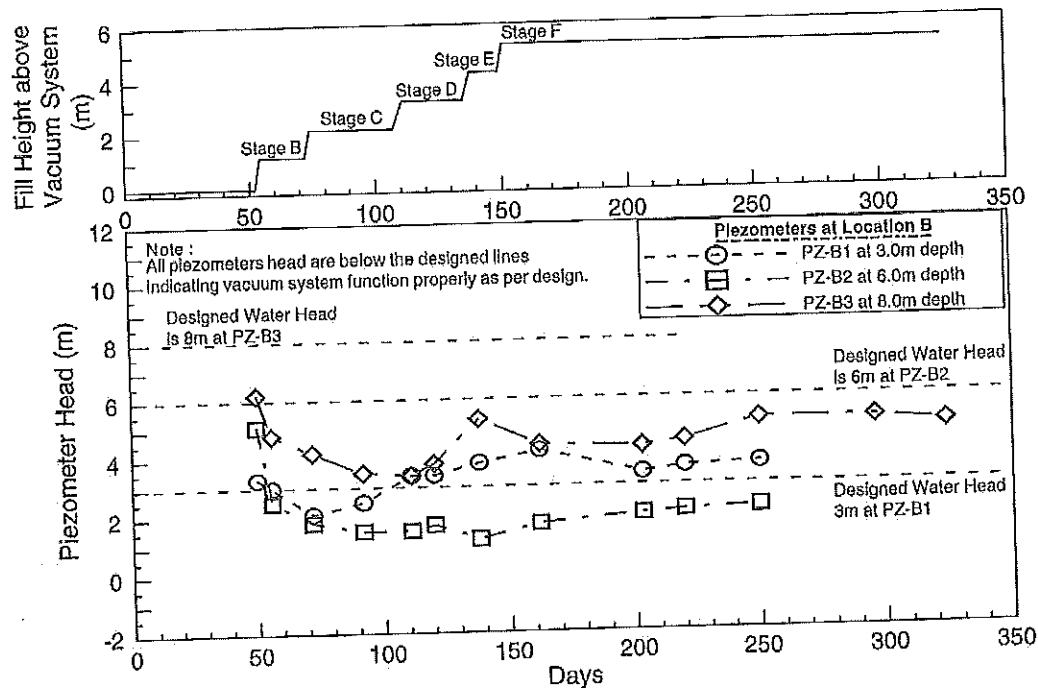
Figure 4. Construction sequence and monitored pore water pressure changes of successfully Constructed Embankment B.

Embankment B, which was not far away from Embankment A and employed the same vacuum preloading ground treatment, was successfully constructed. Figure 4 shows the changes of pore pressures in the piezometers at different depths throughout the construction of Embankment B. The filling sequence is also presented in the same figure for easy reference. The pore pressures in all the piezometers installed were within the designed range indicating the vacuum suction performed as per design. This finding further confirms that the failure of Embankment A was not due to design but rather due to lack of proper construction control.

The observations from two embankments clearly show the importance of the observational approach when employing the vacuum preloading method for embankment construction. It also shows the effectiveness of the observational approach in identifying problems well before failure, provided that the site engineer supervise the work and the design engineer constantly review the monitoring results obtained from the site. In brief, the failure of Embankment A would have been prevented if engineers had observed the changes of pore water pressure in PZ-A2 and PZ-A3 and took necessary precautionary action.

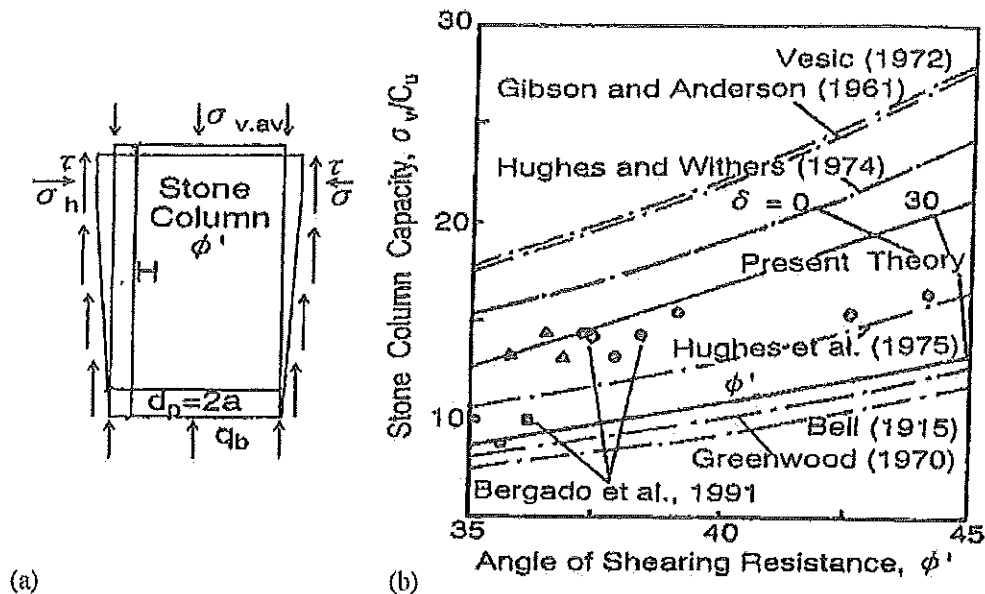
**Figure 6.** (a) Stresses on stone column (b) Comparison of different methods (after Madhav and Miura, 1994).

Most of the methods listed in Table 1 are reproduced in a graph by Madhav and Miura (1994) together with their proposed method as shown in Figure 6. It is observed that there is a large range of possible ultimate bearing capacities when using different methods and this tends to cause confusion to design engineers. Therefore, it is recommended that when using stone columns in very soft ground (e.g. $s_u < 15$ kPa) or as remedial measures for reconstruction of failed embankments, attention shall be given to probable failure due to general shear. In addition, load tests and close monitoring of the instrumentation via the observational method should be carried out to verify the design.

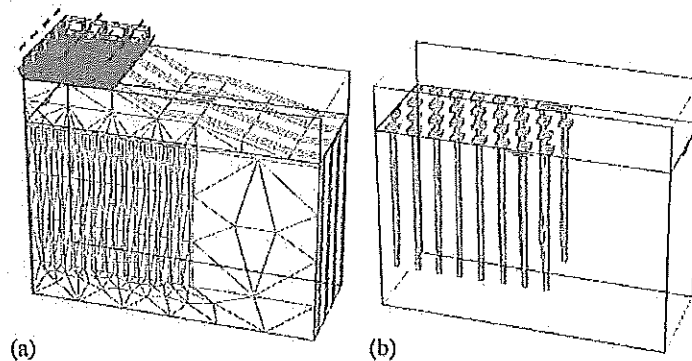
**Figure 9.** (a) Typical 3D FEM Model of Embankment (b) Piles and Pilecaps Modelled.

A typical FEM model adopted for the investigation is shown in Figure 9. In the model, the circular spun piles beneath the embankment are modelled as linear elastic/drained

material with properties defined by Young's Modulus and Poisson's ratio. The piles are assumed to penetrate into the stiff stratum. In both the 2D and 3D analyses, the soft clay subsoils are modelled using Soft Soil Creep model which resembles the Modified Cam–Clay model with isotropic hardening. The fill material is modelled using the Hardening Soil model (Schanz et al., 2000).
