*IEM-GSM Oktoberforum 2005: “Case Histories in Engineering
Geology and Geotechnical Engineering”, 4th Oct. 2005,
Petaling Jaya*

DISCONTINUITIES STUDY AND ROCK SLOPES STABILITY ANALYSIS FOR ROCK MASS AT DAMANSARA AREA, P.JAYA

Prepared by:
Nur Huda & Yew, C.K.

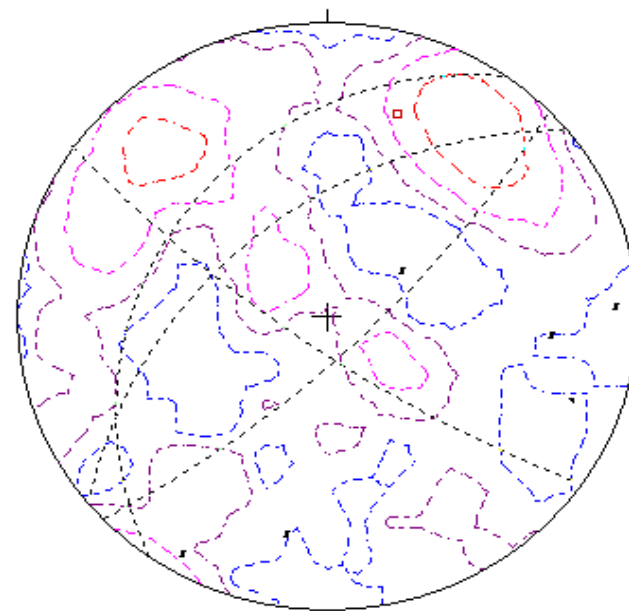
c) Zone B2

Three possible failure identified are circular, plane and wedge failure from the three major discontinuities of J1 (215/77), J2 (136/77, and J3 (305/30)

Analysis on the pole plot shows that the discontinuities data scattered randomly - **possibility of circular failure**

Potential Wedge Failure: J1 & J2

Potential Plane Failure: J1

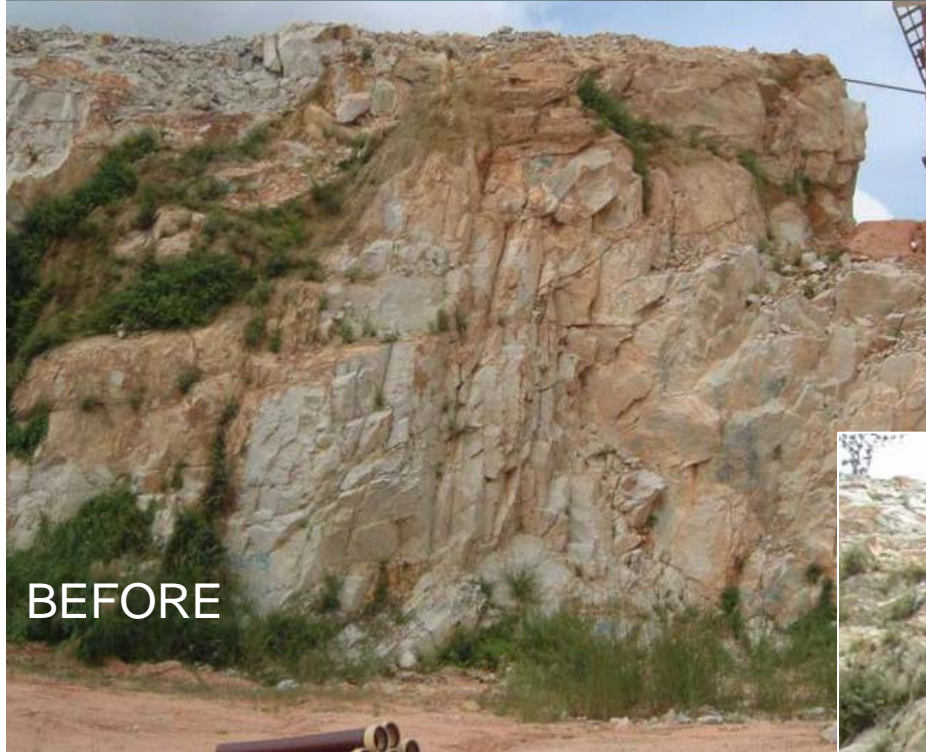
Zone E Rock Slope

Potential **Toppling Failure**: J2

- In addition to kinematic analysis, factor safety analysis were carried out to determine the quantum of the slope stabilisation required to prevent any possible failure
 - Rock slopes were stabilised with:
 1. Spot bolting (with tensioned rock bolts and rock dowels)
 2. Scaling (removal of debris, rock fragments and small boulders)
 3. Shotcrete with wire mesh reinforcement and rock horizontal drain
 - For shotcreting, weephole drain shall be installed properly to prevent build-up of water pressure
