*IEM-GSM Oktoberforum 2005: “Case Histories in Engineering
Geology and Geotechnical Engineering”, 4th Oct. 2005,
Petaling Jaya*

DISCONTINUITIES STUDY AND ROCK SLOPES STABILITY ANALYSIS FOR ROCK MASS AT DAMANSARA AREA, P.JAYA

Prepared by:
Nur Huda & Yew, C.K.

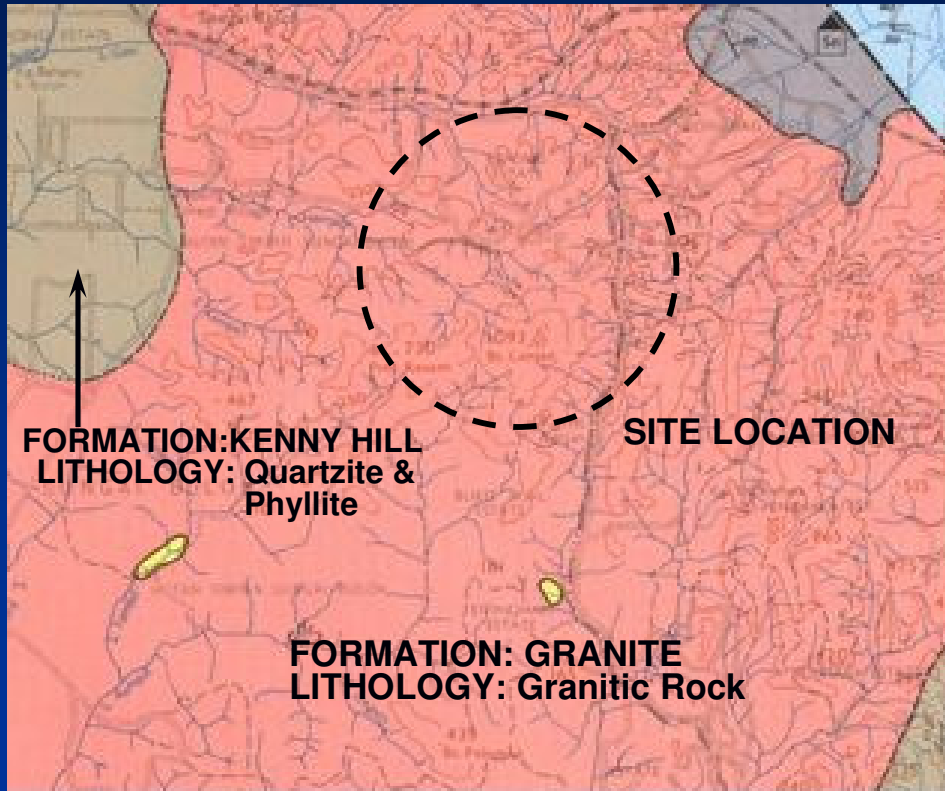
Geology of the Site

- The site is underlain by KL Granite
- Weathering profile: Grade II to VI
- Granite rocks are whitish grey and dark grey in colour with iron stained markings
- **Chemical weathering** is the main character for the weathering process
- Exposed rock is generally Grade II and III

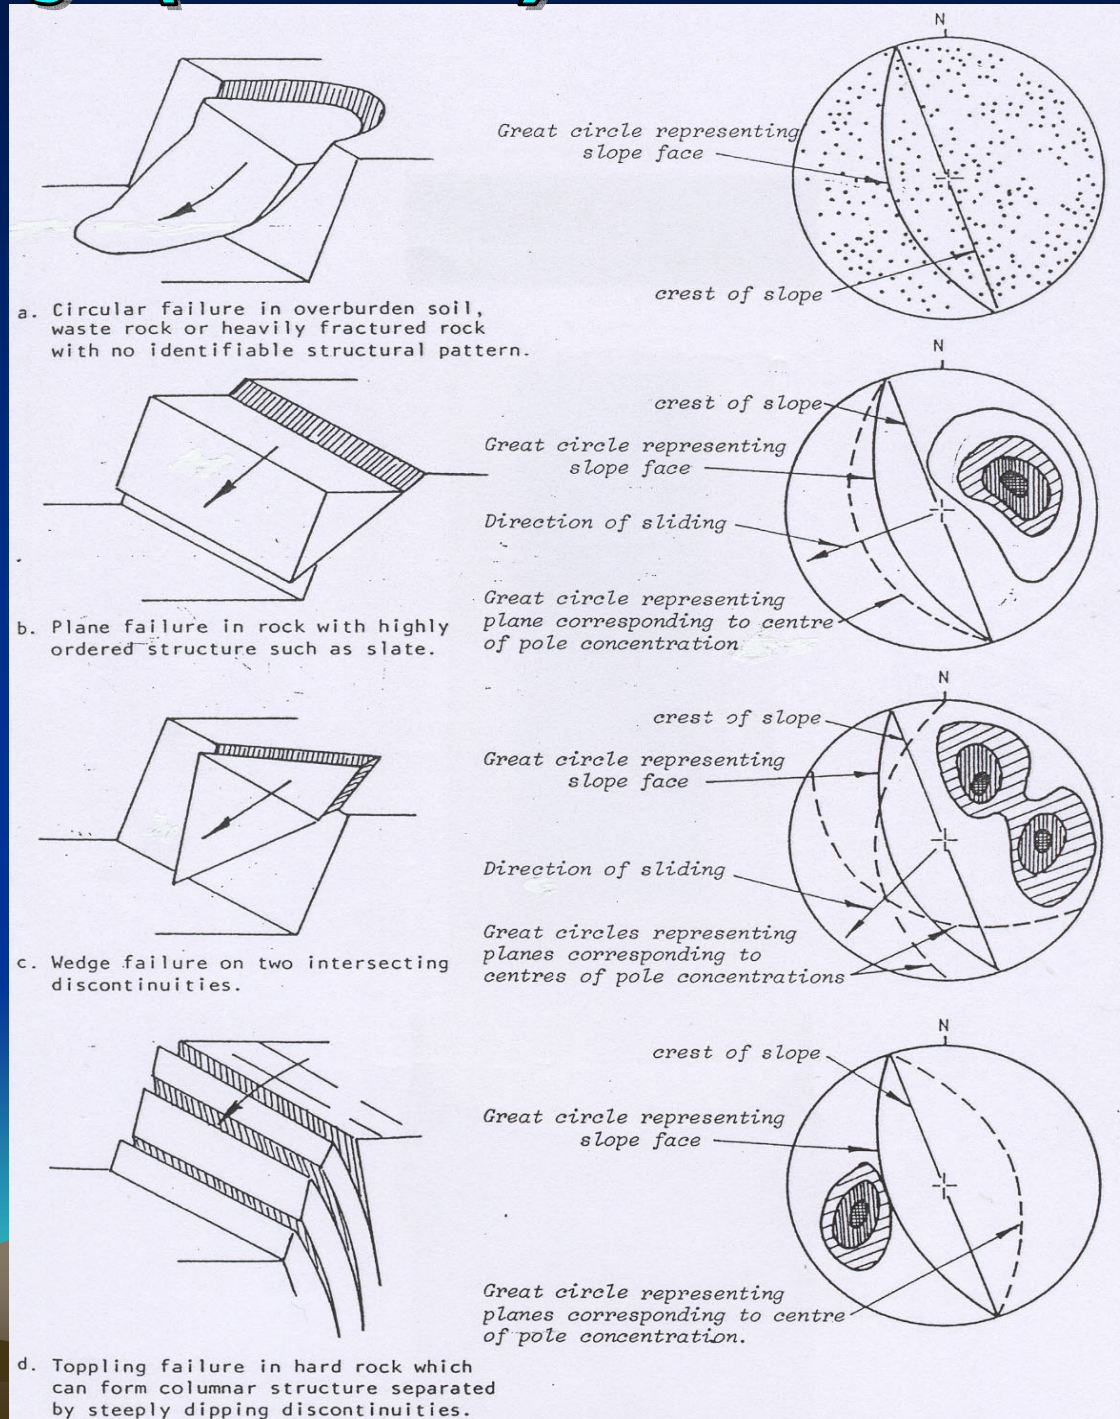
- Determination of possibility of slope instability from the orientation of the discontinuities - **Kinematic Analysis**
- This determination is accomplished by stereoplots analysis
- 4 types of typical failure modes, namely circular failure, plane failure, wedge failure and toppling failure

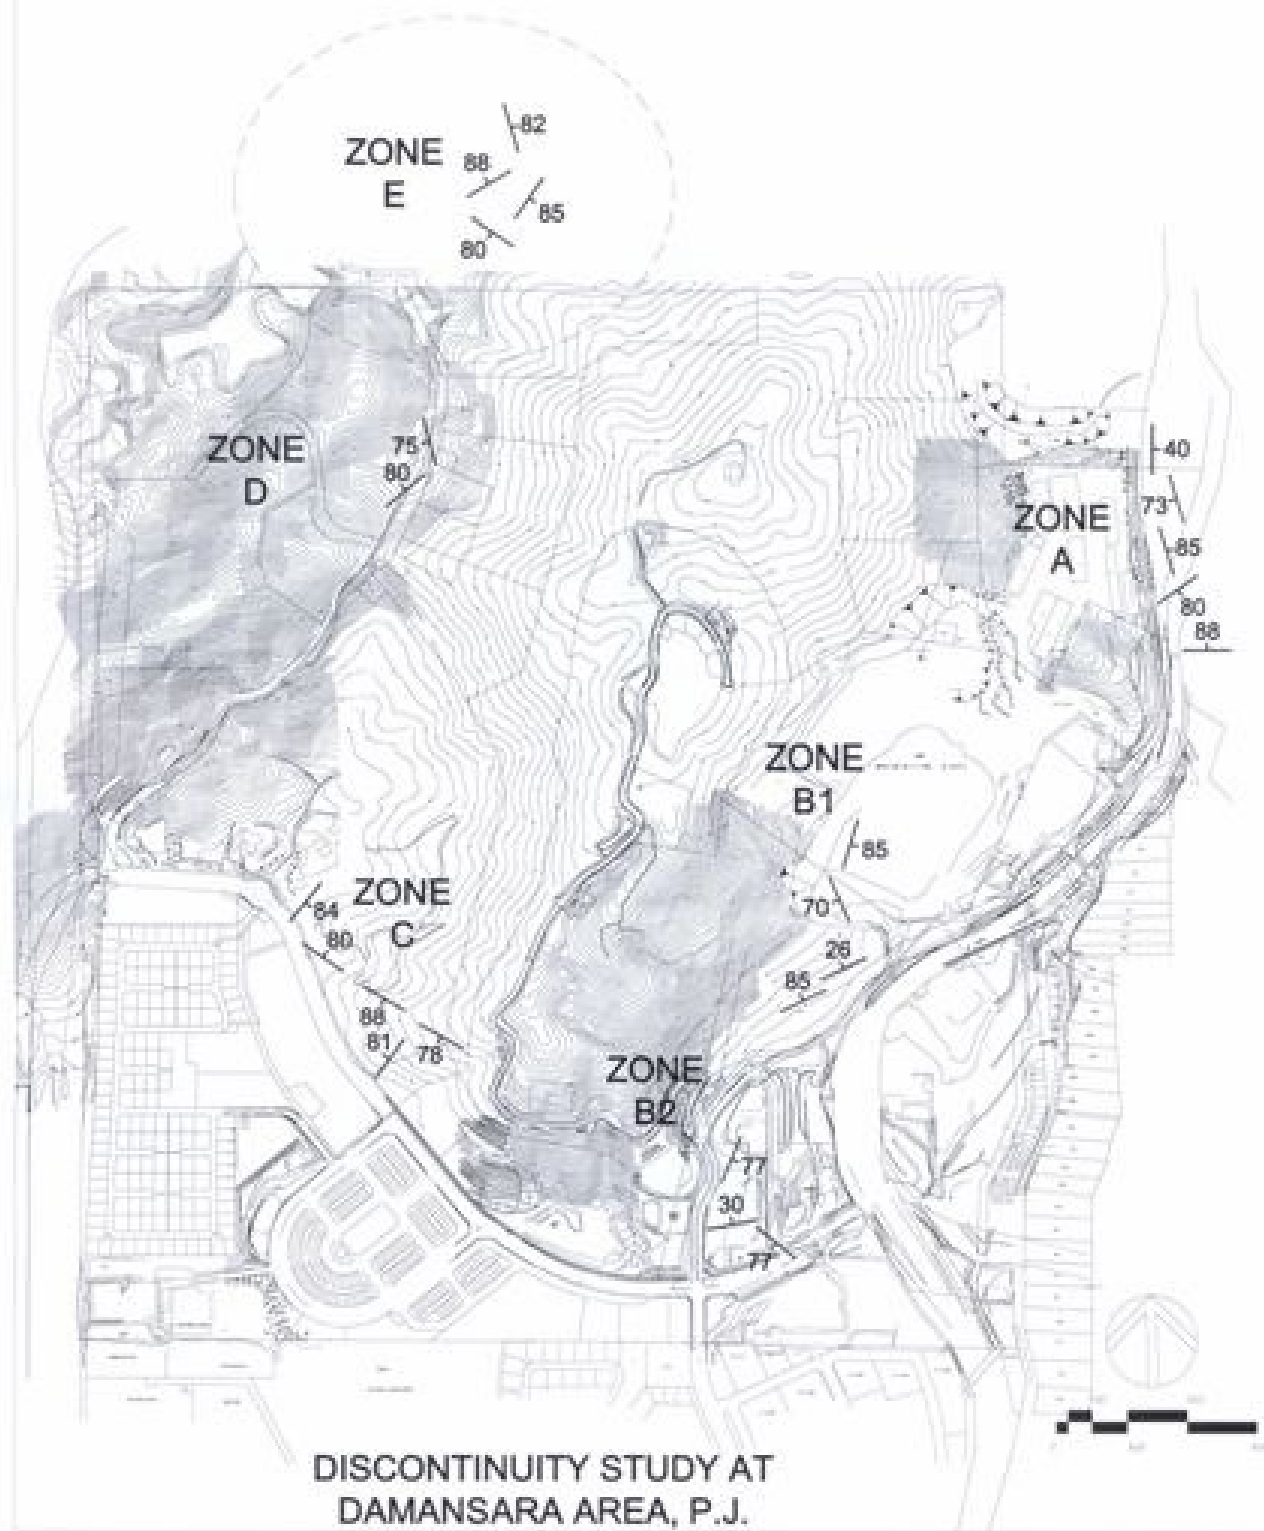
Table 1: Summary of rock slope condition

Area	Zone A	Zone B1	Zone B2	Zone C	Zone D	Zone E
Slope Face Orientation	110°/ 75°	130°/ 80°	150°/ 75°	230°/ 75°	125°/ 70°	340°/ 75°
Major Discontinuities	J1– 203°/73° J2– 090°/40° J3– 071°/85° J4– 140°/80° J5– 360°/88°	J1– 210°/70° J2– 110°/85° J3– 300°/26° J4– 310°/85°	J1– 215°/77° J2– 136°/77° J3– 305°/30°	J1– 030°/80° J2– 310°/81° J3– 122°/84° J4– 209°/88° J5– 209°/78°	J1– 310°/80° J2– 208°/75°	J1– 325°/88° J2– 145°/85° J3– 220°/80° J4– 054°/82°
Potential Failure Mode	Wedge/ Plane	Wedge	Wedge/ Plane/ Circular	Wedge/ Toppling	Toppling	Toppling
Mitigation measure	Completed Rock bolt Rock dowel Shotcrete HD	Proposing	Completed Rock bolt Rock dowel Shotcrete HD	Completed Rock bolt Rock dowel Shotcrete HD	On-going Rock bolt Rock dowel Shotcrete HD	Completed Rock bolt Rock dowel Shotcrete HD
