SESSION 1 : Basic of Geotechnical Forensic Engineering : Myths and Common Problems in

Ir. Liew Shaw Shong

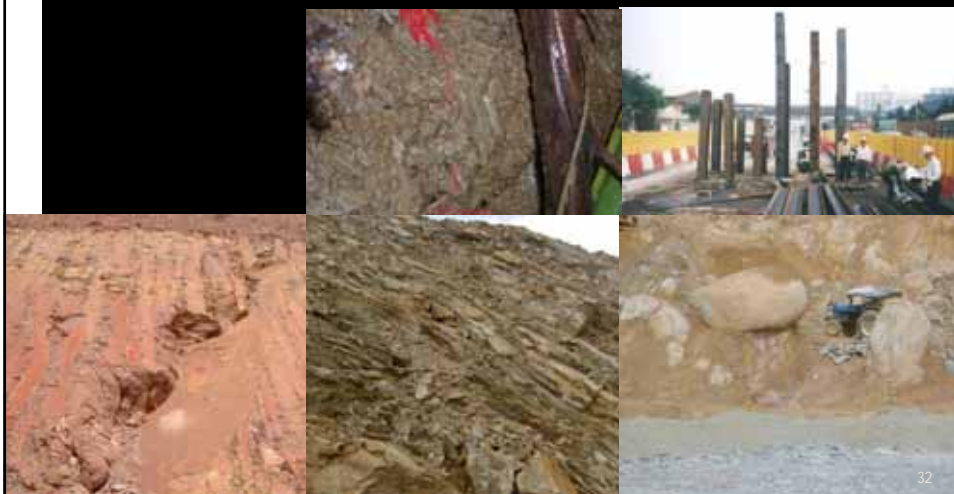
Difficulties in Identification of Complex Geological Settings

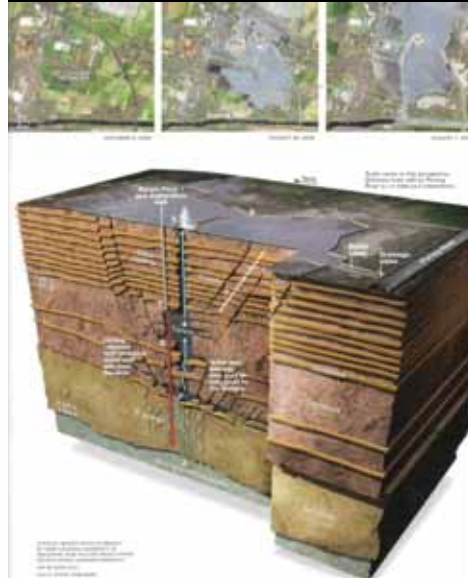
It began with a burst of steam and a spurt of mud. But the gloopy surge that locals call Lusi soon became a sprawling nightmare. Satellite images (top) show Lusi swallowing more than two square miles in the Porong District. A cross section (right) illustrates what geologist Richard Davies believes caused the disaster.

1. Drillers exploring for gas bored 3,580 feet down, then inserted a steel casing to strengthen the hole.
2. Drilling went deeper without the steel casing. Water and gas filled the hole, and the resulting pressure fractured unprotected rock strata.
3. Hot, high-pressure water was released, probably from the Kujung aquifer.
4. The water raced upward and liquefied masses of mudstone.
5. Mud surged through layers of mudstone and sandstone and broke through the surface.
6. Engineers built dikes in an attempt to contain the mud.
7. Underground, caverns formed and collapsed, causing faults.

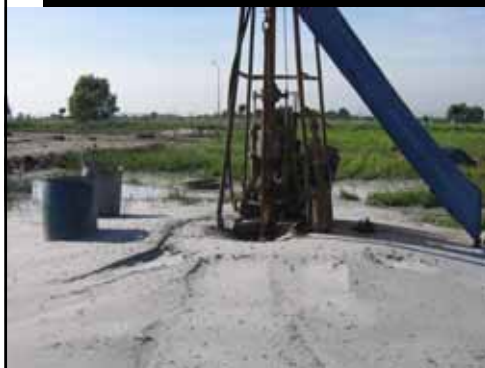
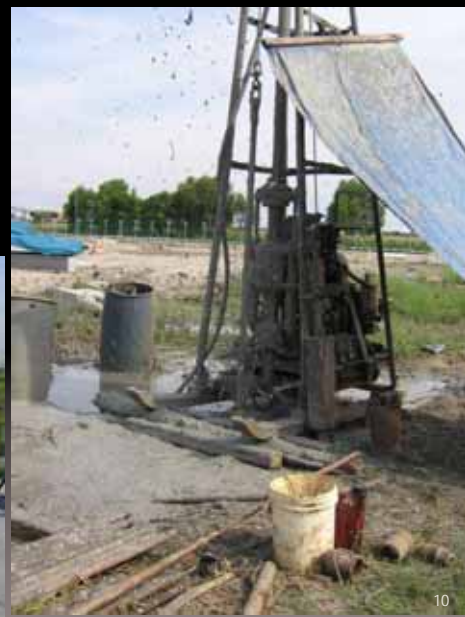
Unexpected Blowout of Underground Gas

- Gas pockets at 32m bgl
- Flushing out of sand

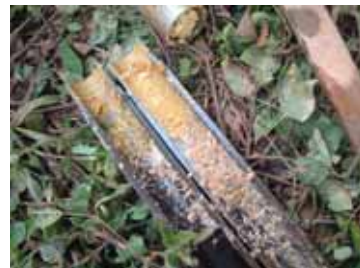
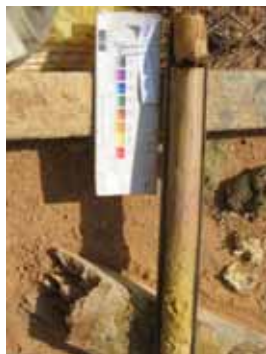
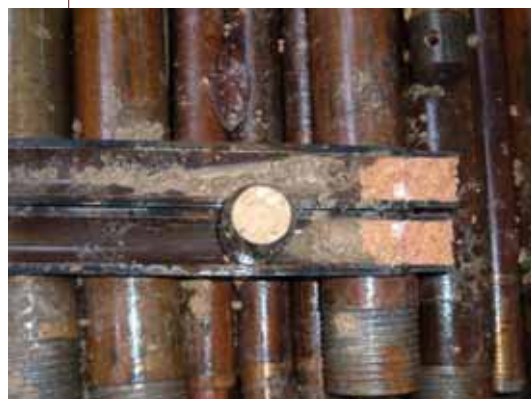
|| Sample Disturbance

- Poor recovery
 - Longer rest period for sample swelling
 - Slight over-sampling
 - Use of sample retainer
- Sample contamination

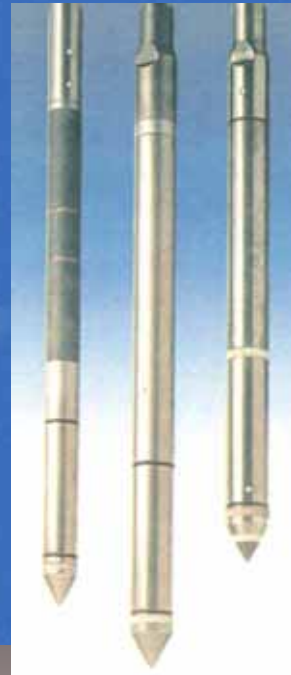
- The Seismic Cone Penetration Test (SCPT) is a reliable, cost effective technique to determine the insitu seismic wave velocity.
- Seismic wave velocities give an indication of ground characteristics such as low strain shear modulus and Poisson's ratio.
- Data from the cone penetrometer is used in delineating the strata changes identified by the seismic results.

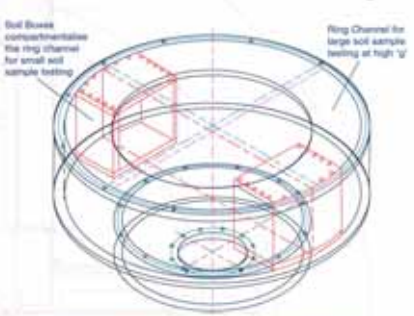
Fig 1: Drum Ring Channel with 2 Soil Compartment Boxes

Soil Boxes compartmentalise the ring channel for small soil sample testing

Ring Channel for large soil sample testing at high 'G'

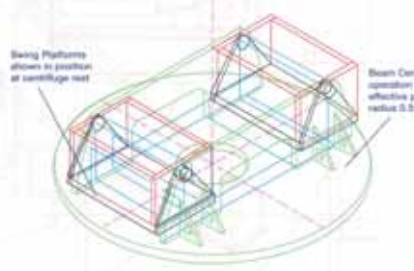
Fig 2: Beam Rotor Table with 2 Swinging Soil Strong Boxes

Swing Platforms shown in position at centrifuge rest

Beam Centrifuge operation with effective payload radius 0.2m

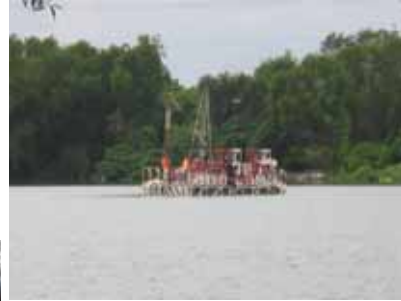
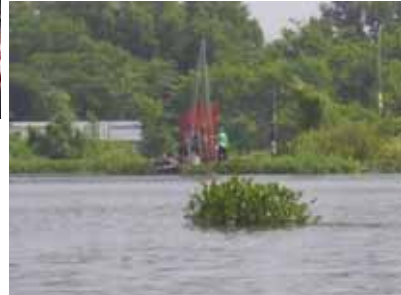
|| Poor Planning & Interpretation

- Inadequate investigation coverage vertically & horizontally
- Wrong investigating tools
- No/wrong interpretation
- Poor investigating sequence

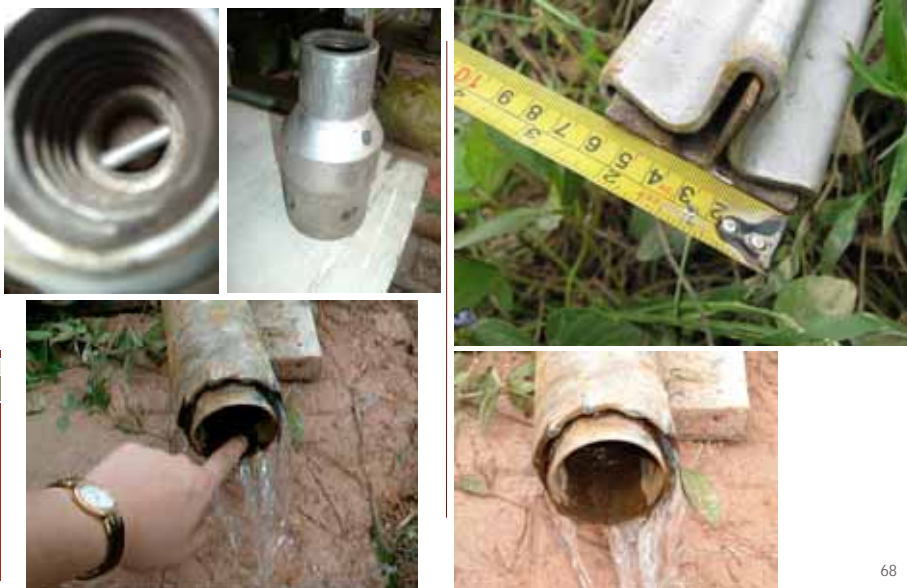
|| Poorly Maintained Tools

- Lack of equipment calibration
 - Wear & Tear Errors
 - Equipment systematic error (rod friction, electronic signal drift, unsaturated porous tip)
 - Defective sensor
 - Inappropriate testing procedures
- Equipment calibration (Variation of pH Values)
 - Improper sample preparation
 - Inadequate saturation
 - Inappropriate testing rate
 - Inadequate QA/QC in testing processes
 - Inherent sample disturbance before testing

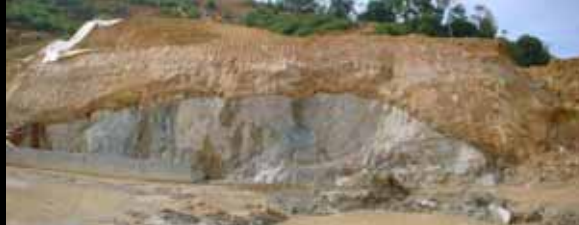
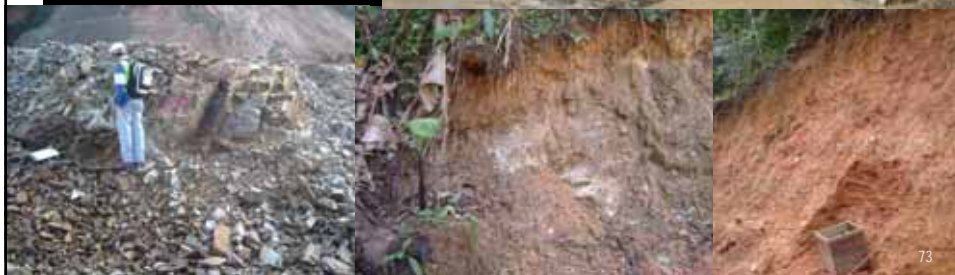
Weathering Profile

- Deviation of material classification between borehole and excavation
(Claim issue – Soil or Rock ?)

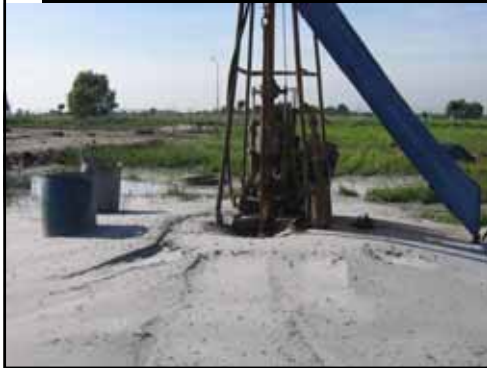
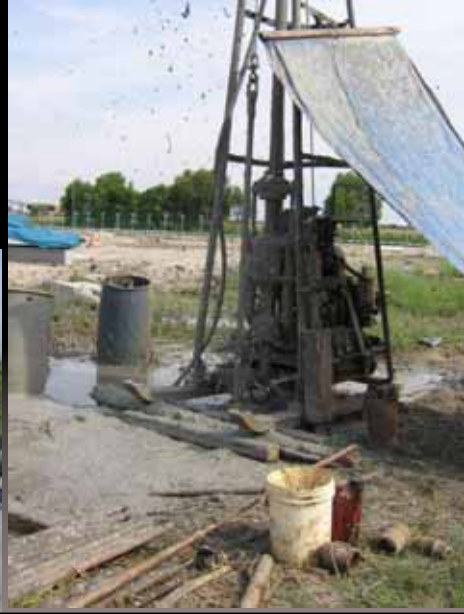
Unexpected Blowout of Underground Gas

- Gas pockets at 32m bgl
- Flushing out of sand

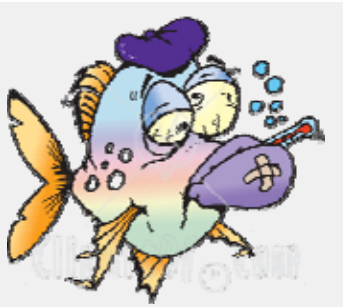
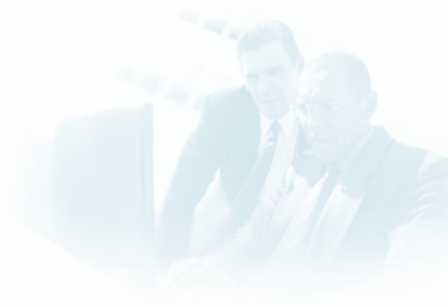
Conformance

- Good conformance of instrument and installation procedures are necessary for measurement of good accuracy.
- Beware of any changes of properties related to parameters to be measured due to presence of instrument

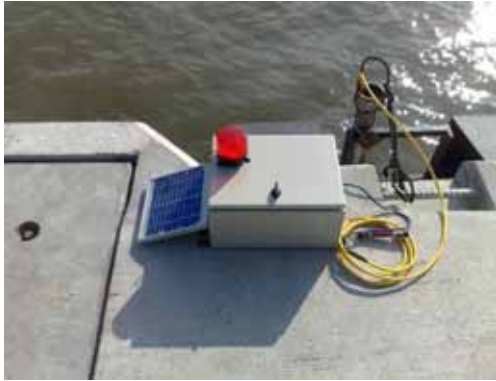
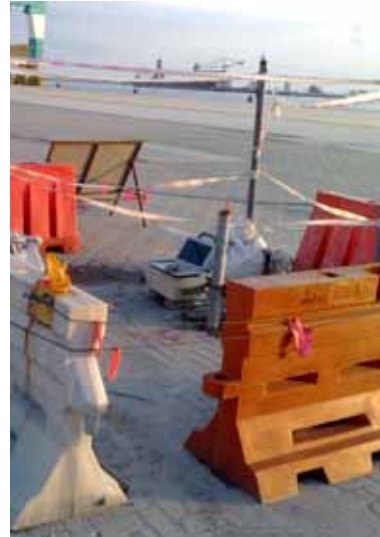
Automatic Water Level Measurement

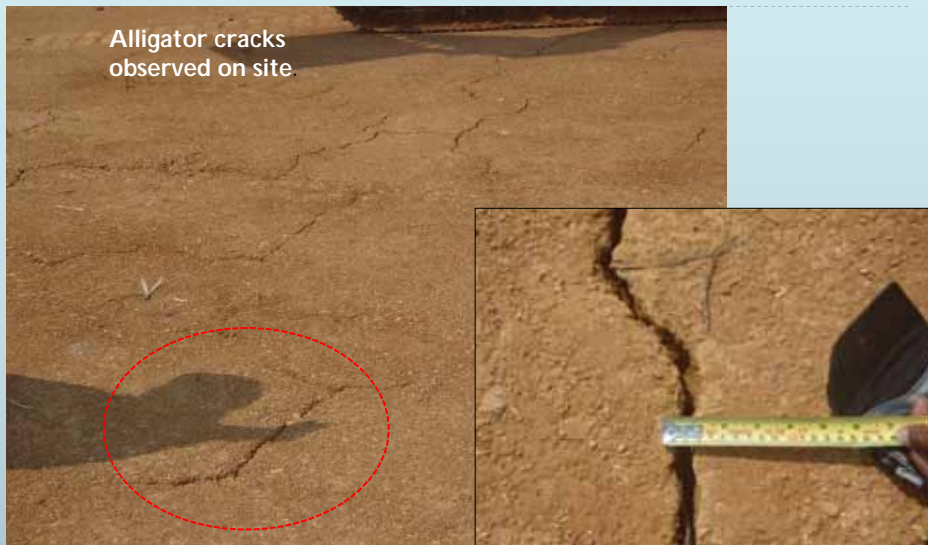
Alligator cracks
observed on site.

- ▶ Longitudinal flexural cracks on embankment surface

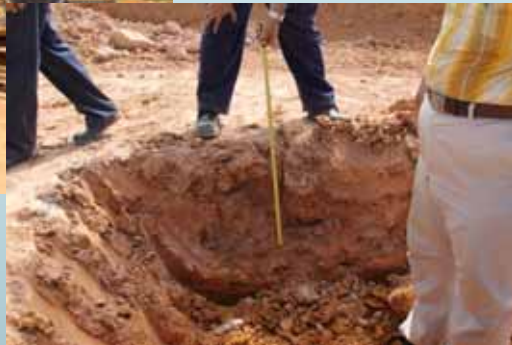
Excavation on cracks found
after 1m surcharge removal

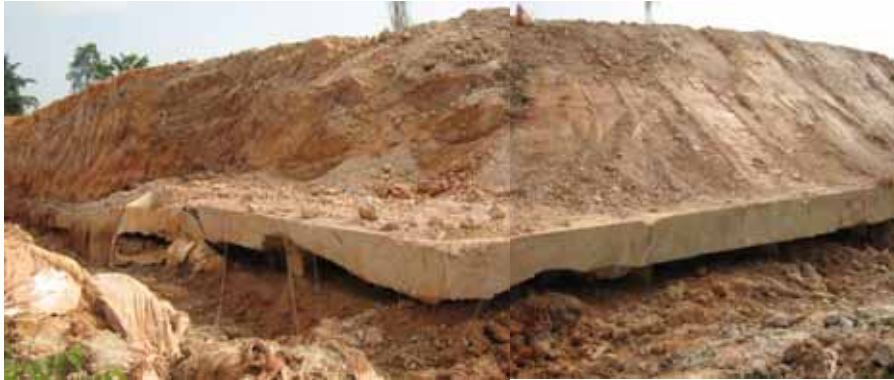
29

- ▶ Piled Embankment 30m from Abutment B shown structural distress

- ▶ Piles & slab of piled embankment suffered structural distress
- ▶ Settlement of 0.4 to 1.0m beneath piled embankment due to consolidation of subsoils under the working filled platform.
- ▶ Bearing distortions confirmed : Bridge deck moving from Abutment B towards Abutment A

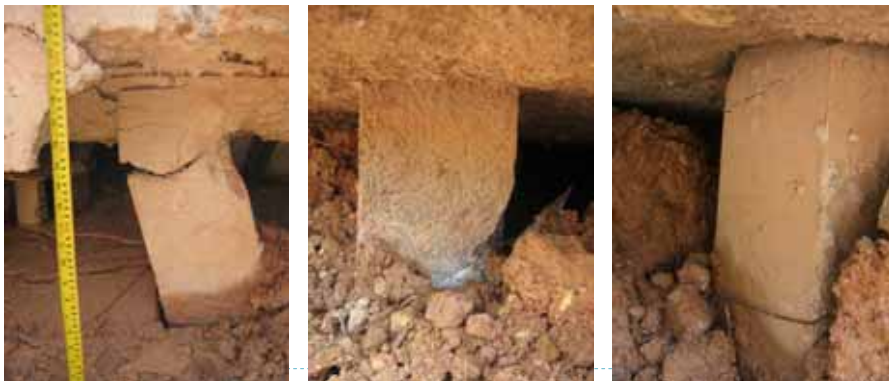
30

- ▶ Piles of Piled Embankment has shown flexural cracks

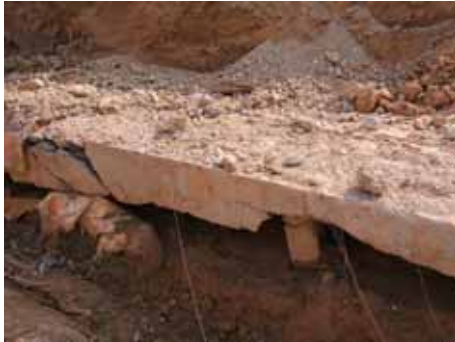
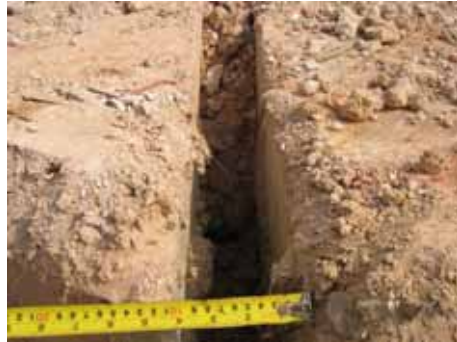
31

- ▶ Damaged piled embankment slab damaged & 100mm gap at slab joint

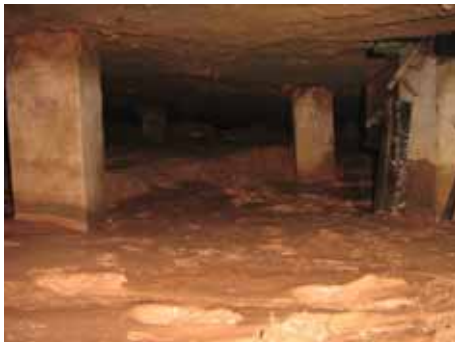
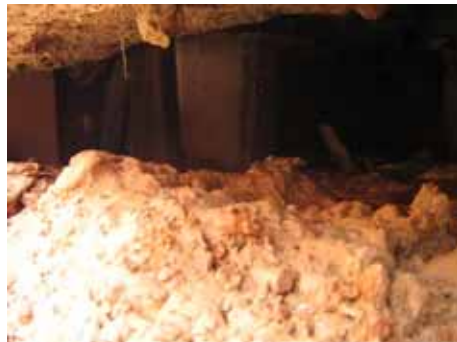
32

- ▶ Settlement of 0.4 to 1.0m under the Piled Embankment

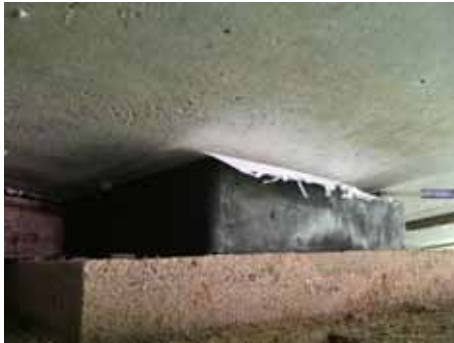
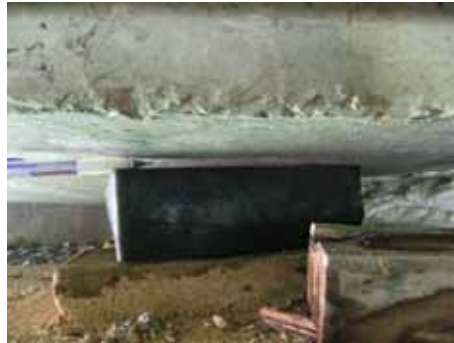
33

► Bearing distortion at Pier P2

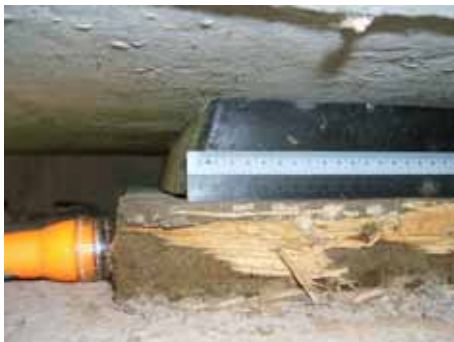
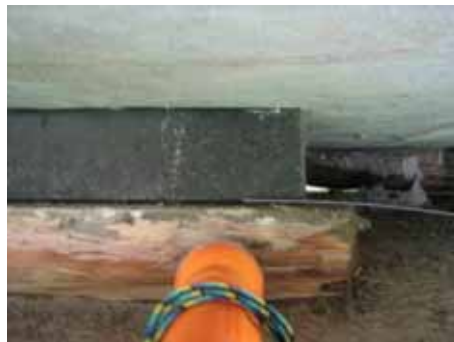
34

► Bearing distortion at Pier P1

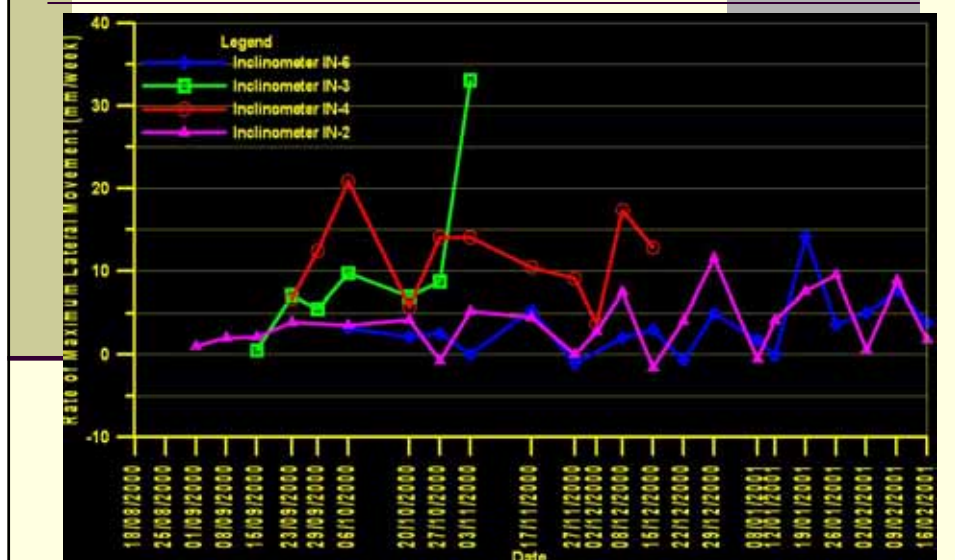
Inclinometer Movement Rate

- Inclinometers detected slip surface.
- Lateral Movement:
- Direction : $225^\circ \sim 250^\circ$
- Max. Movement : 140mm (IN-4)
- Rate of Movement : 2~14mm/week (Max. 21mm/week)

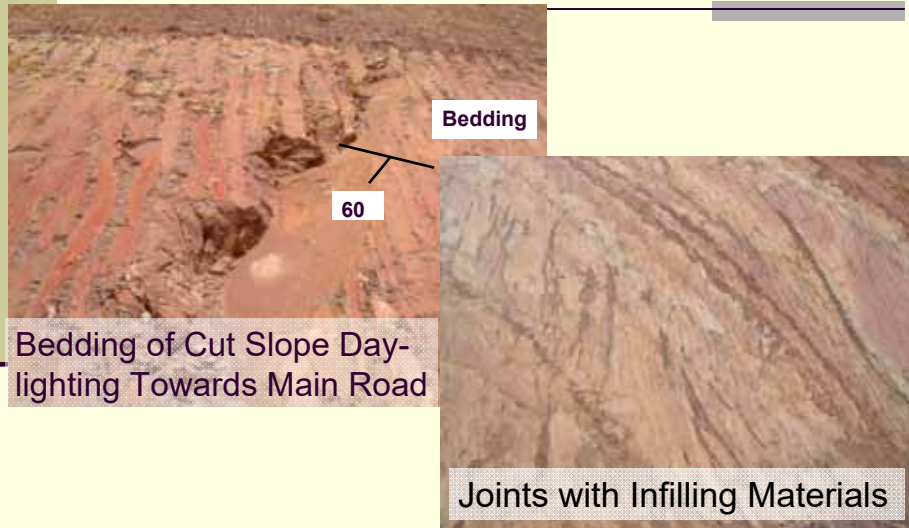
Site Observations

- 'Line Mapping' Method
 - To measure & record discontinuity along the exposed slope face
 - To detect anomalous features
 - Schmidt Rebound Hammer to give indication on weathering condition

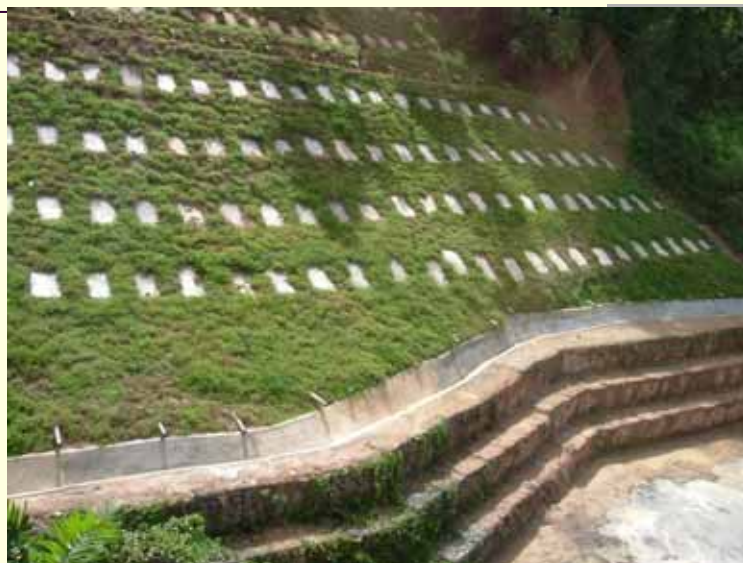
Completed Soil Nailed Slope

- The gradient of the cut slope is steep and is not stable in long term
- Slope strengthening works with installation of soil nails and subsoil drainage system have proven an effective solution to stabilise the distressed slope.

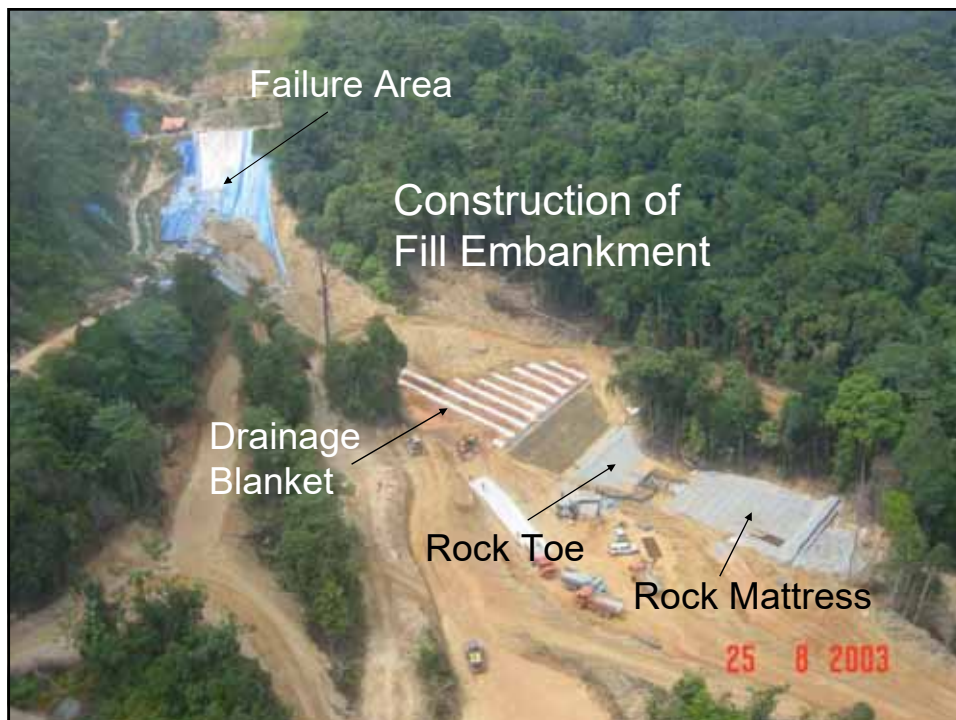
Remedial Works

- Fill embankment over valley.
- Fill embankment comprises of :
rock toe and seven berm slope (1V:2H).
- Provision of extensive subsoil drainage:
French drain and drainage blanket.
- Upgrading and construction of new
drainage system.

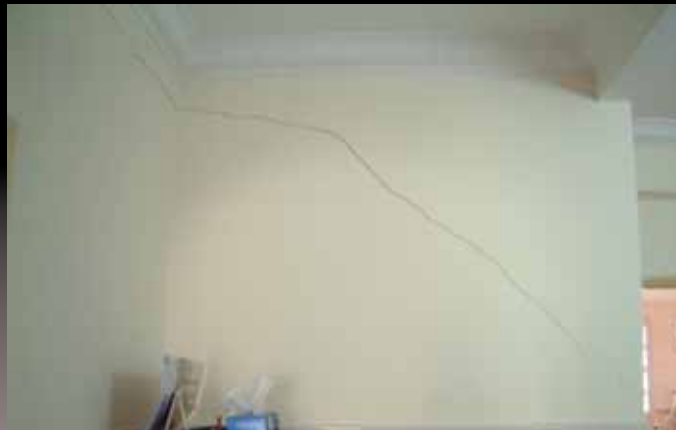
- Cracks on wall – mostly diagonal – due to differential settlement

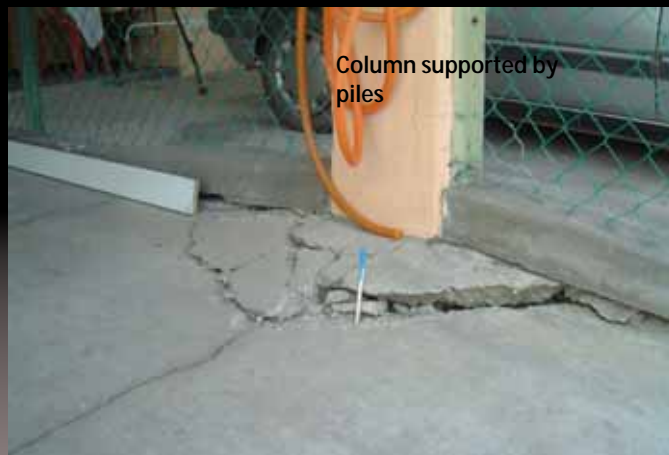
- Distress due to differential settlement

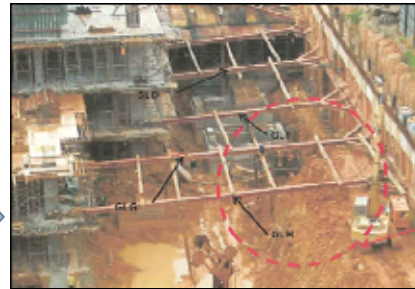
CS2: Important Events Before Collapse

Strut F was reinstated. After installation of struts G and H, temporary passive berm along Gridlines G and H were progressively removed.

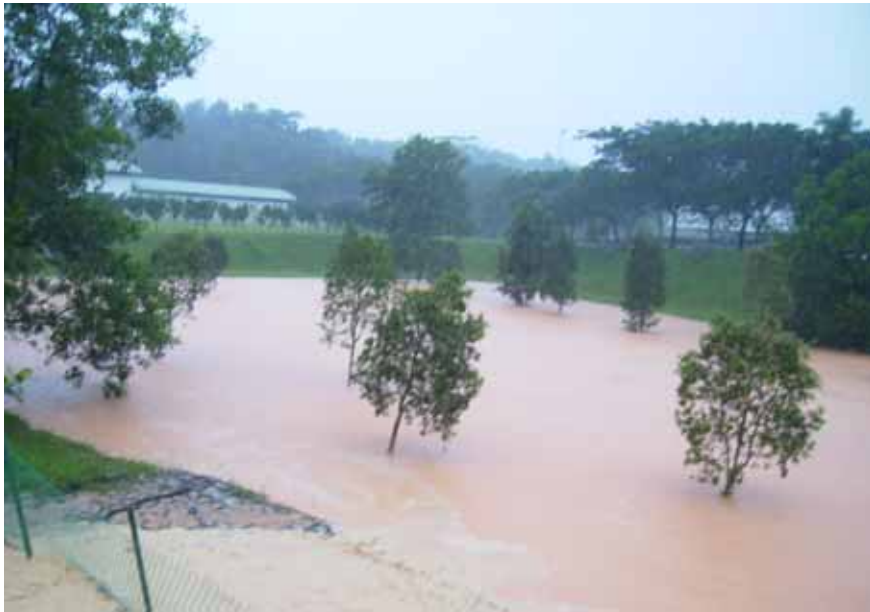
Retention pond full of water

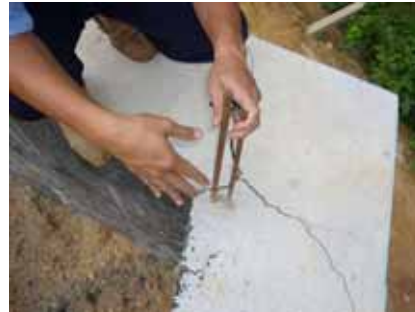
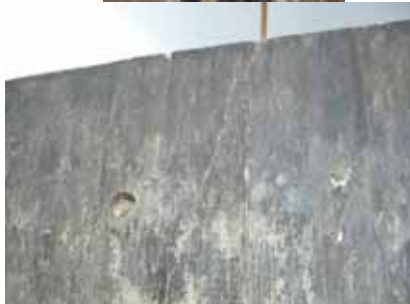
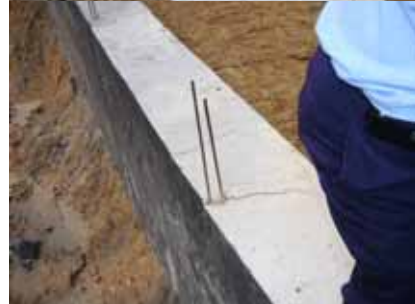
Tension Crack & Wall Distresses

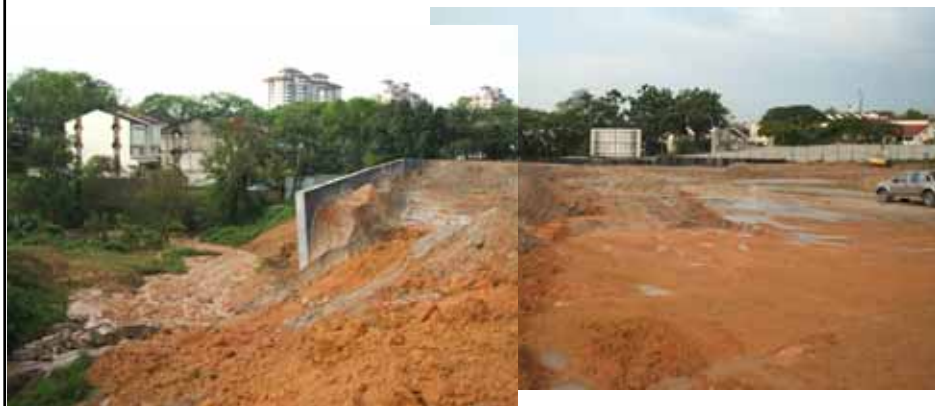
Overall View of Site

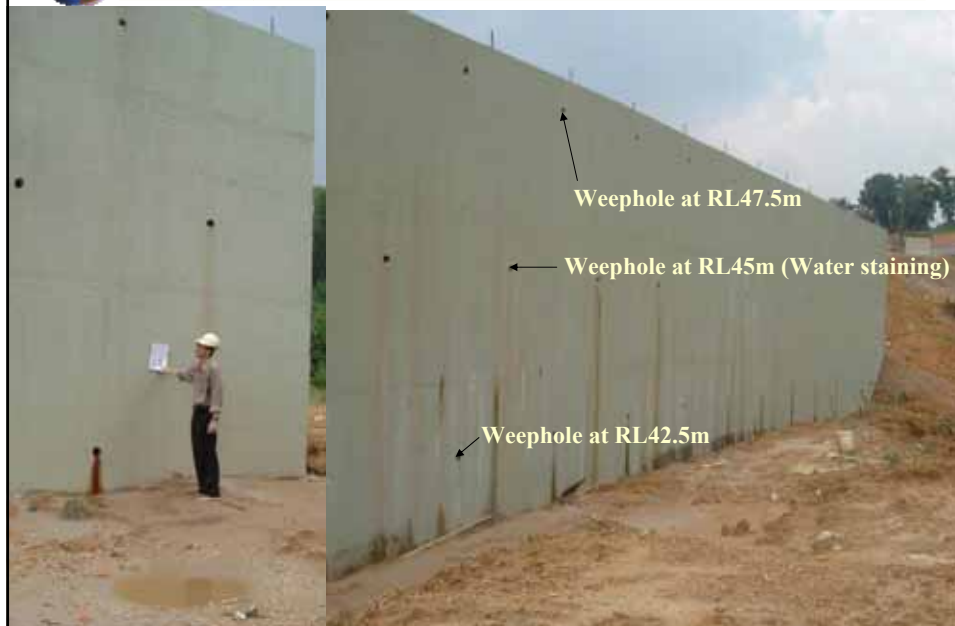
Weephole Drains

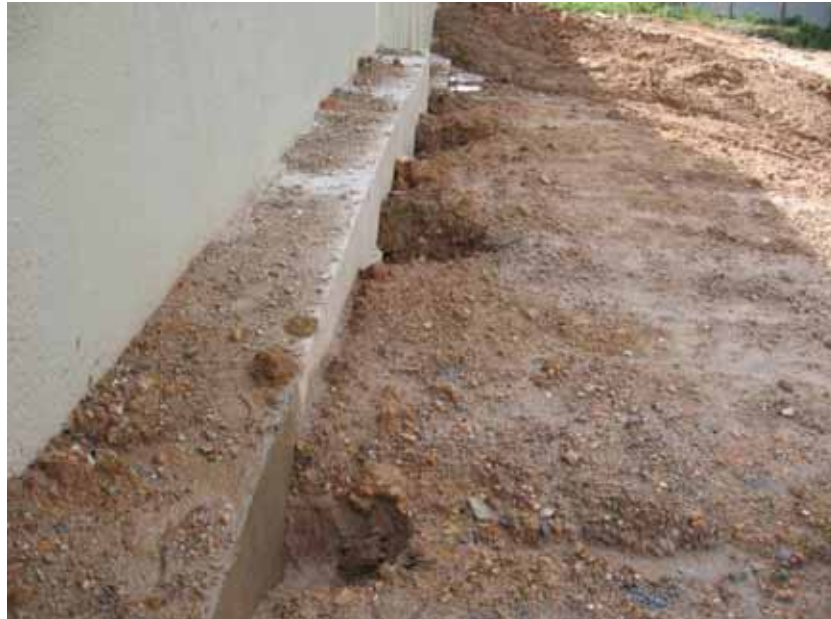
Erosion by Weephole Discharge

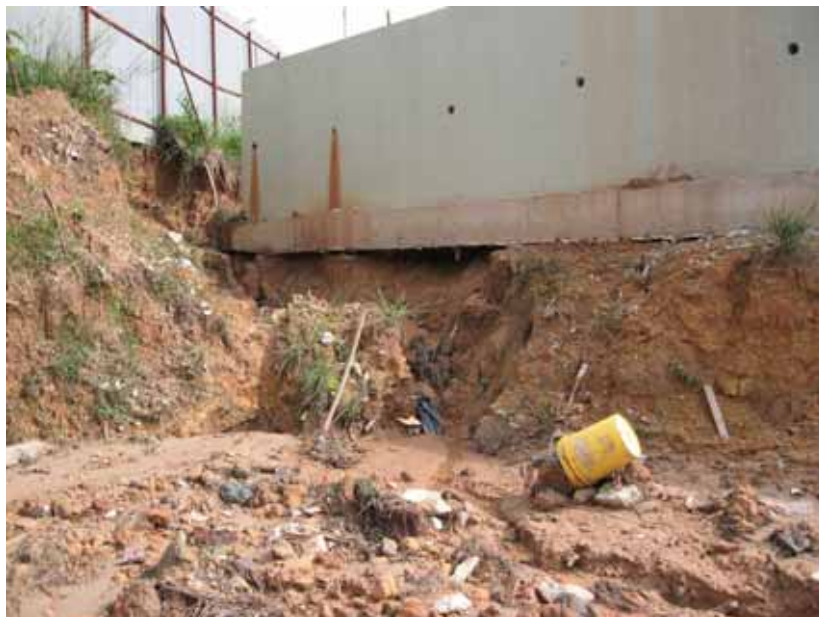
Erosion of Wall Base

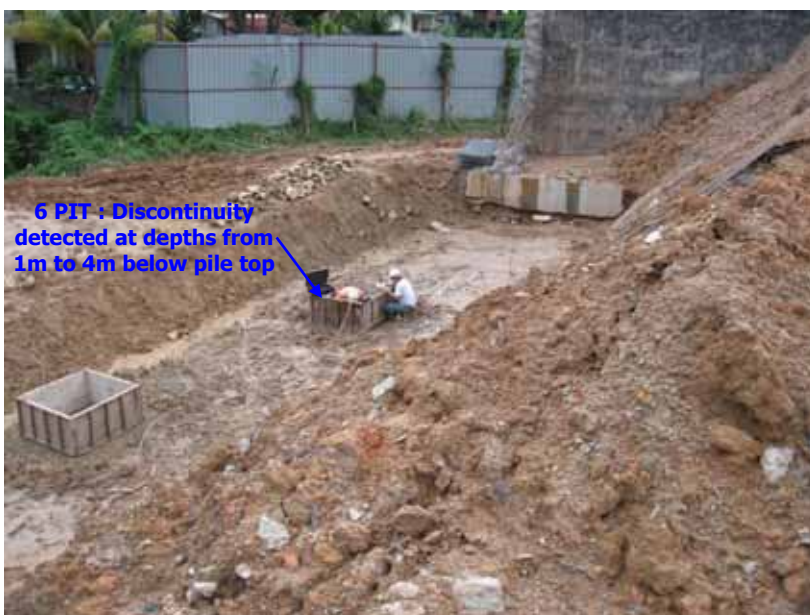
Pile Integrity Testing
