Instrumentation Results on Negative Dnndrag Force of Abutment Piles Underneath the Reinforced Earth Wall Embankment

GUE S. S., LIEW S. S. & TAN Y. C.
Gue & Partners Sdn. Bhd., Malaysia

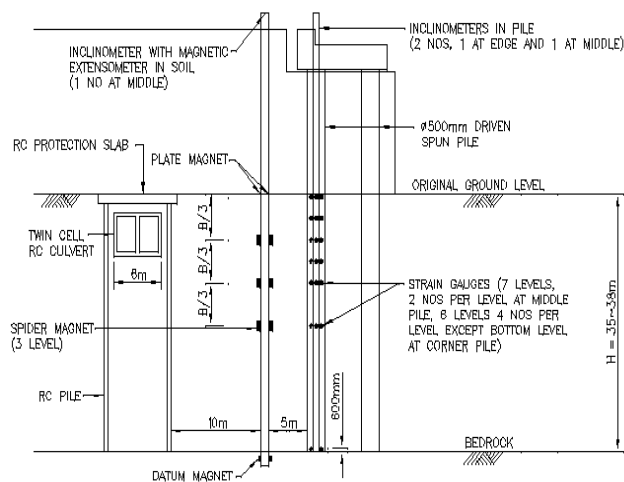
Fig. 1: Elevation View of Abutment and Twin-cell Culvert

The approach embankment structure is located in Petaling Jaya of Selangor State, Malaysia. The instrumentation was implemented at the north abutment, which consists of about 200m long RE wall embankment with the highest vertical dimension of 9m at the abutment. There is a twin-cell reinforced concrete culvert sitting over the starting point of a valley, which is 15 m away from the abutment and underneath the RE wall embankment. The culvert is protected by piled RC slab supporting the overlying RE wall embankment. Figure 1 shows the elevation view

of the abutment and the twin-cell culvert. Photo 1 shows the side view of the RE wall embankment.

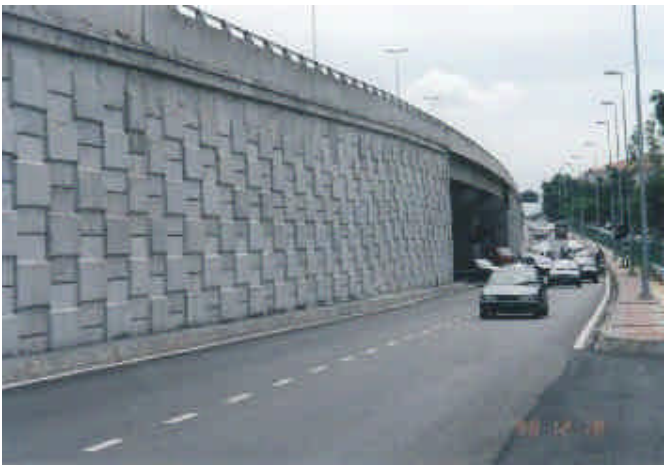
Photo 1: Side View of the RE Wall Embankment

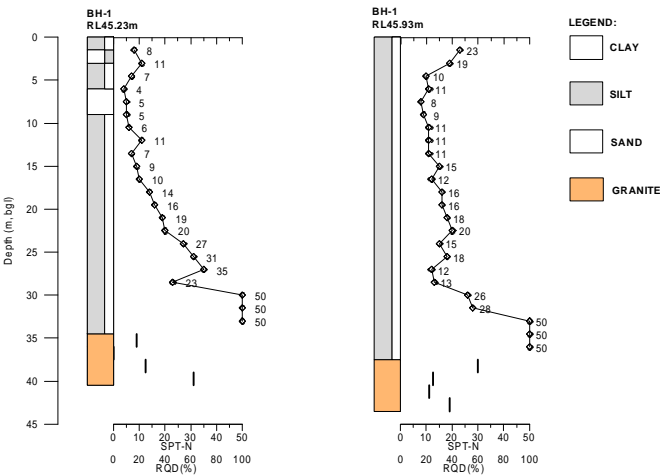
Fig. 2: Typical Borelog Profile

The general subsurface soil profile of the site is shown in Figure 2. The residual soils weathered from granite consist mainly clayey silt with occasional silty sand layers. Typically, there is a 4 to 5m thick of hard weathered residual soil with average plasticity index of 25 % immediately overlying the granitic bedrock. The consistency of the granitic residual increases with depth as reflected in the SPT-N profile. Groundwater table is about 10m below existing ground level. There is no encounter of any boulders in the few boreholes sunk for this interchange. The average rock head encountered during pile installation is about 35m to 38m below original ground level, which is consistent with bedrock level as shown in the boreholes. Borehole BH-1 is located about 28m behind the abutment piles and Boreholes BH-2 is 20m away from the abutment towards the adjacent bridge pier.

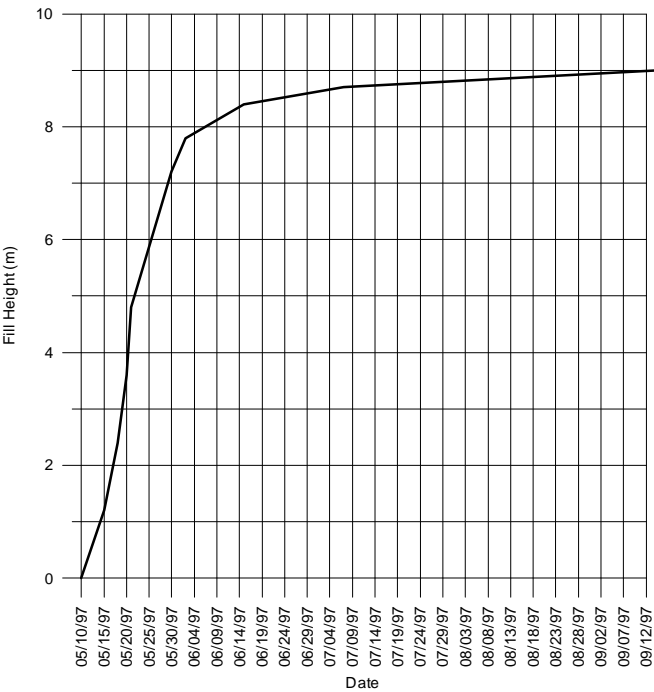
Fig. 3: Fill Height With Time

The construction sequence of the RE wall embankment is tabulated in Figure 3 and Table 1. In general, the entire embankment including the piling at the abutment took about 4 months to reach the final finished road levels. The abutment piling was carried out before erection of the wall panels and instruments were installed not later than the erection of the second layer of RE wall panels. During filling, the inclinometer tubing was extended upwards at every 3.0m filling interval.

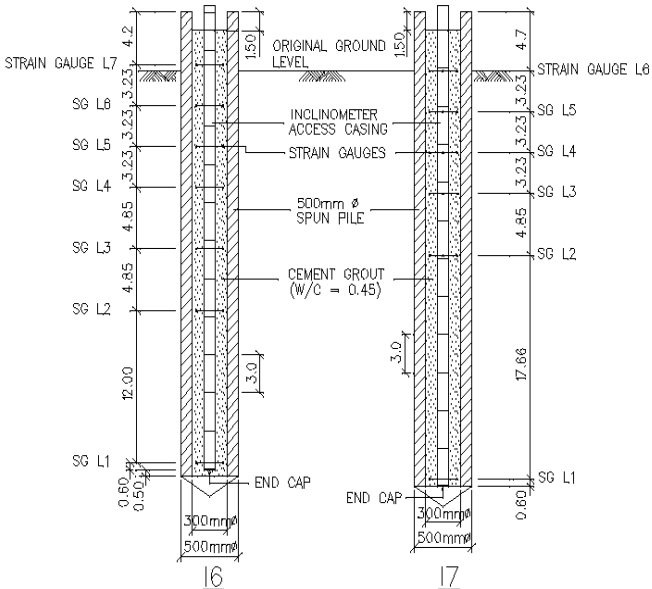
Fig. 5: Elevation View of Instrumented Test Pile

The arrangement of the strain gauges and the inclinometers in the spun pile are shown in Figure 5. Strain gauges were attached at various levels to the inclinometer tubing by the special designed spacers as shown in Figure 6. The empty annulus between the inner wall of the piles and the

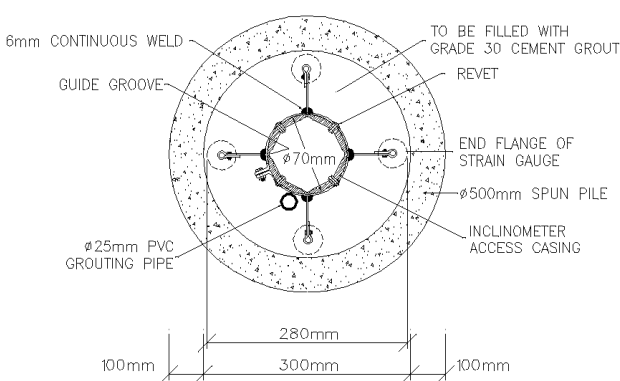
Fig. 6: Sectional View of Instrumented Test Pile

inclinometer tubing was subsequently grouted with Grade G30 cement grout to form a composite section of the piles. Readings at every stage of works were taken to indicate that the conditions of the strain gauges and the potential drift of the readings. The installation of the instruments in the abutment piles were carried out after the piles had been driven into the ground and reached the specified set criteria. The reasons of this installation procedure were to avoid potential damage to the instruments due to the driving impact and difficulties in extending the inclinometer tubing and wiring for strain gauges during the piling operation, particularly jointing of the piles. The multi-level spider magnetic extensometers were attached to the inclinometer tubing with sufficient clearance for sliding along the tubing. All the extensometers were referred to the base magnet installed at the depth of 0.5m into the granite bedrock. In this case, a firm reference datum can be established with minimum interference from the above ground construction activities. Figure 7 shows the perspective view of the instrumented spun pile. The installation details of magnetic spider extensometers are shown in Figure 8. The arrangements of closer spacing of extensometers at the upper soil layer and larger spacing of extensometers at the lower soil layer can provide a better resolution of the soil settlement profile as the upper layer is expected to settle more.

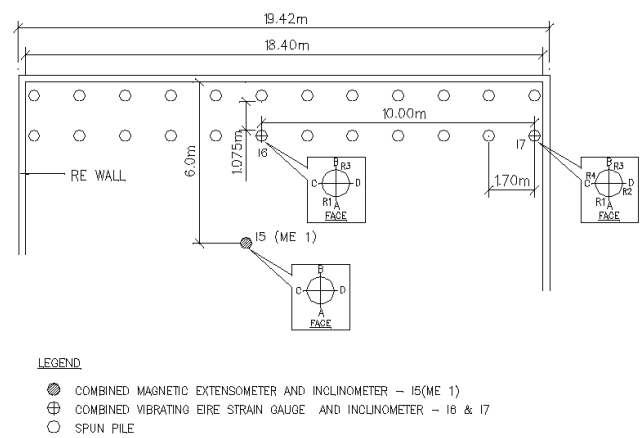
Fig. 4: Layout of Instruments

Two inclinometers, namely I6 and I7, with multilevel strain gauges were installed in the middle and edge piles (φ500mm spun piles) respectively. Another inclinometer, I5, with multilevel spider magnet extensometers was also installed in a borehole behind the abutment. The plan view of the instrumentation layout and the directions of the inclinometer movements are shown in Figure 4.

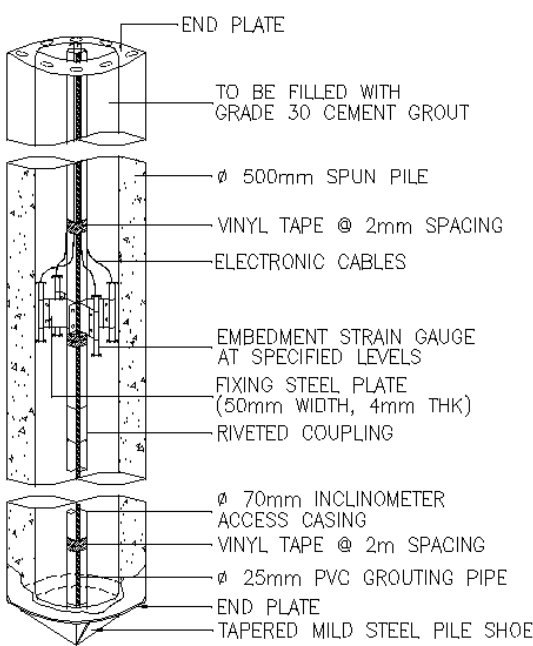
Fig. 7: Perspective View of Instrumented Test Pile

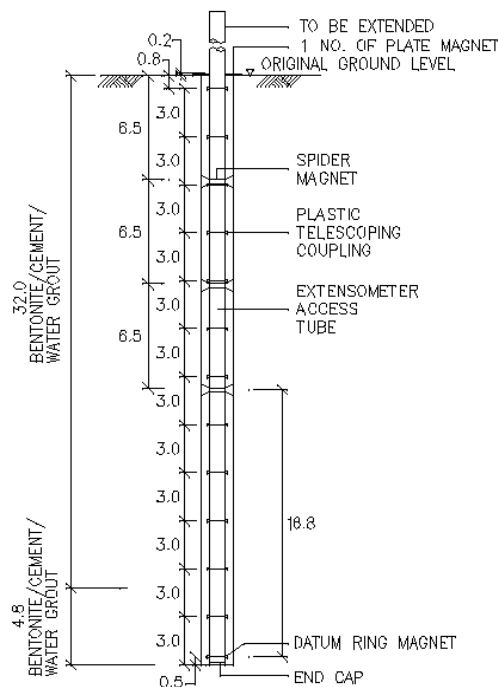
Fig.8: Elevation View of Magnetic Spider Extensometer

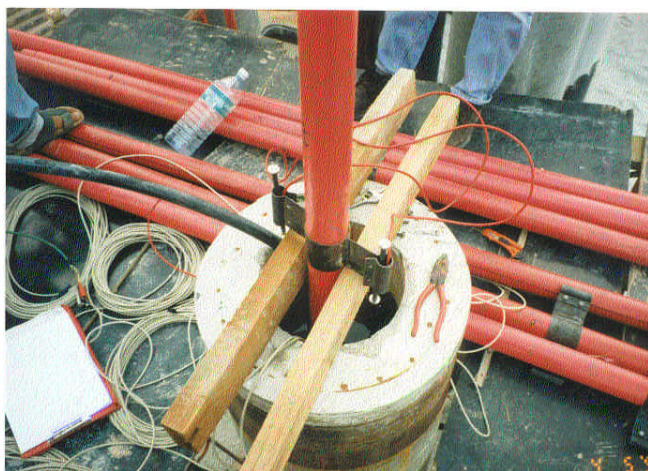
Photo 2: In the Process of Installing Strain Gauges
and Inclinometer in a Spun Pile

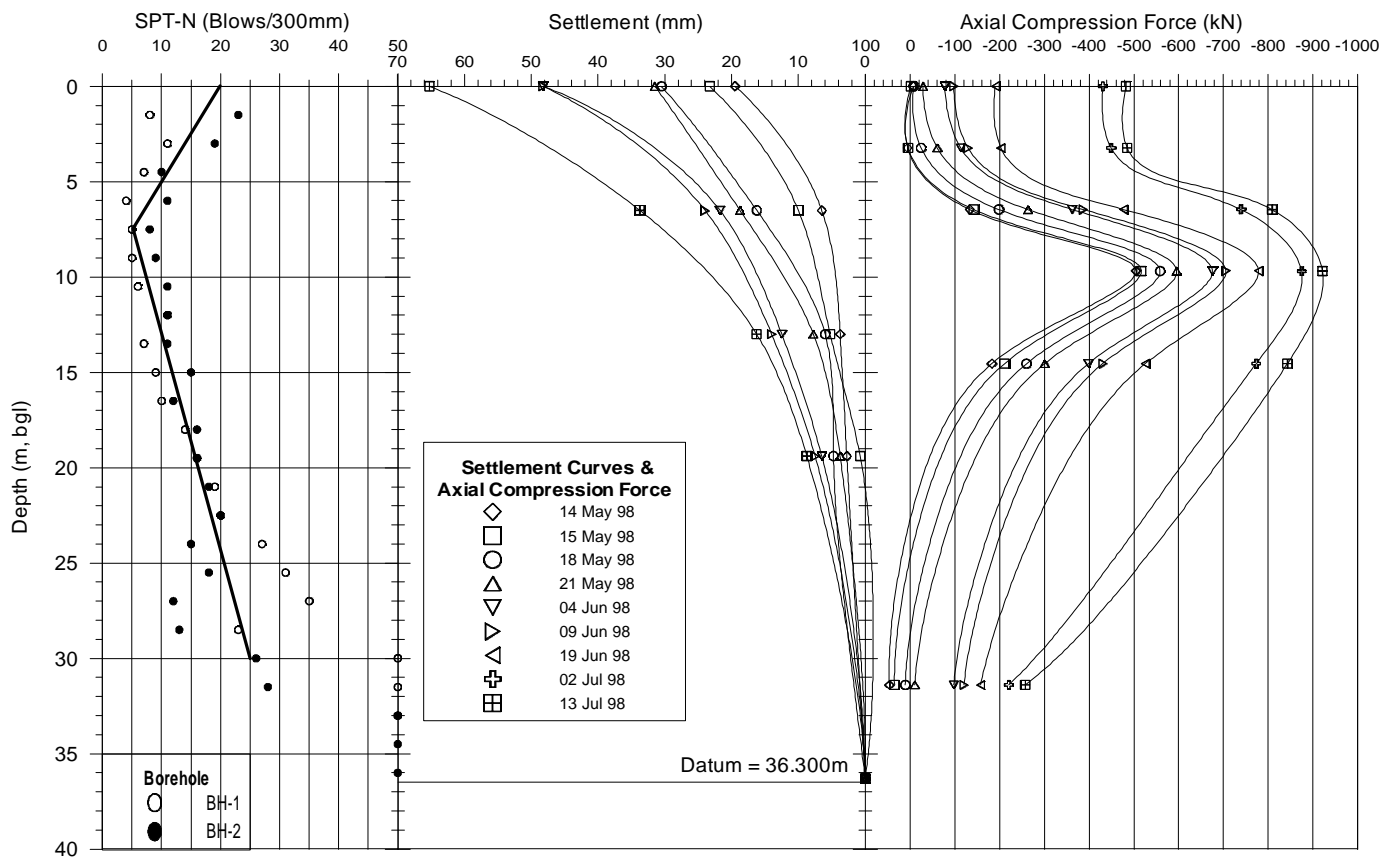
Fig. 9: Subsoil Consistency, Subsoil Settlement Profile and Pile Axial Load for Instrumented Pile (I6, Middle Pile)

The axial compression profiles for the $\phi 500\text{mm}$ spun piles, I6 (middle) and I7 (edge), are visualised in Figures 9 and 10 respectively. The SPT-N profile from the two adjacent boreholes and the settlement profile measured from magnetic spider extensometers at Inclinator I5 are also incorporated in Figures 9 and 10 to show the effect of ground settlement and the subsoil consistency on the induced downdrag force on the abutment piles. From the above results, it is not difficult to

observe that the compressible soil strata for this bridge interchange is at the first 15m below original ground level, where the neutral planes for middle pile and the edge pile are 7m and 10m below ground level respectively. If one was to choose the neutral plane before instrumentation results are available, it is likely that deeper neutral plane will be assumed based on normal practise for end bearing pile, probably at the hard stratum at about 30m below original ground level.

The final measured negative downdrag loads induced on the $\phi 500\text{mm}$ spun piles for portion below the ground and the observed neutral plane is between 440kN (I6) at the middle pile and 820kN (I7) at the edge pile, in which the skin resistance factors, β , in effective stress approach for estimating the negative skin friction are equivalent to 0.11 and 0.36 respectively. Little (1994) has given a very comprehensive review on the range of β values for various soil types. However, maximum pile axial loads of 920kN for I6 and 1100kN for I7 are still within the limit of the allowable structural capacity of 2200kN for $\phi 500\text{mm}$ prestressed spun pile even including the estimated additional live load of about 180kN per pile in service conditions. In fact, the application of the imposed live load will reduce the negative downdrag force on the pile as highlighted by Fellenius (1972) and Leifer (1994).

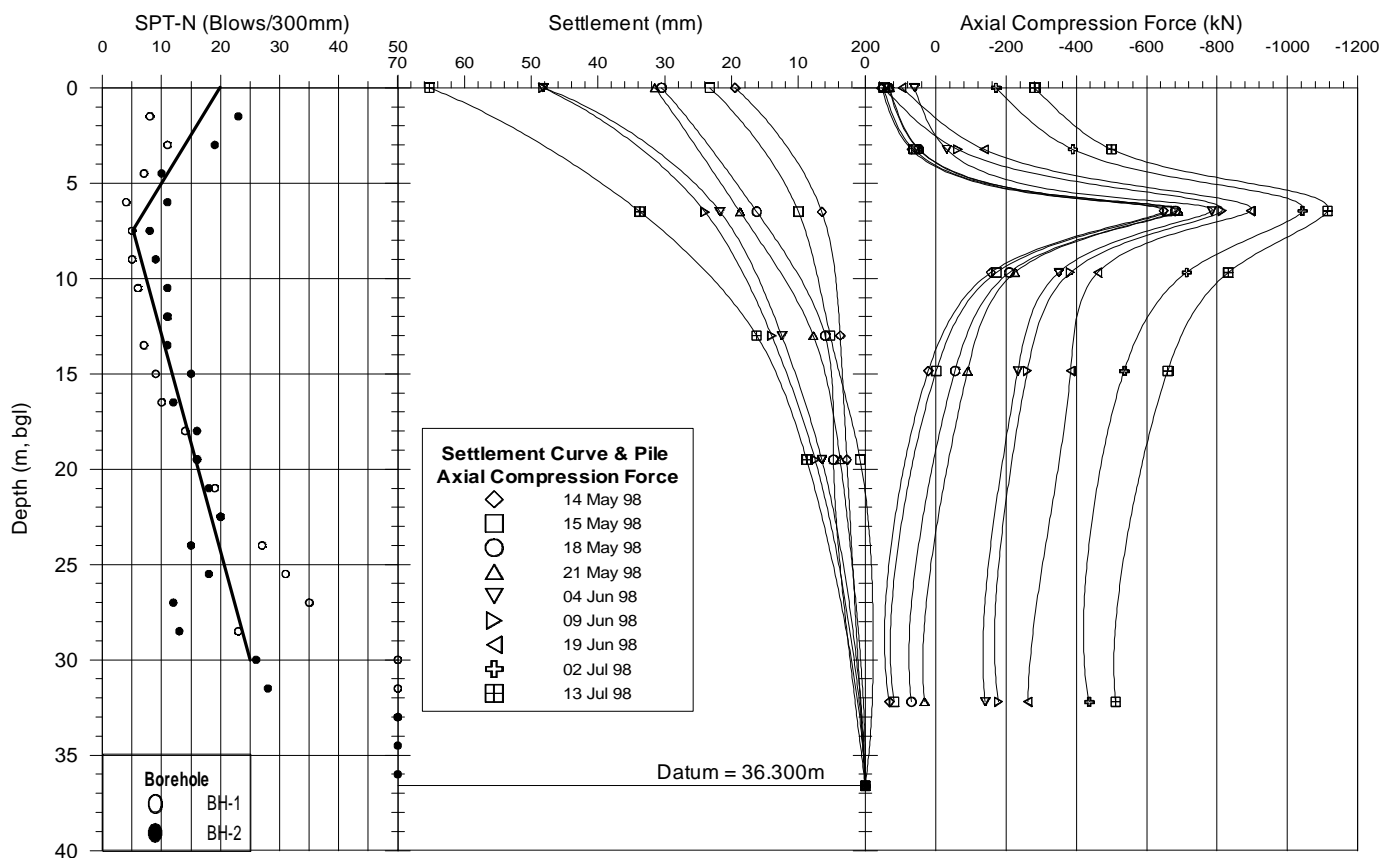
Fig. 10: Subsoil Consistency, Subsoil Settlement Profile and Pile Axial Load for Instrumented Pile (I7, Edge Pile)

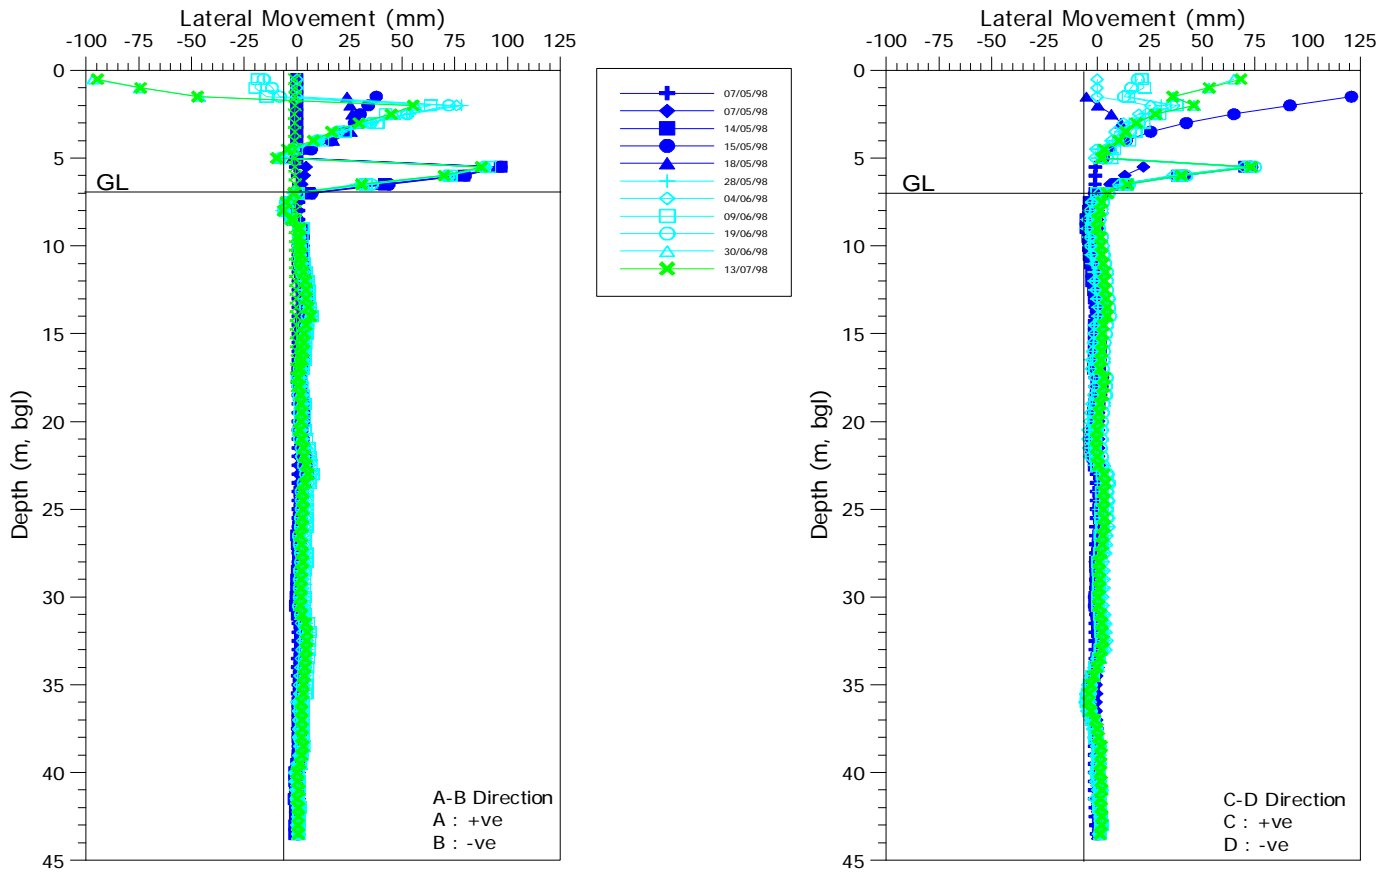
Fig. 11: Lateral Movement of Inclinator 15

The inclinometer profiles are shown in Figures 11 12 and 13 respectively. There were some disturbances on the inclinometer readings close to or above the pile top and above the original ground level due to free-standing length of the tubing and subsequent extension after every stage of filling. This is particularly obvious at the inclinometers installed in the borehole behind that abutment. Therefore, the readings at these disturbed areas were not interpreted in this study. The construction record of the RE wall embankment tabulated in Table 1 provides good indication of the imposed loading on the ground.

- Maximum vertical movement = 65mm at OGL
- Maximum axial compression for I6 = 920kN at 10m BOGL
- Maximum axial compression for I7 = 1100kN at 7.5m BOGL
- Maximum lateral movement for I5 (non-pile) = 8mm at OGL
- Maximum lateral movement for I6 (pile) = 24mm at 8m above OGL
- Maximum lateral movement for I7 (pile) = 28mm at 6m above OGL

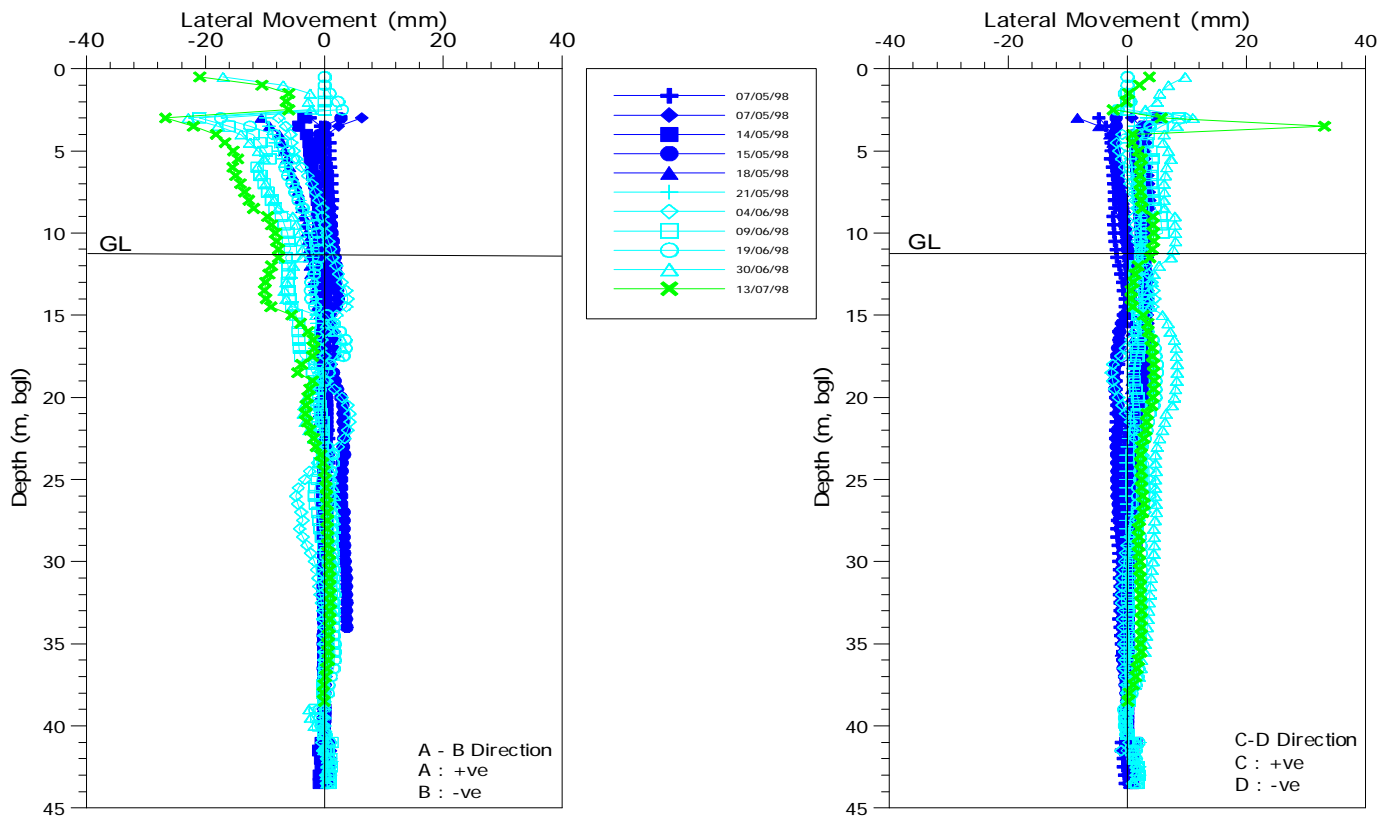
Fig. 12: Lateral Movement of Inclinator 16

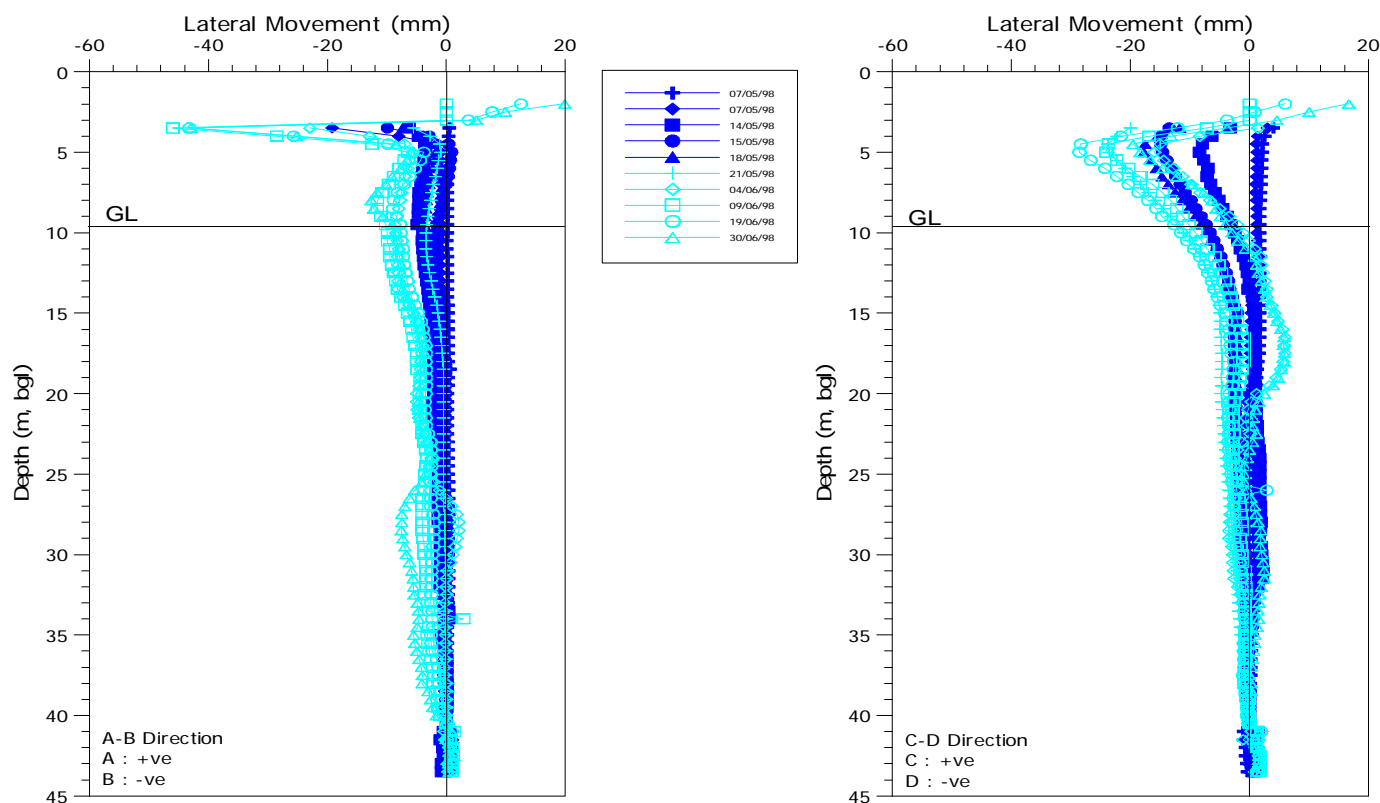
Fig. 13: Lateral Movement of Inclinomometer I7
