## **Problem and Solutions of Weak Soil In Engineering Application**

Ir. Liew Shaw Shong

G&P Geotechnics Sdn Bhd, Kuala Lumpur, Malaysia

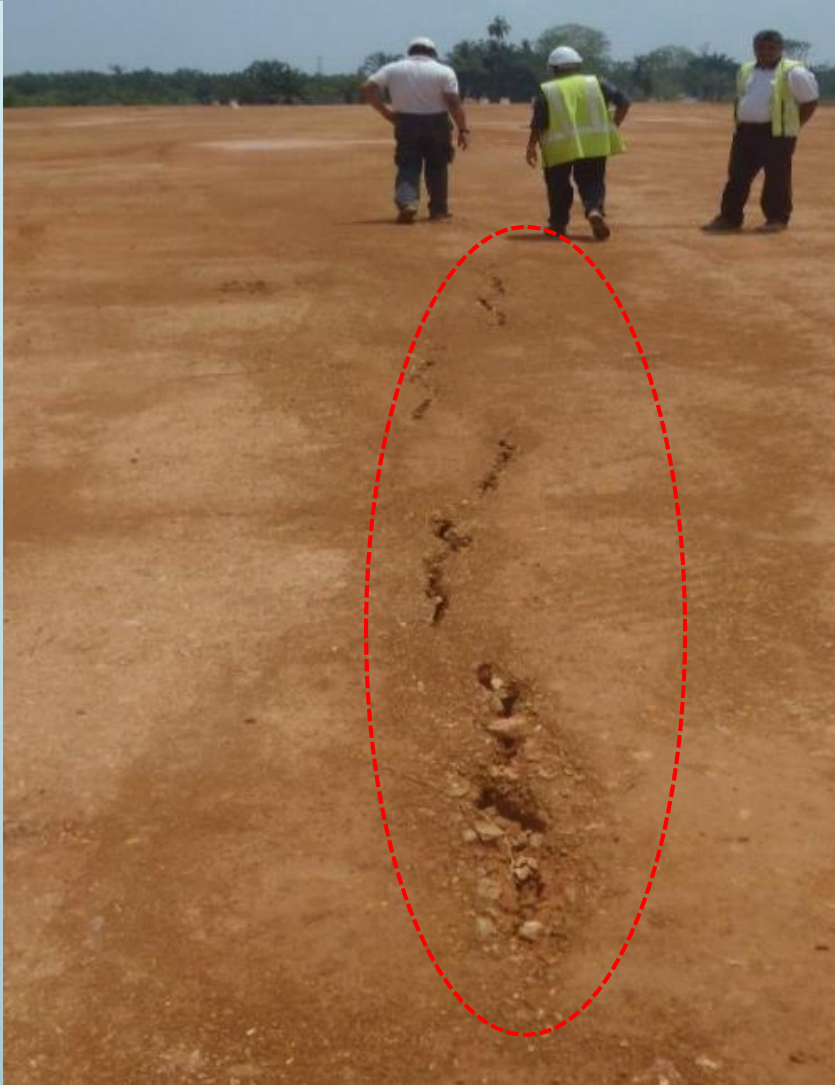
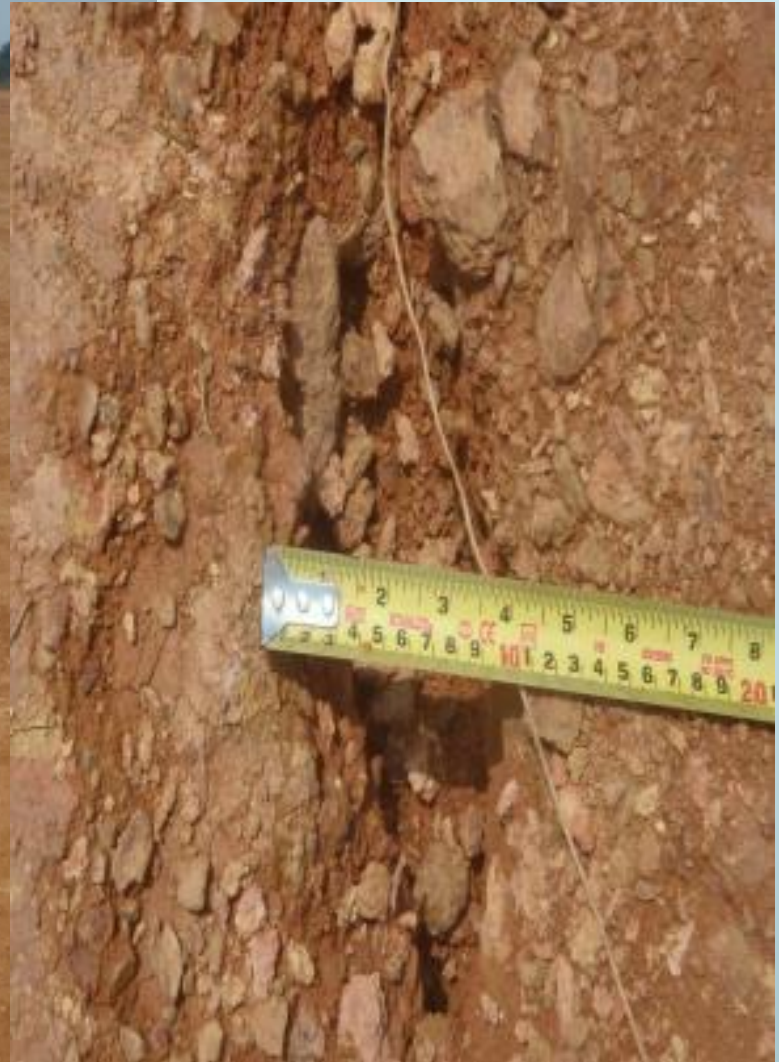
# Embankment Distresses

- ▶ Longitudinal flexural cracks on embankment surface

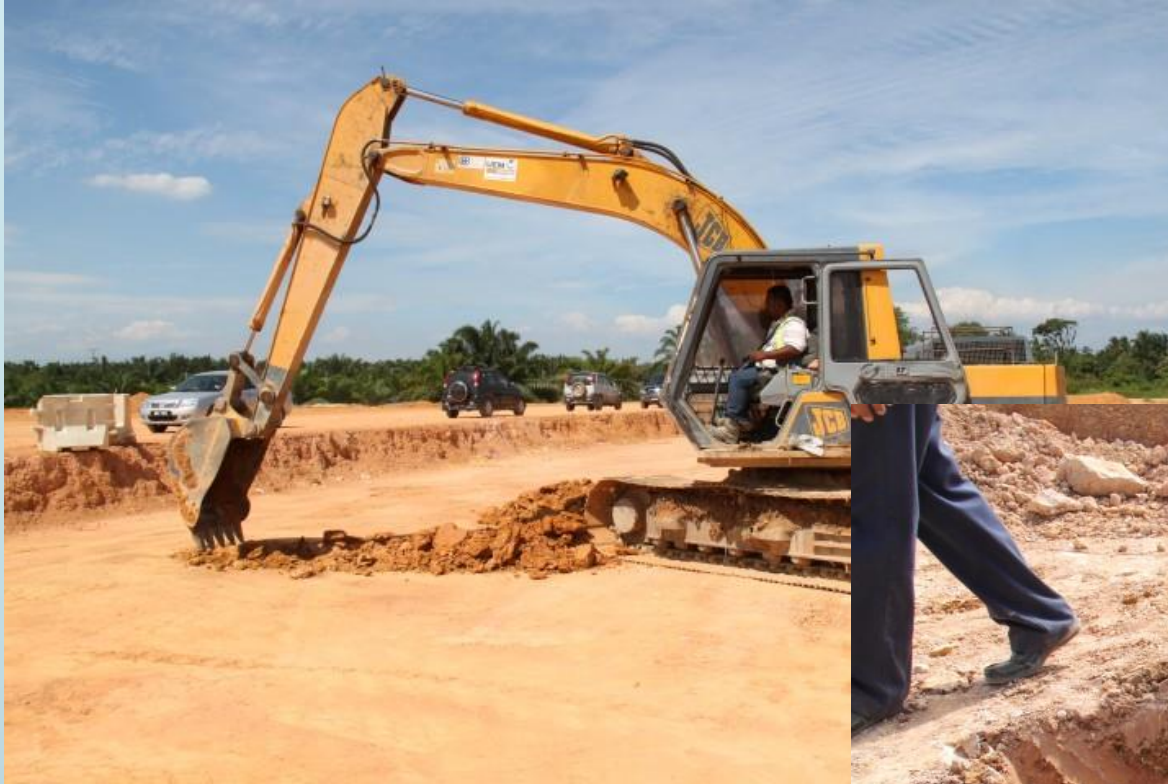
# Embankment Distresses

**Excavation on cracks found  
after 1m surcharge removal**
